Revised Asbestos Reassessment

St. James the Apostle
29 John Murray Street, Stoney
Creek, Ontario

August 5, 2021

Pinchin File: 286533.001

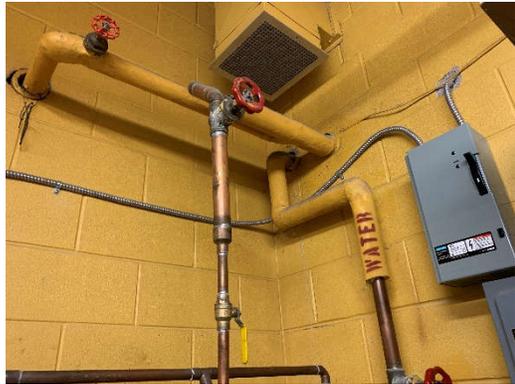
Material and Application	Asbestos Type/Friability	Photo
Parging cement is present on pipe fittings (elbows, valves, tees, hangers etc.).	None

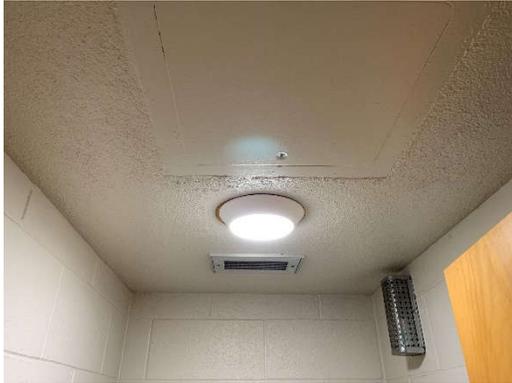
Material and Application	Asbestos Type/Friability	Photo
24"x48" lay-in ceiling tiles, with a short fissure and pinhole pattern are present.	None	
Smooth plaster present on ceilings does not contain asbestos.	None	
Textured plaster is present as a ceiling finish.	Chrysotile/Potentially Friable

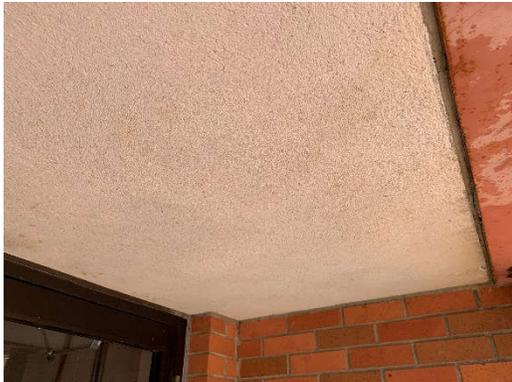
Textured plaster is present on exterior soffits.	Chrysotile/Potentially Friable

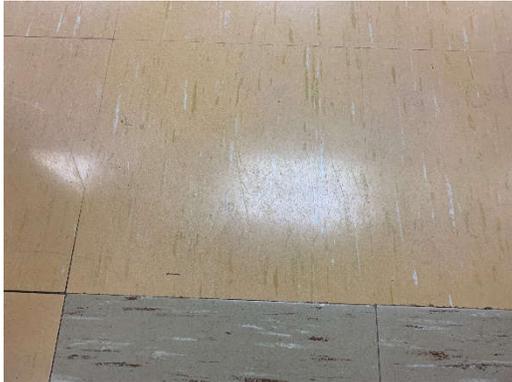
Vinyl sheet flooring, with a brown pebble pattern is present.	Presumed/Potentially Friable	
Vinyl floor tiles, 12"x12", yellow with white streak are present.	Chrysotile/Non-friable (tile) Presumed/Non-friable (mastic)

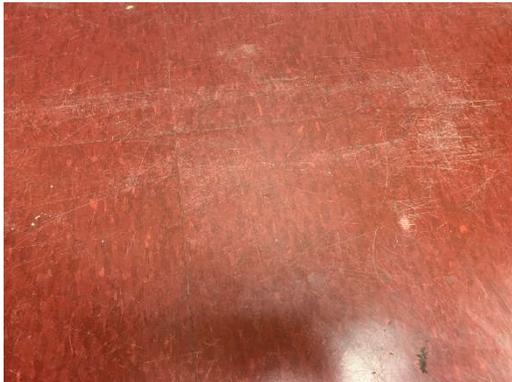
Vinyl floor tiles, 12"x12" red are present.	Chrysotile/Non-friable (tile) Presumed/Non-friable (mastic)

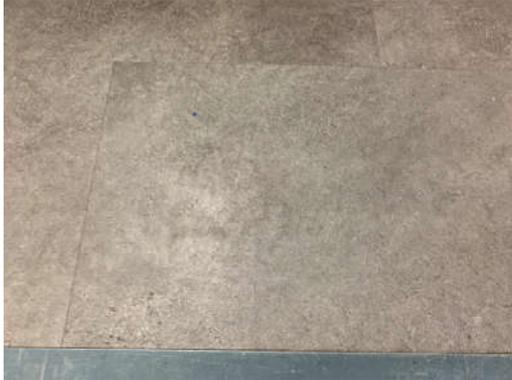
Material and Application	Asbestos Type/Friability	Photo
<p>Vinyl floor tiles, 12"x12" pink are present.</p>	<p>Presumed/Non-friable (tile) Presumed/Non-friable (mastic)</p>

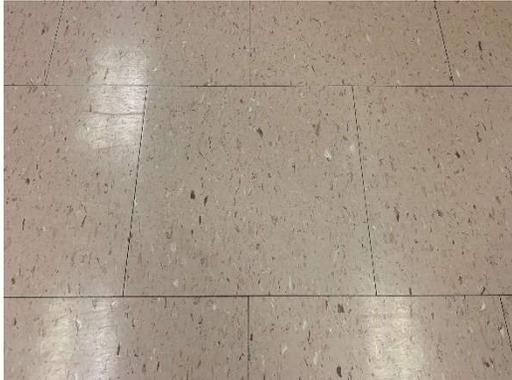
<p>Vinyl floor tiles, 12"x12", pink with red and white fleck are present.</p>	<p>Presumed/Non-friable (tile) Presumed/Non-friable (mastic)</p>

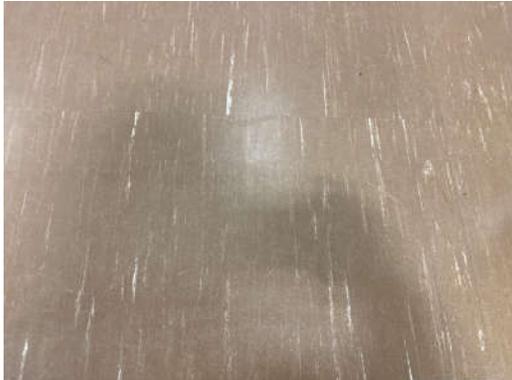
<p>Vinyl floor tiles, 12"x12", brown with white streaks are present.</p>	<p>Presumed/Non-friable (tile) Presumed/Non-friable (mastic)</p>

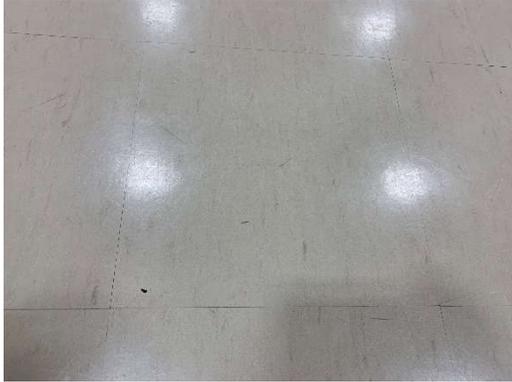
Material and Application	Asbestos Type/Friability	Photo
Vinyl floor tiles, 12"x12", beige with brown streaks are present.	Presumed/Non-friable (tile) Presumed/Non-friable (mastic)

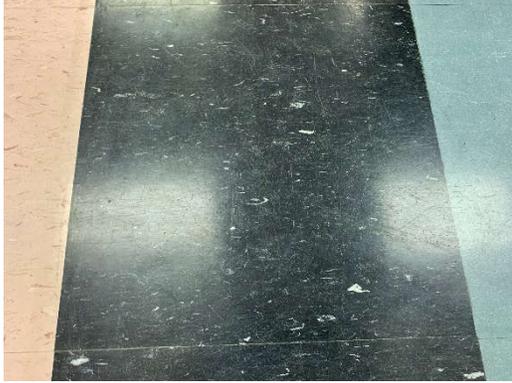
Vinyl floor tiles, 12"x12", black stripe are present.	Presumed/Non-friable (tile) Presumed/Non-friable (mastic)

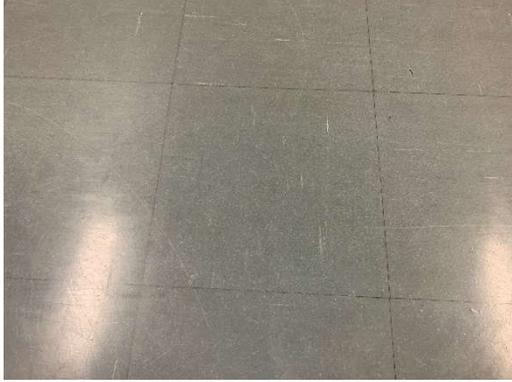
Vinyl floor tiles, 12"x12", blue with white streaks are present.	None (tile) None (mastic)

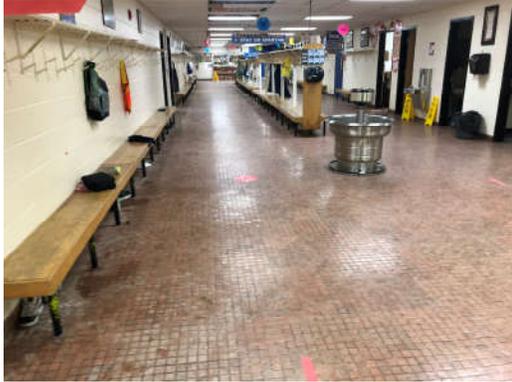
Material and Application	Asbestos Type/Friability	Photo
Textured paint on concrete block walls is present.	Chrysotile/Non-friable
