## **Asbestos Assessment**

Annunciation of our Lord  
250 Limeridge Road West,  
Hamilton, Ontario

**Hamilton-Wentworth Catholic  
District School Board**

December 30, 2021

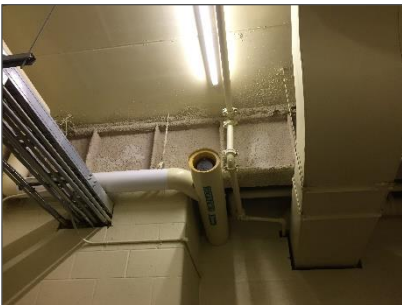
Material and Application	Asbestos Type/Friability	Photo
Non-asbestos containing fireproofing is present on structural steel including beams, trusses, joists, corrugated steel deck, concrete deck, columns.	None

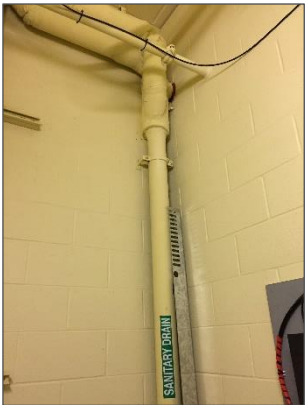
Pipes are either uninsulated or insulated with non-asbestos fibreglass.	None

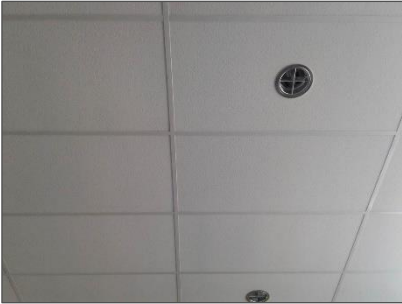
Material and Application	Asbestos Type/Friability	Photo
Mechanical equipment is either uninsulated or insulated with non-asbestos fibreglass.	None	
All ceiling tiles are presumed to be non-asbestos based on the date of manufacture determined from the date stamp applied to the top of the tiles and the age of the materials determined from the age of the building.	None

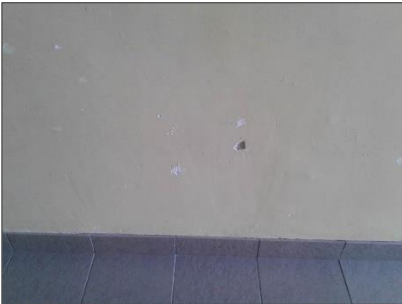
Plaster present on walls and ceilings does not contain asbestos.	None

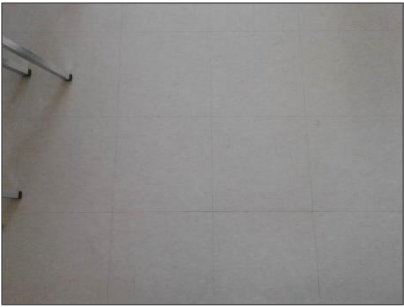
Material and Application	Asbestos Type/Friability	Photo
Vinyl floor tiles were presumed to be non-asbestos based on historical knowledge of the date of installation.	None
