## **Asbestos Assessment**

Bishop Ryan  
1824 Rymal Road East, Hamilton,  
Ontario

December 30, 2021

Pinchin File: 286533.001

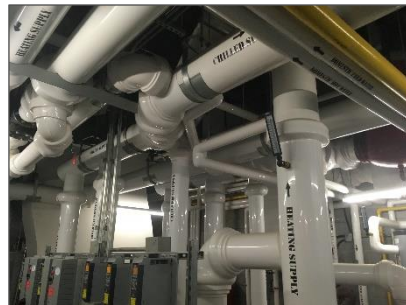
Pipes are either uninsulated or insulated with non-asbestos fibreglass or elastomeric insulation (Armaflex).	None

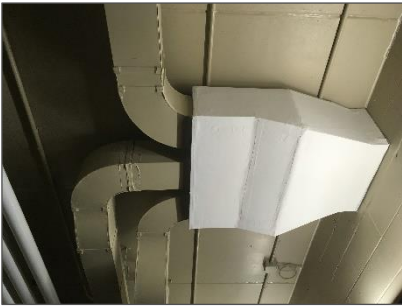
Material and Application	Asbestos Type/Friability	Photo
Ducts are either uninsulated or insulated with non-asbestos fibreglass (foil-faced or canvas).	None

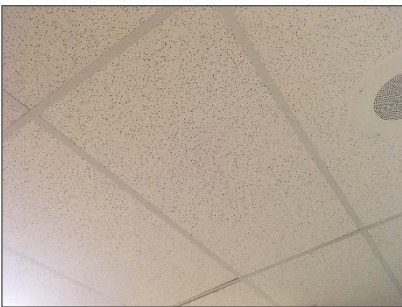
Mechanical equipment is either uninsulated or insulated with non-asbestos fibreglass.	None	
All ceiling tiles are presumed to be non-asbestos based on the date of manufacture determined from the date stamp applied to the top of the tiles and the age of the materials determined from the age of the building.	None

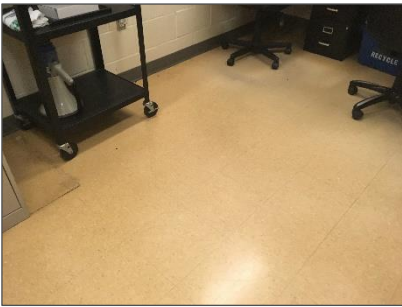
Asbestos in drywall joint compound was banned in Canada in 1980. The building was constructed after 1986 (1980 plus a reasonable non-compliance period based on our experience) and the drywall joint compound is assumed to contain no asbestos.	None	
Vinyl floor tiles and mastic were presumed to be non-asbestos based on historical knowledge of the date of installation.	None
