# **Asbestos Assessment**

Bishop Tonnos  
100 Panabaker Drive, Ancaster,  
Ontario

December 30, 2021

Pinchin File: 286533.001

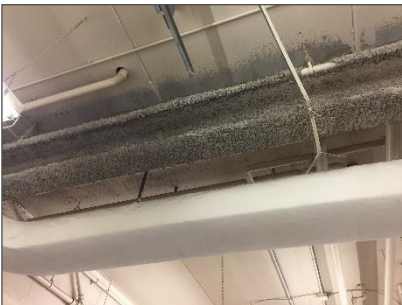
Material and Application	Asbestos Type/Friability	Photo
Non-asbestos containing fireproofing is present on structural steel including beams, trusses, joists, corrugated steel deck, concrete deck, columns.	None

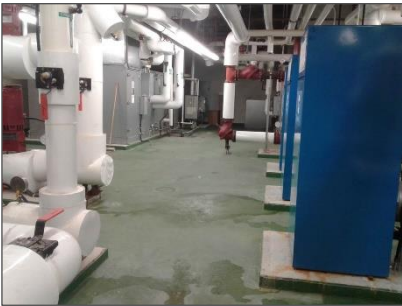
Non-asbestos texture finish is present on the concrete deck.	None	
Pipes are either uninsulated or insulated with non-asbestos fibreglass or elastomeric insulation (Armaflex).	None

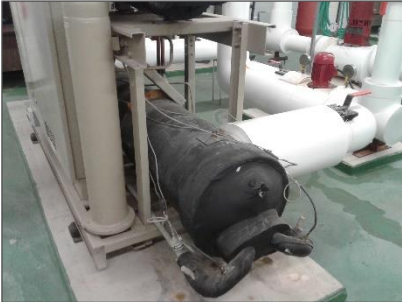
Material and Application	Asbestos Type/Friability	Photo
Mechanical equipment is either uninsulated or insulated with non-asbestos fibreglass.	None

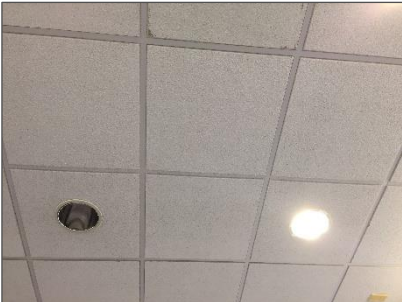
All ceiling tiles are presumed to be non-asbestos based on the date of manufacture determined from the date stamp applied to the top of the tiles and the age of the materials determined from the age of the building.	None
