Asbestos Assessment

Cardinal Newman
127 Grays Road, Stoney Creek,
Ontario

December 30, 2021

Pinchin File: 286533.001

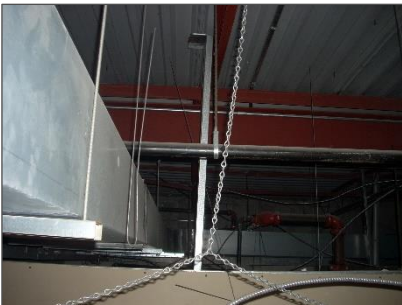
Material and Application	Asbestos Type/Friability	Photo
Pipes are either uninsulated or insulated with non-asbestos fibreglass	None	
Ducts are either uninsulated or insulated with non-asbestos fibreglass (foil-faced or canvas).	None

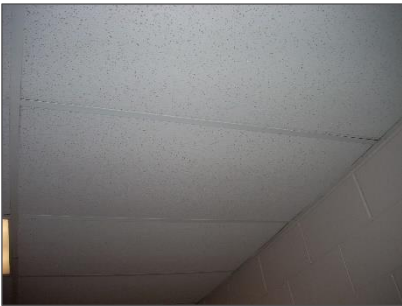
Mechanical equipment is either uninsulated or insulated with non-asbestos fibreglass.	None	
All ceiling tiles are presumed to be non-asbestos based on the date of manufacture determined from the date stamp applied to the top of the tiles and the age of the materials determined from the age of the building.	None
