Asbestos Assessment

Guardian Angels
705 Centre Road, Hamilton, Ontario

December 30, 2021

Pinchin File: 286533.001

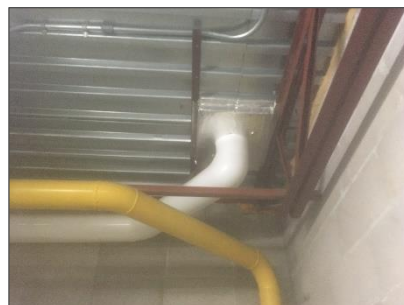
Material and Application	Asbestos Type/Friability	Photo
Pipes are either uninsulated or insulated with non-asbestos fibreglass insulation.	None

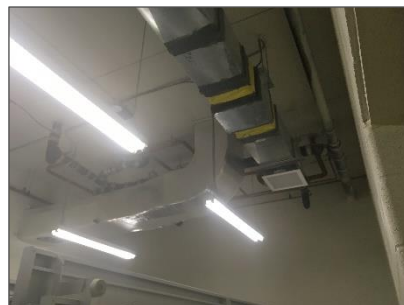
Ducts are either uninsulated or insulated with non-asbestos fibreglass (foil-faced).	None

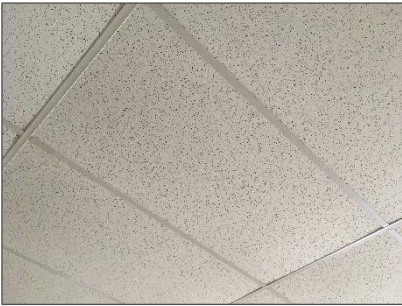
Material and Application	Asbestos Type/Friability	Photo
All ceiling tiles are presumed to be non-asbestos based on the date of manufacture determined from the date stamp applied to the top of the tiles and the age of the materials determined from the age of the building.	None

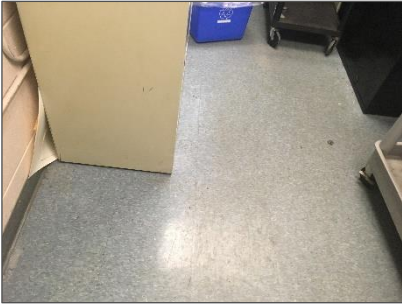
Asbestos in drywall joint compound was banned in Canada in 1980. The building was constructed after 1986 (1980 plus a reasonable non-compliance period based on our experience) and the drywall joint compound is assumed to contain no asbestos.	None	
Vinyl floor tiles were presumed to be non-asbestos based on historical knowledge of the date of installation.	None
