Asbestos Assessment

Holy Name of Jesus
181 Belmont Avenue, Hamilton,
Ontario

Pinchin File: 286533.001

Holy Name of Jesus, 181 Belmont Avenue, Hamilton, Ontario
Hamilton-Wentworth Catholic District School Board

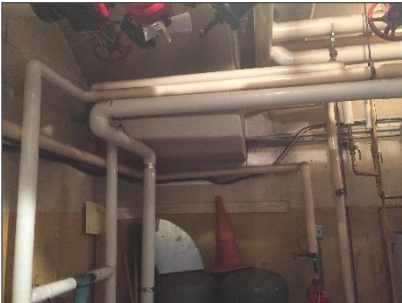
| Material and Application | Asbestos Type/Friability | Photo |
|---|---|---|
| Pipes are either uninsulated or insulated with non-asbestos fibreglass insulation. | None | |
| Ducts are either uninsulated or insulated with non-asbestos fibreglass (foil-faced or canvas). | None | |
| Mechanical equipment is either uninsulated or insulated with non-asbestos fibreglass. | None | |

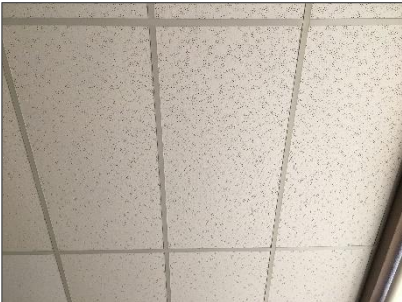
| Material and Application | Asbestos Type/Friability | Photo |
|---|---|---|
| All ceiling tiles are presumed to be non-asbestos based on the date of manufacture determined from the date stamp applied to the top of the tiles and the age of the materials determined from the age of the building. | None | |

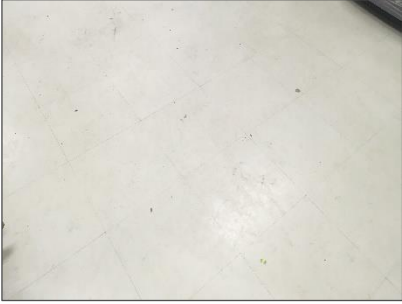
| Material and Application | Asbestos Type/Friability | Photo |
|---|---|--|
| Vinyl floor tiles and mastic were presumed to be non-asbestos based on historical knowledge of the date of installation. | None | |
