Asbestos Assessment

Holy Name of Mary
161 Meadowlands Boulevard,
Ancaster, Ontario

December 30, 2021

Pinchin File: 286533.001

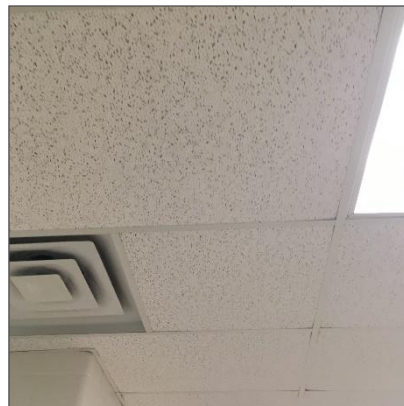
Material and Application	Asbestos Type/Friability	Photo
Pipes are either uninsulated or insulated with non-asbestos fibreglass or elastomeric insulation (Armaflex).	None	
Ducts are either uninsulated or insulated with non-asbestos fibreglass (foil-faced).	None	
Mechanical equipment is either uninsulated or insulated with non-asbestos fibreglass.	None	
All ceiling tiles are presumed to be non-asbestos based on the date of manufacture determined from the date stamp applied to the top of the tiles and the age of the materials determined from the age of the building.	None

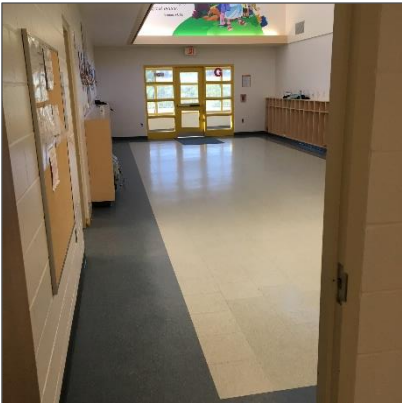
Material and Application	Asbestos Type/Friability	Photo
Asbestos in drywall joint compound was banned in Canada in 1980. The building was constructed after 1986 (1980 plus a reasonable non-compliance period based on our experience) and the drywall joint compound is assumed to contain no asbestos.	None	
Vinyl floor tiles and mastic were presumed to be non-asbestos based on historical knowledge of the date of installation.	None

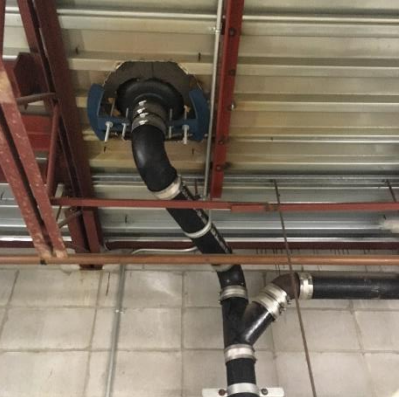
Exterior and interior caulking [window frames, door frames, expansion joints, and flashings] does not contain asbestos.	None	
Rain water leaders were observed to be cast iron.	None
