Asbestos Assessment

Immaculate Conception
470 Kitty Murray Lane, Ancaster,
Ontario

December 30, 2021

Pinchin File: 286533.001

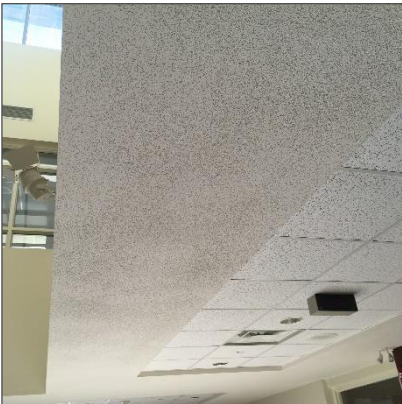
Material and Application	Asbestos Type/Friability	Photo
Texture finish is present on drywall finishes within the Corridor is presumed to be non-asbestos based on historical knowledge of the date of installation.	None

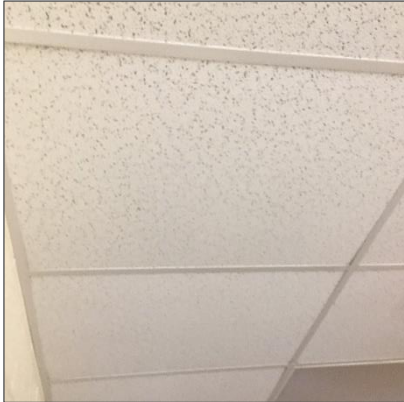
Material and Application	Asbestos Type/Friability	Photo
All ceiling tiles are presumed to be non-asbestos based on the date of manufacture determined from the date stamp applied to the top of the tiles and the age of the materials determined from the age of the building.	None

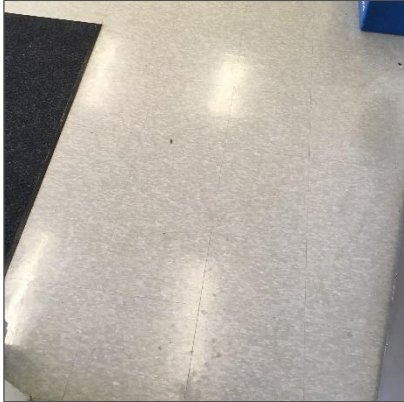
Asbestos in drywall joint compound was banned in Canada in 1980. The building was constructed after 1986 (1980 plus a reasonable non-compliance period based on our experience) and the drywall joint compound is assumed to contain no asbestos.	None	
Vinyl floor tiles and mastic were presumed to be non-asbestos based on historical knowledge of the date of installation.	None

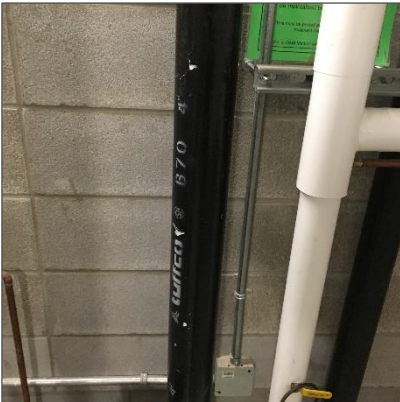
Material and Application	Asbestos Type/Friability	Photo
Rain water leaders were observed to be cast iron.	None
