## **Asbestos Assessment**

Immaculate Heart of Mary  
190 Glover Road, Stoney Creek,  
Ontario

**Hamilton-Wentworth Catholic  
District School Board**

December 30, 2021

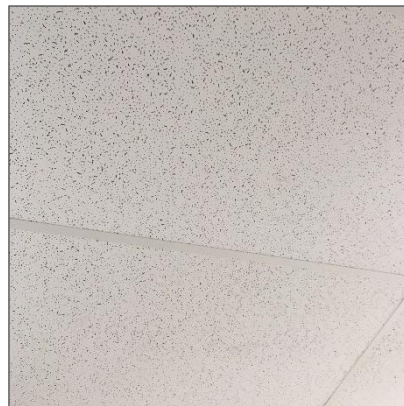
Material and Application	Asbestos Type/Friability	Photo
Pipes are either uninsulated or insulated with non-asbestos fibreglass or elastomeric insulation (Armaflex).	None	
Ducts are either uninsulated or insulated with non-asbestos fibreglass (foil-faced).	None	
Mechanical equipment is either uninsulated or insulated with non-asbestos fibreglass.	None	
All ceiling tiles are presumed to be non-asbestos based on the date of manufacture determined from the date stamp applied to the top of the tiles and the age of the materials determined from the age of the building.	None

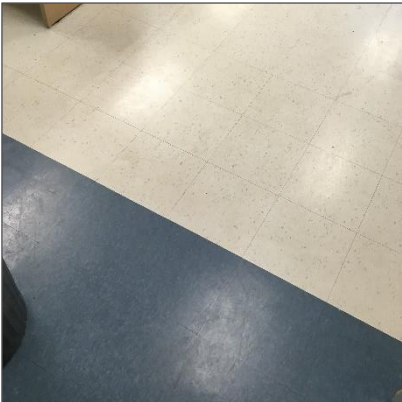
Material and Application	Asbestos Type/Friability	Photo
Asbestos in drywall joint compound was banned in Canada in 1980. The building was constructed after 1986 (1980 plus a reasonable non-compliance period based on our experience) and the drywall joint compound is assumed to contain no asbestos.	None	
Vinyl floor tiles and mastic were presumed to be non-asbestos based on historical knowledge of the date of installation.	None

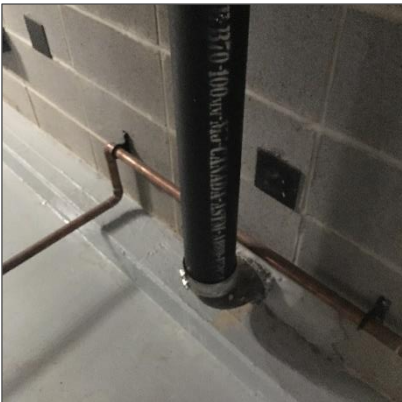
Exterior and interior caulking does not contain asbestos.	None	
Rain water leaders were observed to be cast iron.	None
