Asbestos Assessment

New Our Lady of the Assumption
103 Fletcher Road, Hannon,
Ontario

December 30, 2021

Pinchin File: 286533.001

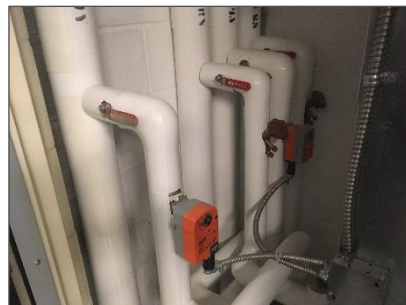
Material and Application	Asbestos Type/Friability	Photo
Non-asbestos texture finish is present on drywall walls ceilings.	None	
Pipes are either uninsulated or insulated with non-asbestos fibreglass insulation.	None

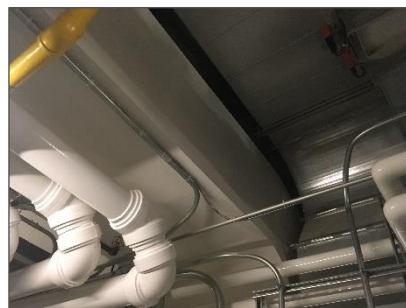
Ducts are either uninsulated or insulated with non-asbestos fibreglass (foil-faced or canvas).	None

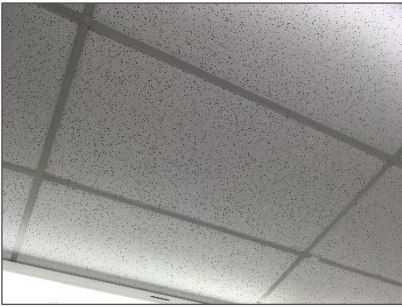
Material and Application	Asbestos Type/Friability	Photo
All ceiling tiles are presumed to be non-asbestos based on the date of manufacture determined from the date stamp applied to the top of the tiles and the age of the materials determined from the age of the building.	None

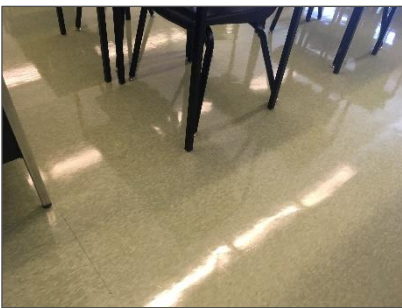
Asbestos in drywall joint compound was banned in Canada in 1980. The building was constructed after 1986 (1980 plus a reasonable non-compliance period based on our experience) and the drywall joint compound is assumed to contain no asbestos.	None	
Vinyl floor tiles were presumed to be non-asbestos based on historical knowledge of the date of installation.	None
