Asbestos Assessment

Our Lady of Mount Carmel
1624 Centre Road, Carlisle, Ontario

December 30, 2021

Pinchin File: 286533.001

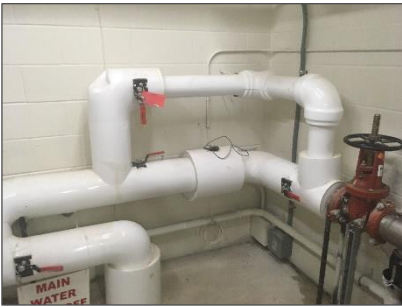
Material and Application	Asbestos Type/Friability	Photo
Pipes are either uninsulated or insulated with non-asbestos fibreglass or elastomeric insulation (Armaflex).	None

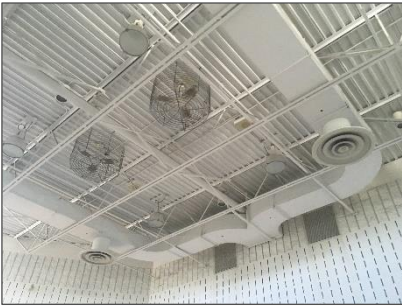
Ducts are either uninsulated or insulated with non-asbestos fibreglass (foil-faced).	None

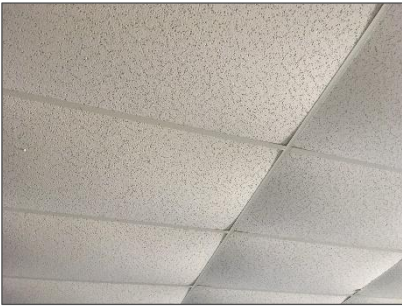
Material and Application	Asbestos Type/Friability	Photo
All ceiling tiles are presumed to be non-asbestos based on the date of manufacture determined from the date stamp applied to the top of the tiles and the age of the materials determined from the age of the building.	None

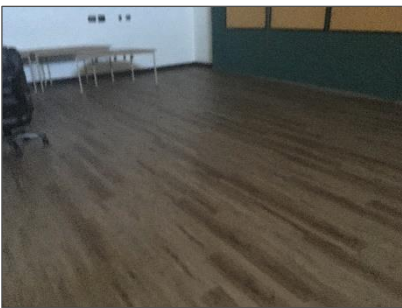
Asbestos in drywall joint compound was banned in Canada in 1980. The building was constructed after 1986 (1980 plus a reasonable non-compliance period based on our experience) and the drywall joint compound is assumed to contain no asbestos.	None	
Vinyl sheet flooring is presumed to be non-asbestos based on historical knowledge of the type of flooring (foam) or based on the lack of a paper backing layer (underpad).	None

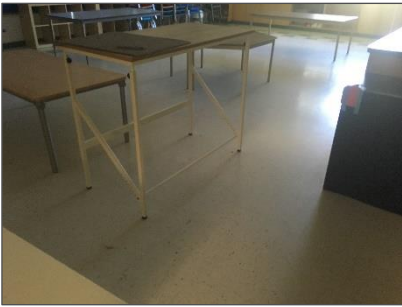
Vinyl floor tiles were presumed to be non-asbestos based on historical knowledge of the date of installation.	None
