Asbestos Assessment

St. Therese of Lisieux
1760 Garth Street, Hamilton, Ontario

**Hamilton-Wentworth Catholic
District School Board**

December 30, 2021

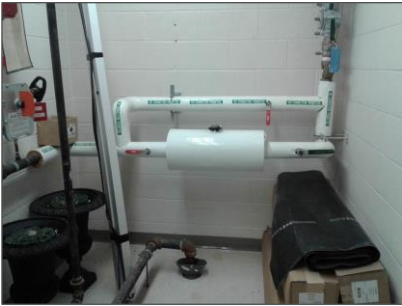
Material and Application	Asbestos Type/Friability	Photo
Pipes are either uninsulated or insulated with non-asbestos fibreglass or elastomeric insulation (Armaflex).	None

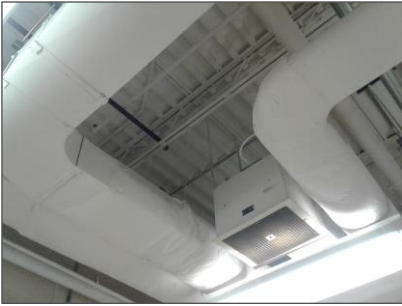
Ducts are either uninsulated or insulated with non-asbestos fibreglass (foil-faced or canvas).	None
