Asbestos Assessment

St. Ann Hamilton
15 St. Ann Street, Hamilton, Ontario

December 30, 2021

Pinchin File: 286533.001

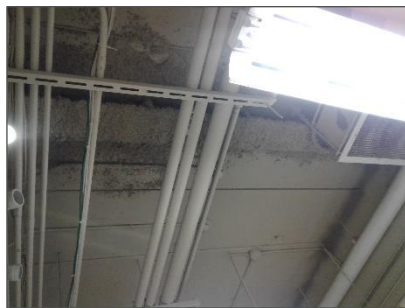
Material and Application	Asbestos Type/Friability	Photo
Non-asbestos containing fireproofing is present on structural steel including beams, trusses, joists, corrugated steel deck, concrete deck, columns.	None

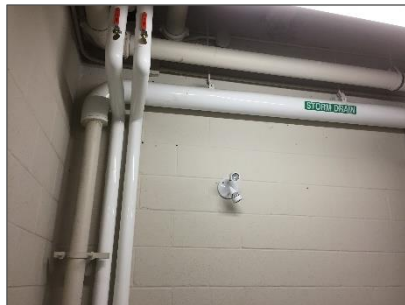
Pipes are either uninsulated or insulated with non-asbestos fibreglass or elastomeric insulation (Armaflex).	None

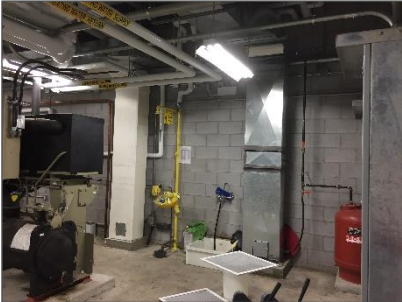
Material and Application	Asbestos Type/Friability	Photo
Ducts are either uninsulated or insulated with non-asbestos fibreglass (foil-faced or canvas).	None

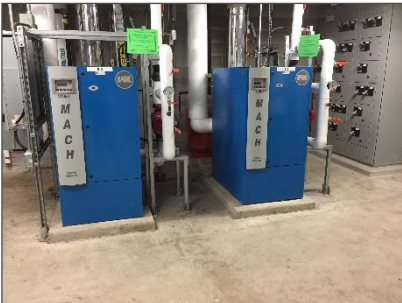
Duct mastic does not contain asbestos.	None	
Mechanical equipment is either uninsulated or insulated with non-asbestos fibreglass or elastomeric insulation (Armaflex).	None

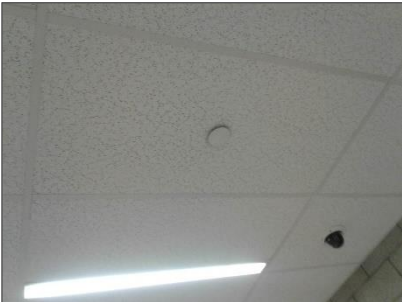
All ceiling tiles are presumed to be non-asbestos based on the date of manufacture determined from the date stamp applied to the top of the tiles and the age of the materials determined from the age of the building.	None

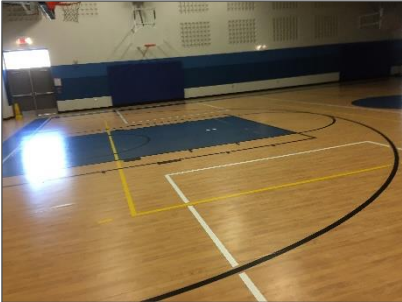
Material and Application	Asbestos Type/Friability	Photo
Vinyl sheet flooring is presumed to be non-asbestos based on historical knowledge of the type of flooring (foam) or based on the lack of a paper backing layer (underpad).	None

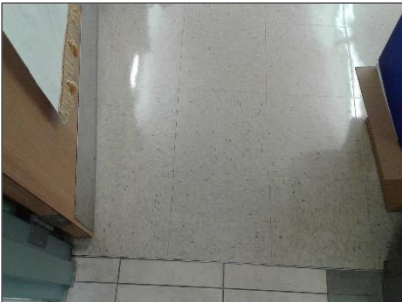
Vinyl floor tiles were presumed to be non-asbestos based on historical knowledge of the date of installation.	None
