Asbestos Assessment

St. Bernadette
270 Governors Road, Dundas,
Ontario

December 30, 2021

Pinchin File: 286533.001

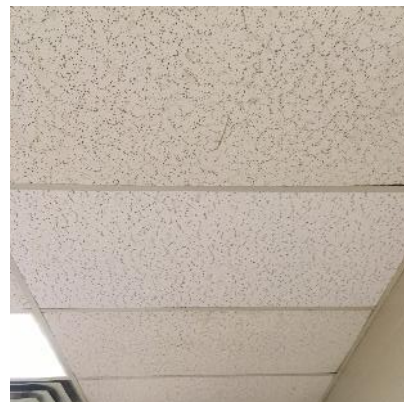
Material and Application	Asbestos Type/Friability	Photo
Pipes are either uninsulated or insulated with non-asbestos fibreglass or elastomeric insulation (Armaflex).	None	
Ducts are either uninsulated or insulated with non-asbestos fibreglass (foil-faced).	None	
Mechanical equipment is either uninsulated or insulated with non-asbestos fibreglass.	None	
All ceiling tiles are presumed to be non-asbestos based on the date of manufacture determined from the date stamp applied to the top of the tiles or the age of the materials determined from the age of the building or the renovation.	None

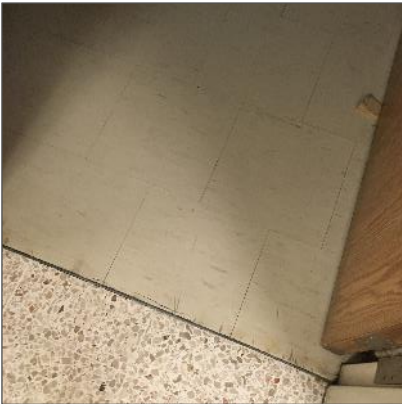
Material and Application	Asbestos Type/Friability	Photo
Asbestos in drywall joint compound was banned in Canada in 1980. Drywall joint compound in the 1991 was installed after 1986 (1980 plus a reasonable non-compliance period based on our experience) and is assumed to contain no asbestos.	None	
Vinyl floor tiles (12"x12") and mastic, throughout the building are presumed to contain asbestos until sampling proves otherwise.	Presumed

- A comprehensive testing program for mastic was not performed and therefore all mastic is presumed to contain asbestos.

Sample presumed ACM prior to alteration or maintenance work if the presumed ACM may be disturbed by the work.
