Asbestos Assessment

St. John Paul II
600 Acadia Drive, Hamilton, Ontario

December 30, 2021

Pinchin File: 286533.001

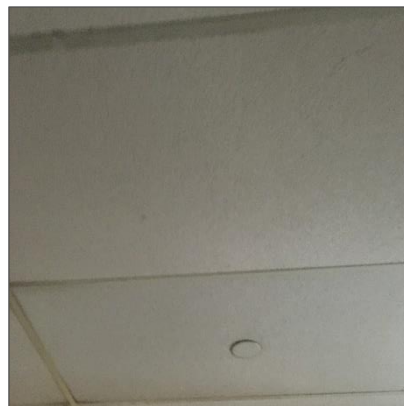
Material and Application	Asbestos Type/Friability	Photo
Pipes are either uninsulated or insulated with non-asbestos fibreglass or elastomeric insulation (Armaflex).	None	
Ducts are either uninsulated or insulated with non-asbestos fibreglass (foil-faced).	None	
Mechanical equipment is either uninsulated or insulated with non-asbestos fibreglass.	None	
All ceiling tiles are presumed to be non-asbestos based on the date of manufacture determined from the date stamp applied to the top of the tiles and the age of the materials determined from the age of the building.	None

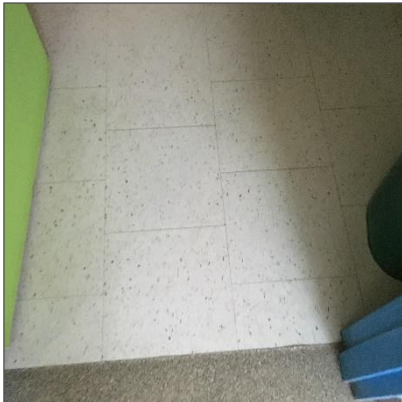
Material and Application	Asbestos Type/Friability	Photo
<p>Asbestos in drywall joint compound was banned in Canada in 1980. The building was constructed after 1986 (1980 plus a reasonable non-compliance period based on our experience) and the drywall joint compound is assumed to contain no asbestos.</p>	None	
<p>Vinyl floor tiles and mastic were presumed to be non-asbestos based on historical knowledge of the date of installation.</p>	None
