Asbestos Assessment

St. Marguerite d'Youville
20 Bonaparte Way, Hamilton,
Ontario

December 30, 2021

Pinchin File: 286533.001

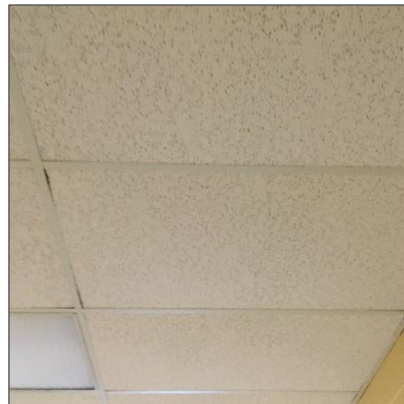
Material and Application	Asbestos Type/Friability	Photo
Pipes are either uninsulated or insulated with non-asbestos fibreglass or elastomeric insulation (Armaflex).	None	
Ducts are either uninsulated or insulated with non-asbestos fibreglass (foil-faced).	None	
Mechanical equipment is either uninsulated or insulated with non-asbestos fibreglass.	None	
All ceiling tiles are presumed to be non-asbestos based on the date of manufacture determined from the date stamp applied to the top of the tiles and the age of the materials determined from the age of the building.	None

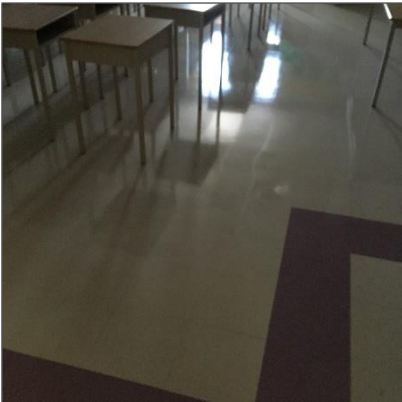
Material and Application	Asbestos Type/Friability	Photo
Asbestos in drywall joint compound was banned in Canada in 1980. The building was constructed after 1986 (1980 plus a reasonable non-compliance period based on our experience) and the drywall joint compound is assumed to contain no asbestos.	None	
Vinyl floor tiles and mastic were presumed to be non-asbestos based on historical knowledge of the date of installation.	None

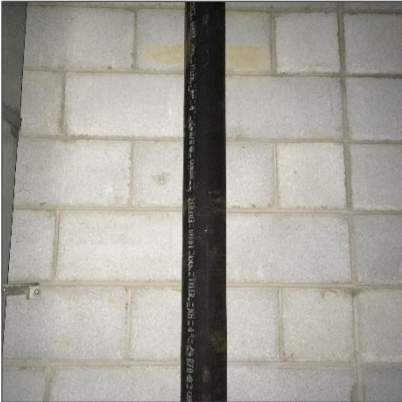
Exterior and interior caulking [window frames, door frames, expansion joints, and flashings] does not contain asbestos.	None	
Rain water leaders were observed to be cast iron.	None
