Asbestos Assessment

St. Mark's
43 Whitdeer Road, Stoney Creek,
Ontario

December 30, 2021

Pinchin File: 286533.001

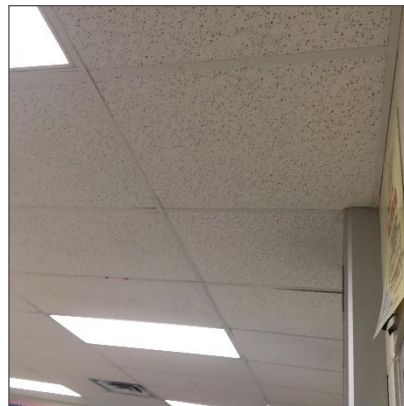
Material and Application	Asbestos Type/Friability	Photo
Non-asbestos texture finish is present on the concrete deck.	None	
Pipes are either uninsulated or insulated with non-asbestos fibreglass or elastomeric insulation (Armaflex).	None	
Ducts are either uninsulated or insulated with non-asbestos fibreglass (foil-faced).	None	
Mechanical equipment is either uninsulated or insulated with non-asbestos fibreglass.	None	
All ceiling tiles are presumed to be non-asbestos based on the date of manufacture determined from the date stamp applied to the top of the tiles and the age of the materials determined from the age of the building.	None

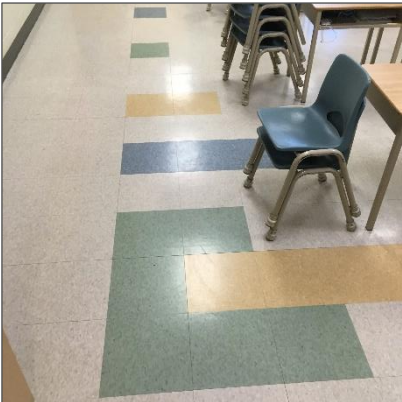
Material and Application	Asbestos Type/Friability	Photo
Asbestos in drywall joint compound was banned in Canada in 1980. The building was constructed after 1986 (1980 plus a reasonable non-compliance period based on our experience) and the drywall joint compound is assumed to contain no asbestos.	None	
Vinyl floor tiles and mastic were presumed to be non-asbestos based on historical knowledge of the date of installation.	None
