Asbestos Assessment

St. Matthew
200 Windwood Drive, Binbrook,
Ontario

December 30, 2021

Pinchin File: 286533.001

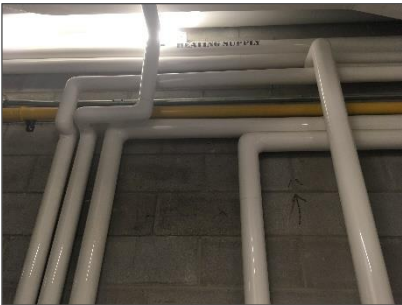
Material and Application	Asbestos Type/Friability	Photo
Pipes are either uninsulated or insulated with non-asbestos fibreglass or elastomeric insulation (Armaflex).	None

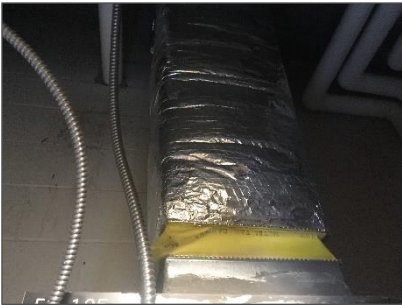
Ducts are either uninsulated or insulated with non-asbestos fibreglass (foil-faced or canvas).	None

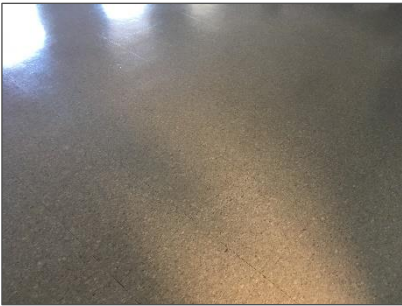
Material and Application	Asbestos Type/Friability	Photo
All ceiling tiles are presumed to be non-asbestos based on the date of manufacture determined from the date stamp applied to the top of the tiles and the age of the materials determined from the age of the building.	None	
Asbestos in drywall joint compound was banned in Canada in 1980. The building was constructed after 1986 (1980 plus a reasonable non-compliance period based on our experience) and the drywall joint compound is assumed to contain no asbestos.	None	
Vinyl floor tiles were presumed to be non-asbestos based on historical knowledge of the date of installation.	None
