Asbestos Assessment

St. Teresa of Calcutta
1 Rexford Drive, Hamilton, Ontario

**Hamilton-Wentworth Catholic
District School Board**

December 30, 2021

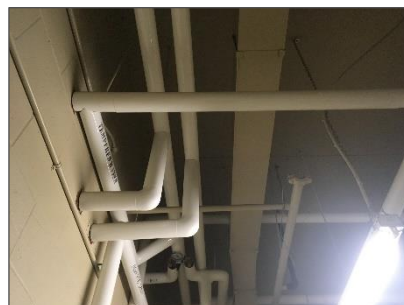
Material and Application	Asbestos Type/Friability	Photo
Pipes are either uninsulated or insulated with non-asbestos fibreglass insulation (Armaflex).	None

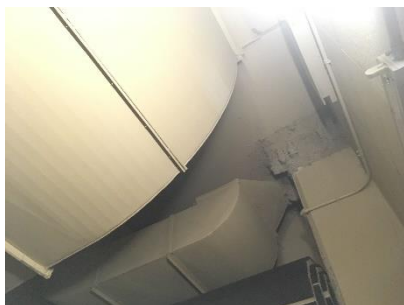
Ducts are either uninsulated or insulated with non-asbestos fibreglass (foil-faced).	None

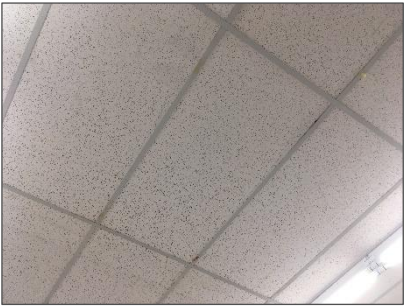
Material and Application	Asbestos Type/Friability	Photo
All ceiling tiles are presumed to be non-asbestos based on the date of manufacture determined from the date stamp applied to the top of the tiles and the age of the materials determined from the age of the building.	None

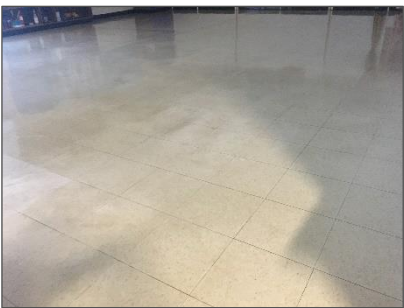
Asbestos in drywall joint compound was banned in Canada in 1980. The building was constructed after 1986 (1980 plus a reasonable non-compliance period based on our experience) and the drywall joint compound is assumed to contain no asbestos.	None	
Vinyl floor tiles were presumed to be non-asbestos based on historical knowledge of the date of installation.	None
