Asbestos Reassessment

St. Thomas More
1045 Upper Paradise Road,
Hamilton, Ontario

December 30, 2021

Pinchin File: 286533.001

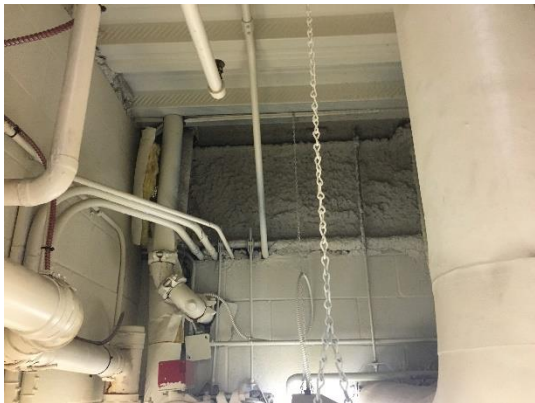
Material and Application	Asbestos Type/Friability	Photo
Non-asbestos containing fireproofing is present on structural steel including beams, trusses, joists, corrugated steel deck, concrete deck, columns.	None

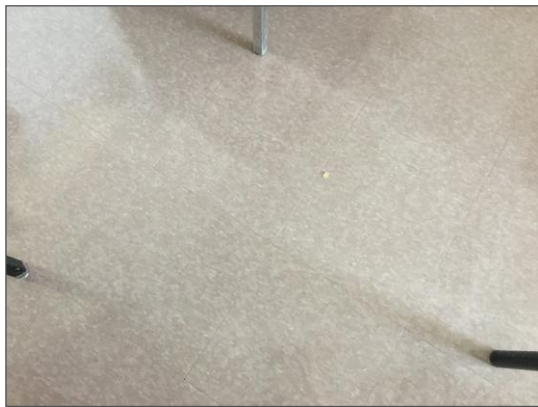
Material and Application	Asbestos Type/Friability	Photo
Asbestos in drywall joint compound was banned in Canada in 1980. Drywall joint compound in the building was installed after 1986 (1980 plus a reasonable non-compliance period based on our experience) and is assumed to contain no asbestos.	None	
Vinyl floor tiles, 12"x12", pink dense fleck, are present.	None (tile) None (mastic)

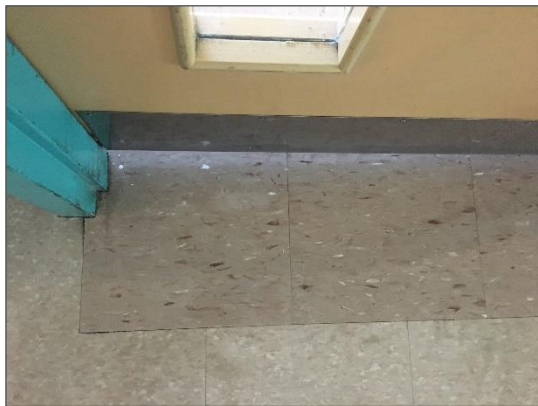
Vinyl floor tiles, 12"x12", green dense fleck, are present.	None (tile) None (mastic)	
Vinyl floor tiles, 12"x12", pink with pink and white lines, are present.	None (tile) None (mastic)

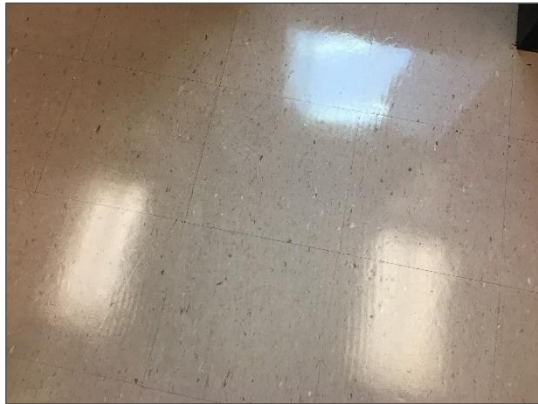
Material and Application	Asbestos Type/Friability	Photo
Vinyl floor tiles, 12"x12", pink with pink and grey fleck, are present.	None (tile) None (mastic)

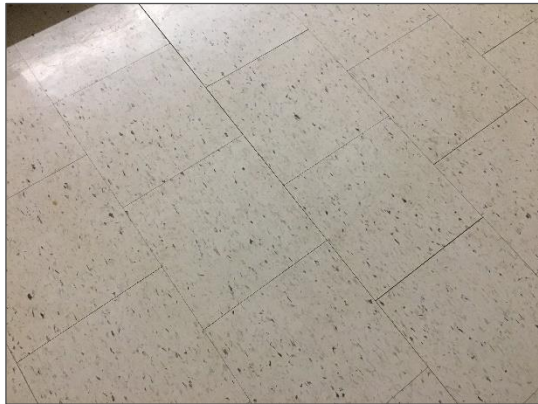
Vinyl floor tiles, 12"x12", white with blue and black streak, are present.	None (tile) None (mastic)

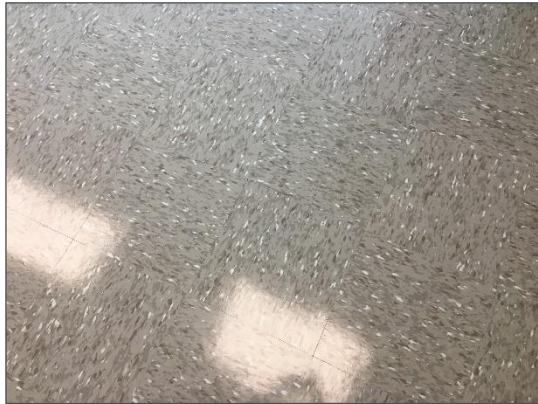
Vinyl floor tiles, 12"x12", beige with brown and white streak, are present.	None (tile) None (mastic)
