Asbestos Assessment

St. Thomas the Apostle
170 Skinner Road, Waterdown,
Ontario

December 30, 2021

Pinchin File: 286533.001

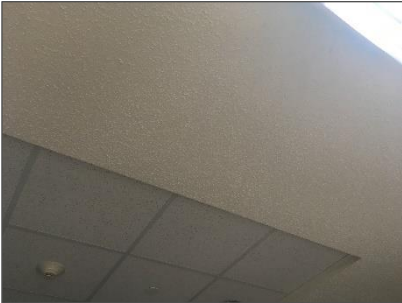
Material and Application	Asbestos Type/Friability	Photo
Non-asbestos texture finish is present on non-asbestos drywall ceilings.	None

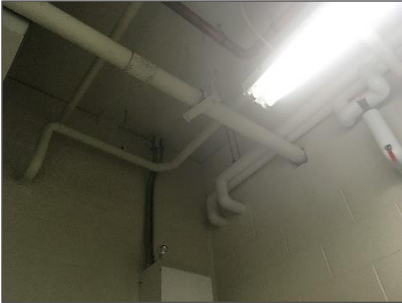
Pipes are either uninsulated or insulated with non-asbestos fiberglass or elastomeric insulation (Armaflex).	None

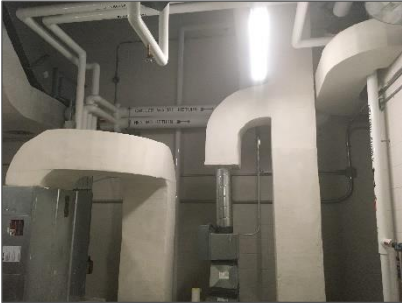
Material and Application	Asbestos Type/Friability	Photo
Ducts are either uninsulated or insulated with non-asbestos fibreglass (canvas).	None

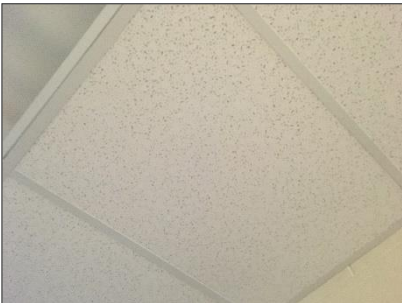
Mechanical equipment is either uninsulated or insulated with non-asbestos fibreglass.	None	
All ceiling tiles are presumed to be non-asbestos based on the date of manufacture determined from the date stamp applied to the top of the tiles and the age of the materials determined from the age of the building.	None

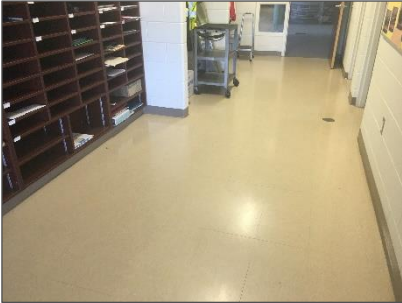
Asbestos in drywall joint compound was banned in Canada in 1980. The building was constructed after 1986 (1980 plus a reasonable non-compliance period based on our experience) and the drywall joint compound is assumed to contain no asbestos.	None	
Vinyl floor tiles were presumed to be non-asbestos based on historical knowledge of the date of installation.	None
