Asbestos Reassessment

Blessed Sacrament
315 East 37th Street, Hamilton,
Ontario

Pinchin File: 303992.004

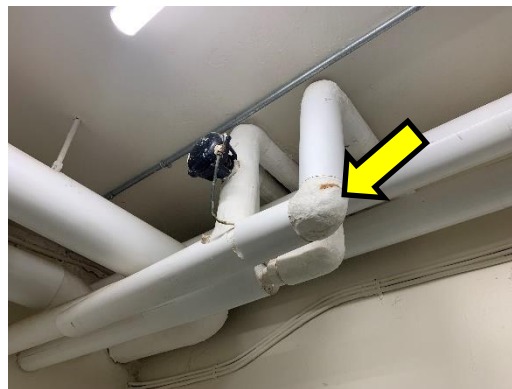
Material and Application	Asbestos Type/Friability	Photo
Parging cement is present on pipe fittings (elbows, valves, tees, hangers etc.).	Chrysotile/Friable

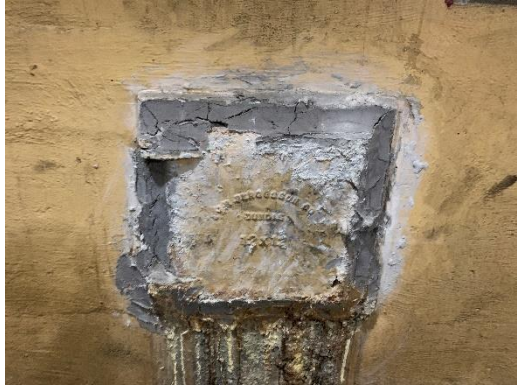
Material and Application	Asbestos Type/Friability	Photo
Parging cement is present as firestopping at outer perimeter hatch penetration in the Boiler Room (Location 1001).	Presumed/Potentially Friable

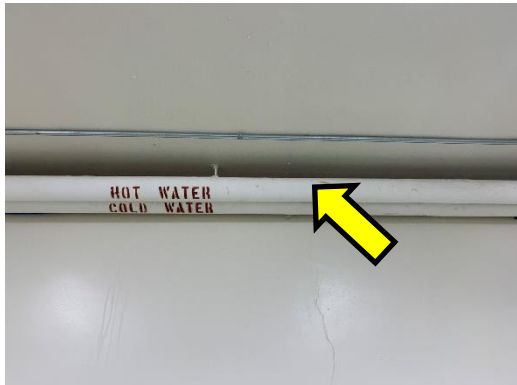
A white corrugated paper insulation (trade name Aircell) is present on pipes.	Chrysotile/Friable

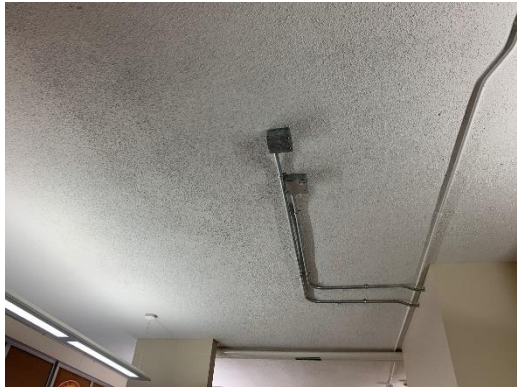
Material and Application	Asbestos Type/Friability	Photo
Remaining ceiling tiles were determined to be non-asbestos by sample analysis or are presumed to be non-asbestos based on the date of manufacture determined from the date stamp applied to the top of the tiles or the age of the materials determined from the age of the building renovation.	None	
Smooth plaster present on walls and ceilings does not contain asbestos.	None	
Textured plaster present on bulkheads and ceilings in Classrooms (Locations 1011-1021) does not contain asbestos.	None	
Asbestos-containing textured plaster is present on ceilings of the Kindergarten (Location 1042).	Chrysotile/Potentially friable

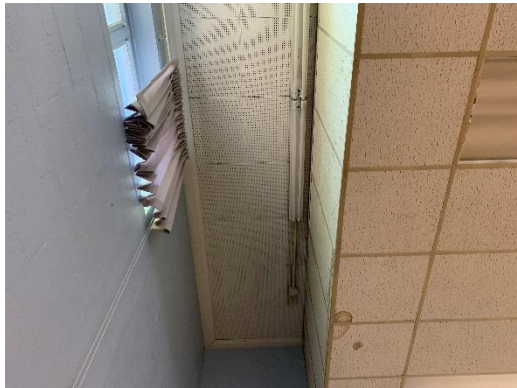
Material and Application	Asbestos Type/Friability	Photo
Asbestos in drywall joint compound was banned in Canada in 1980. Any drywall joint compound in the building that was installed after 1986 (1980 plus a reasonable non-compliance period based on our experience) is assumed to contain no asbestos.	None	
Transite board is present as acoustic ceiling tiles and acoustic panels.	Presumed/Non-friable

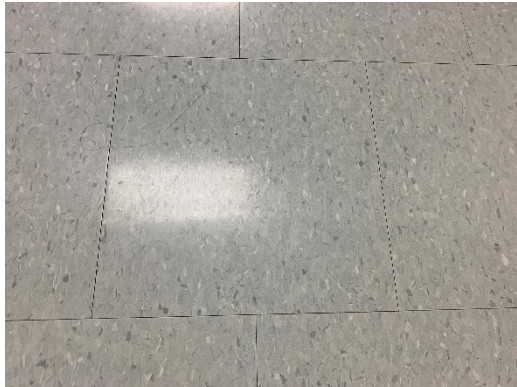
Vinyl floor tiles, 12"x12", light grey streaks, are present.	Presumed/Non-friable (tile) Presumed/Non-friable (mastic)

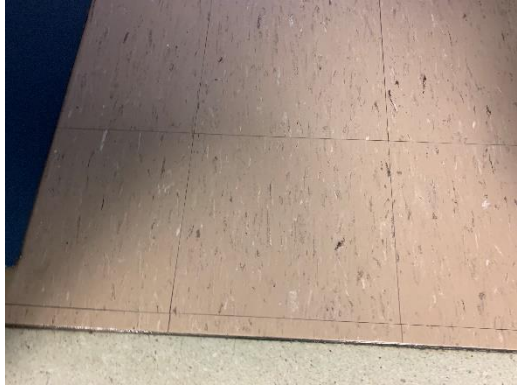
Material and Application	Asbestos Type/Friability	Photo
Vinyl floor tiles, 12"x12", pink and white, are present.	Presumed/Non-friable (tile) Presumed/Non-friable (mastic)

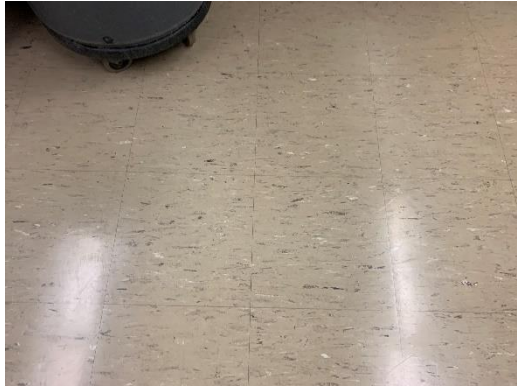
Vinyl floor tiles, 12"x12", light brown with light/dark streaks, are present.	Presumed/Non-friable (tile) Presumed/Non-friable (mastic)

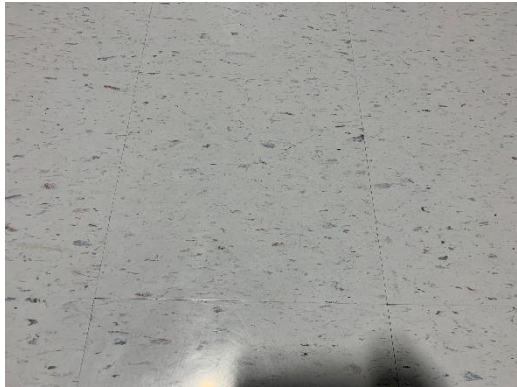
Vinyl floor tiles, 12"x12", white with black streaks, are present.	Presumed/Non-friable (tile) Presumed/Non-friable (mastic)

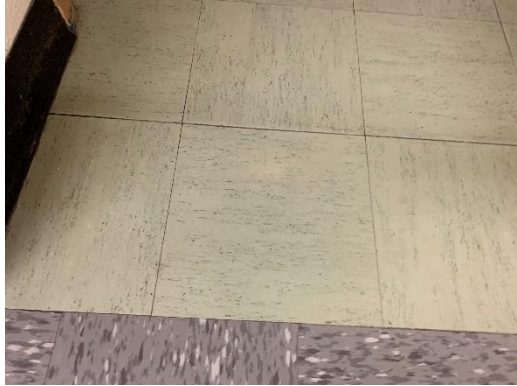
Material and Application	Asbestos Type/Friability	Photo
Vinyl floor tiles, 12"x12", beige with light fleck, are present.	Presumed/Non-friable (tile) Presumed/Non-friable (mastic)

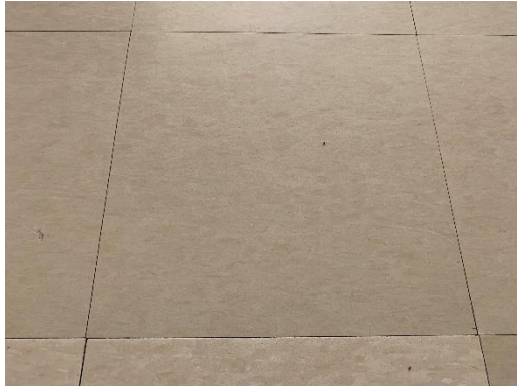
Vinyl floor tiles, 12"x12", beige with pale marbling, are present.	Presumed/Non-friable (tile) Presumed/Non-friable (mastic)

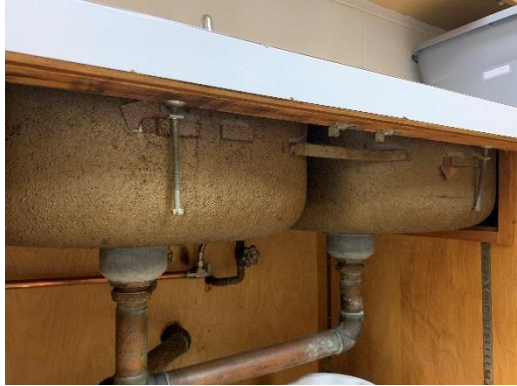
Material and Application	Asbestos Type/Friability	Photo
Gold mastic is present as a sink undercoating.	Presumed/Non-Friable
