Asbestos Reassessment

Canadian Martyrs
1355 Main Street West,
Hamilton, Ontario

August 18, 2022

Pinchin File: 303992.004

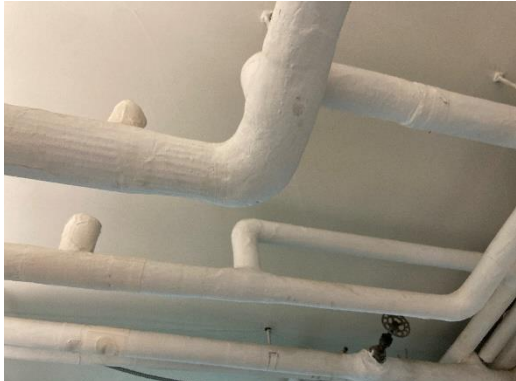
| Material and Application | Asbestos Type/Friability | Photo |
|--|---|---|
| <p>Parging cement is present on pipe fittings (elbows, valves, tees, hangers etc.)</p> | <p>Chrysotile/Friable</p> | |

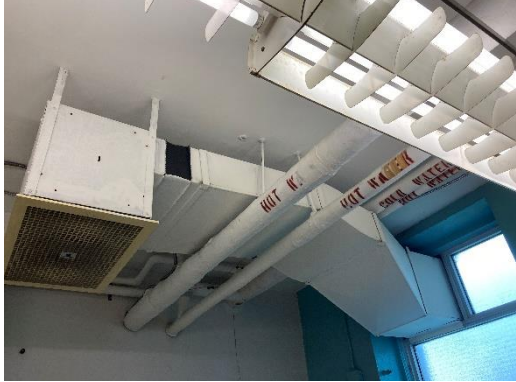
| Material and Application | Asbestos Type/Friability | Photo |
|--|---|---|
| <p>A white corrugated paper insulation (trade name Aircell), containing chrysotile asbestos, is present on straight sections of pipes.</p> | <p>Chrysotile/Friable</p> | |

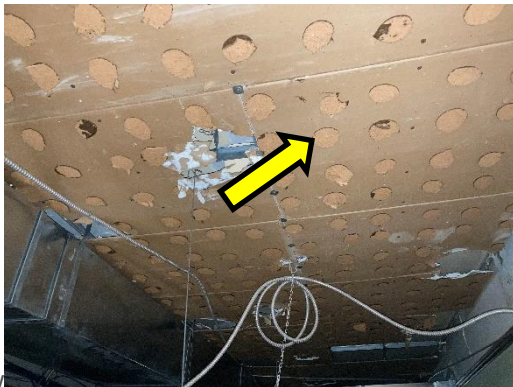
| Material and Application | Asbestos Type/Friability | Photo |
|---|---|--|
| Puck adhesive, formerly above glue-on ceiling tiles is present. | Presumed/Non-friable | |

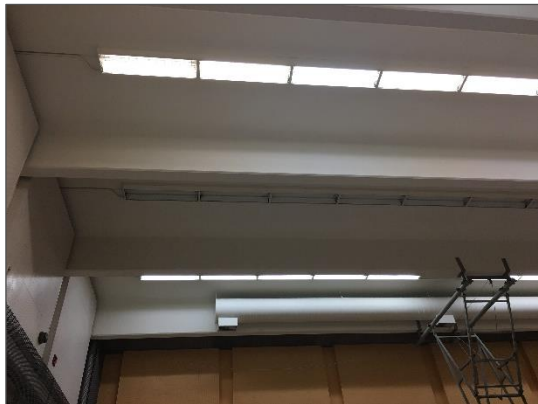
| Material and Application | Asbestos Type/Friability | Photo |
|---|---|--|
| Textured plaster ceiling in the Gymnasium (Location 1010) is presumed to contain asbestos. | Presumed/Friable | |

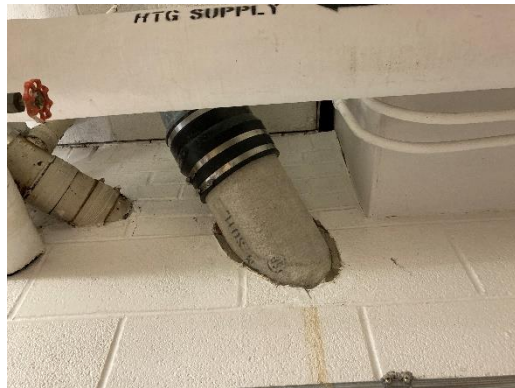
| Material and Application | Asbestos Type/Friability | Photo |
|---|---|--|
| Transite pipe is present as a rain water leader. | Presumed/Non-friable | |

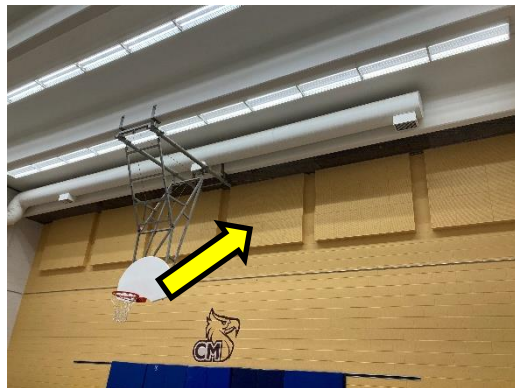
| Material and Application | Asbestos Type/Friability | Photo |
|---|---|--|
| Acoustic Transite panels are present in the Gymnasium (Location 1010). | Presumed/Non-friable | |

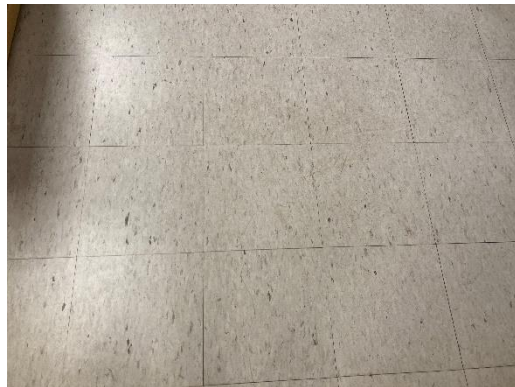
| Material and Application | Asbestos Type/Friability | Photo |
|--|--|--|
| Vinyl floor tiles, 12"x12", beige with brown and white streaks, are present. | Chrysotile/Non-friable (tile) None (mastic) | |

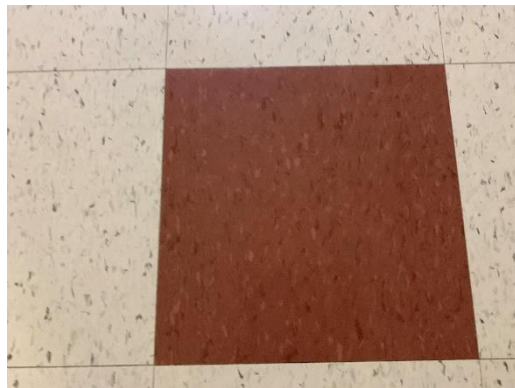
| Material and Application | Asbestos Type/Friability | Photo |
|--|--|--|
| Vinyl floor tiles, 12"x12", white with grey flecks, are present. | Presumed/Non-friable (tile) Presumed/Non-friable (mastic) | |

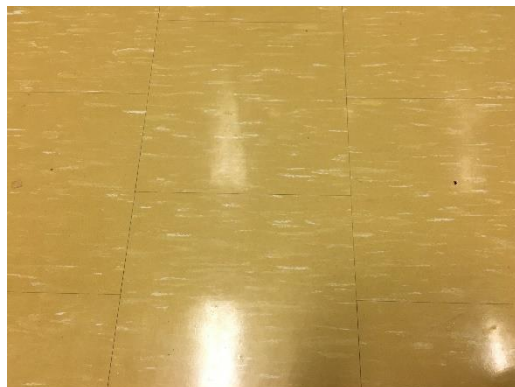
| Material and Application | Asbestos Type/Friability | Photo |
|--|--|--|
| Vinyl floor tiles, 12"x12", yellow with white specks, are present. | Presumed/Non-friable (tile) Presumed/Non-friable (mastic) | |

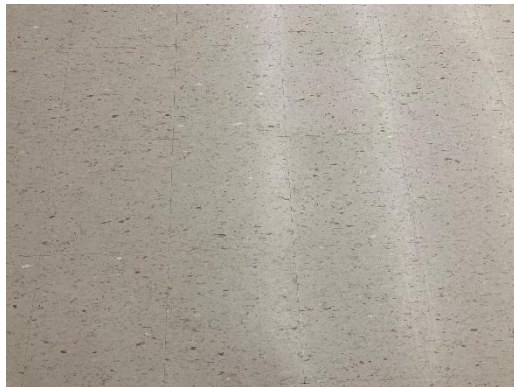
| Material and Application | Asbestos Type/Friability | Photo |
|---|--|--|
| Vinyl floor tiles, 12"x12", cream with brown streaks, are present. | Presumed/Non-friable (tile) Presumed/Non-friable (mastic) | |

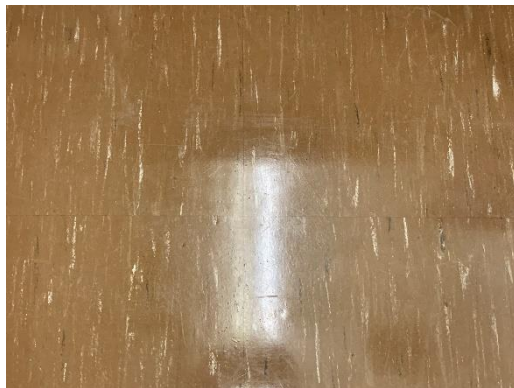
| Material and Application | Asbestos Type/Friability | Photo |
|---|--|--|
| Vinyl floor tiles, 12"x12", brown with white and black streaks, are present. | Presumed/Non-friable (tile) Presumed/Non-friable (mastic) | |

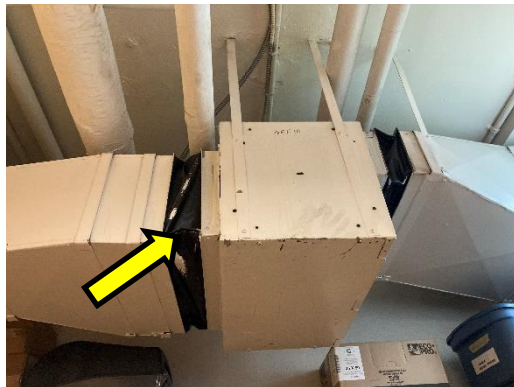
| Material and Application | Asbestos Type/Friability | Photo |
|---|--|--|
| Vibration dampener is present on ductwork in the Kiln Room (Location 1020). | Presumed/Non-friable | |
