# Asbestos Reassessment

Cathedral High School  
30 Wentworth Street North,  
Hamilton, Ontario

Pinchin File: 303992.004

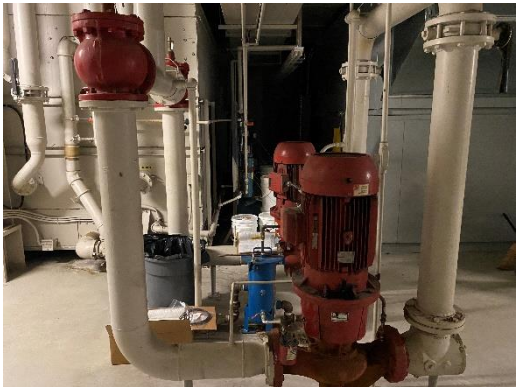
Material and Application	Asbestos Type/Friability	Photo
Gaskets are present in the mechanical rooms.	Chrysotile/Non-friable

Remove asbestos-containing materials (ACM) prior to alteration or maintenance work if ACM may be disturbed by the work. Follow appropriate asbestos precautions for the classification of work being performed.
