Asbestos Reassessment

Corpus Christi
25 Alderson Drive, Hamilton,
Ontario

August 30, 2022

Pinchin File: 303922.004

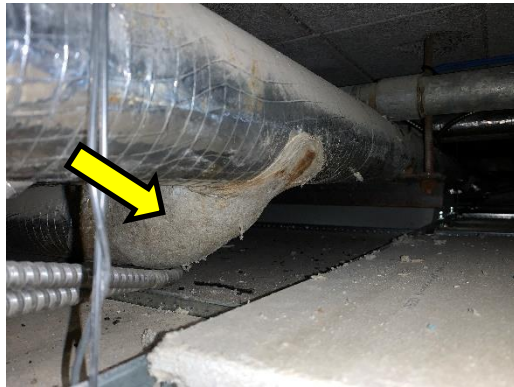
Material and Application	Asbestos Type/Friability	Photo
Parging cement is present on a pipe fitting in the Corridor (Location 1020).	Chrysotile/Friable

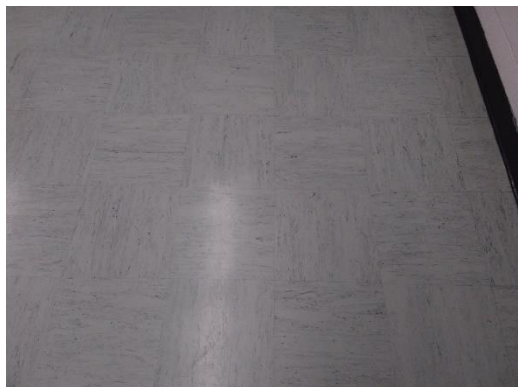
Material and Application	Asbestos Type/Friability	Photo
Non-asbestos drywall joint compound is present on wall and ceiling finishes.	None	
Asbestos in drywall joint compound was banned in Canada in 1980. Drywall joint compound in the 1999 addition was installed after 1986 (1980 plus a reasonable non-compliance period based on our experience) and is assumed to contain no asbestos.	None	
Vinyl sheet flooring in the additions were presumed to be non-asbestos based on the lack of a paper backing layer (underpad).	None	
Vinyl floor tiles, 12"x12", green with green streaks, are present.	Presumed/Non-friable (tile) Presumed/Non-friable (mastic)

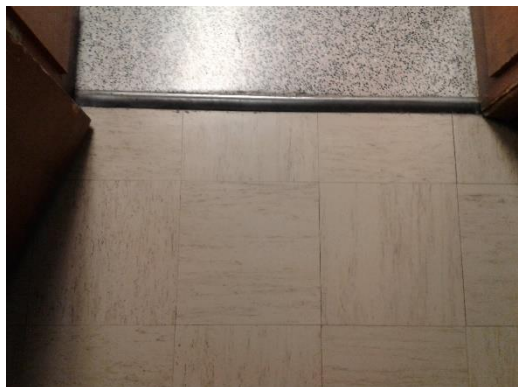
Vinyl floor tiles, 12"x12", beige with dark streaks, are present.	Presumed/Non-friable (tile) Presumed/Non-friable (mastic)

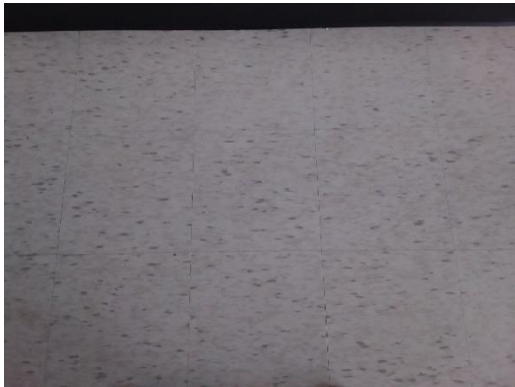
Material and Application	Asbestos Type/Friability	Photo
Vinyl floor tiles, 12"x12", light grey with dark streaks, are present.	Presumed/Non-friable (tile) Presumed/Non-friable (mastic)

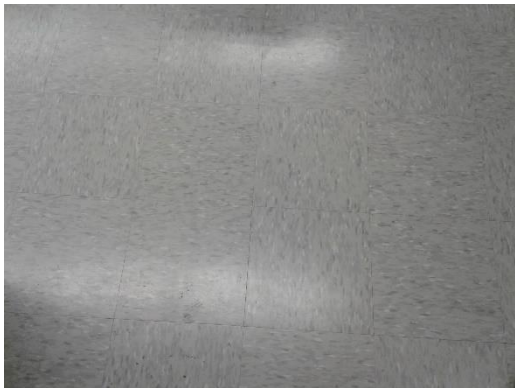
Vinyl floor tiles, 12"x12", cream with beige and dark streaks, are present.	Presumed/Non-friable (tile) Presumed/Non-friable (mastic)

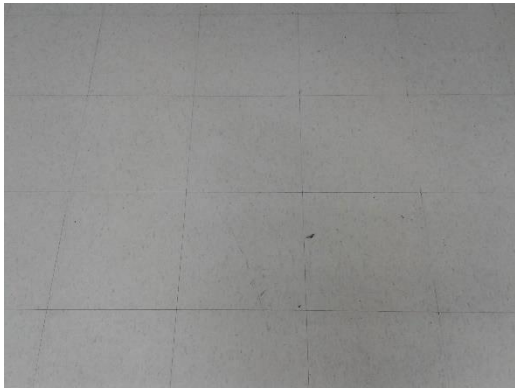
Vinyl floor tiles, 12"x12", grey with grey streaks, are present.	Presumed/Non-friable (tile) Presumed/Non-friable (mastic)
