Asbestos Reassessment

Father Kyran
90 Mulberry Street, Hamilton,
Ontario

**Hamilton-Wentworth Catholic
District School Board**

August 23, 2022

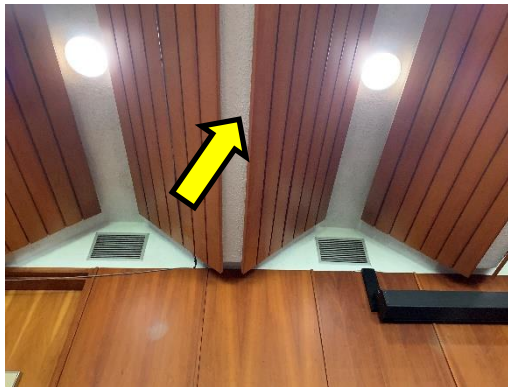
Material and Application	Asbestos Type/Friability	Photo
<p>Texture finish is present on ceilings in the Hearing Room (Location 1001) and the Boardroom (Location 1002).</p> <p>Overspray from the asbestos-containing texture coat is presumed to be present above the ceiling at light fixture openings, on the deck, ducts and within junction boxes.</p>	Chrysotile/Friable

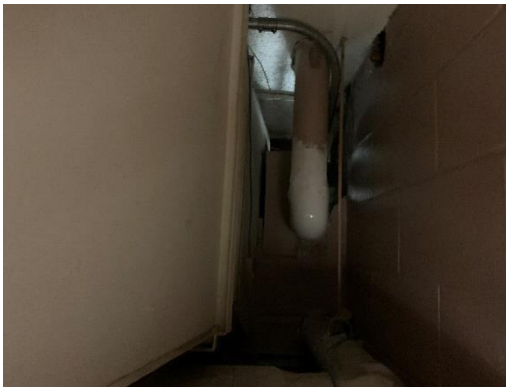
Material and Application	Asbestos Type/Friability	Photo
<p>Parging cement is present on pipe fittings (elbows, valves, tees, hangers etc.).</p> <p>Pipes insulated with asbestos-containing insulations may be present in inaccessible spaces such as above solid ceilings, in chases, in column enclosures and within shafts</p>	Chrysotile/Friable

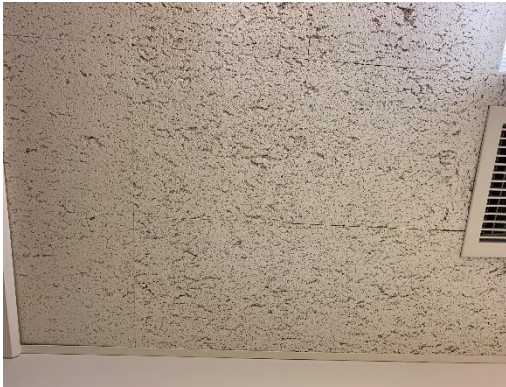
Remaining pipes are either uninsulated or insulated with non-asbestos fibreglass or elastomeric insulation (Armaflex).	None	
Ducts are either uninsulated or insulated with non-asbestos fibreglass.	None	
Mechanical equipment is either uninsulated or insulated with non-asbestos fibreglass.	None	
12"x12" glued-on ceiling tiles, with a fissured pattern are present.	Amosite/Non-friable

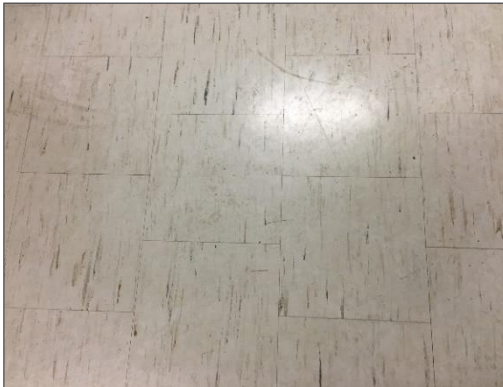
Material and Application	Asbestos Type/Friability	Photo
Vinyl floor tiles, 12"x12", white with brown and black streaks, are present.	Presumed/Non-friable (tile) Presumed/Non-friable (mastic)

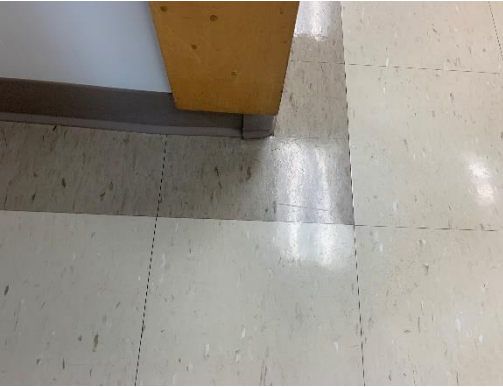
Vinyl floor tiles, 12"x12", grey marble, are present.	Presumed/Non-friable (tile) Presumed/Non-friable (mastic)	 
Vinyl floor tiles, 12"x12", white with grey, are present.	Presumed/Non-friable (tile) Presumed/Non-friable (mastic)

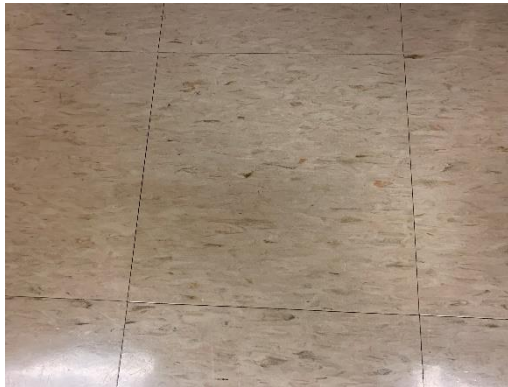
Material and Application	Asbestos Type/Friability	Photo
Vinyl floor tiles, 12"x12", cream with brown and white specks, are present.	Presumed/Non-friable (tile) Presumed/Non-friable (mastic)

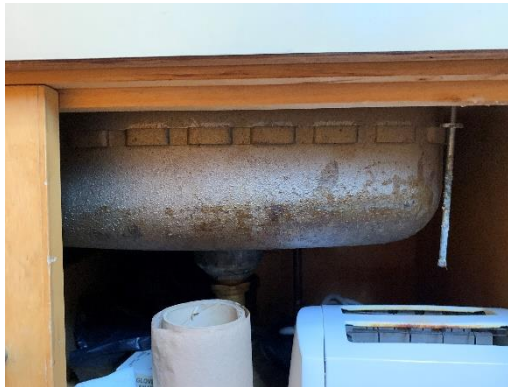
Vinyl floor tiles, 12"x12", brown with multi-brown fleck, are present.	Presumed/Non-friable (tile) Presumed/Non-friable (mastic)	 
Mastic is present on the concrete floor or presumed present under new flooring.	Presumed/Non-friable	
Gold mastic is present as a sink undercoating.	Presumed/Non-friable
