Asbestos Reassessment

Nicolas Mancini Centre
44 Hunt Street, Hamilton,
Ontario

**Hamilton-Wentworth Catholic
District School Board**

August 26, 2022

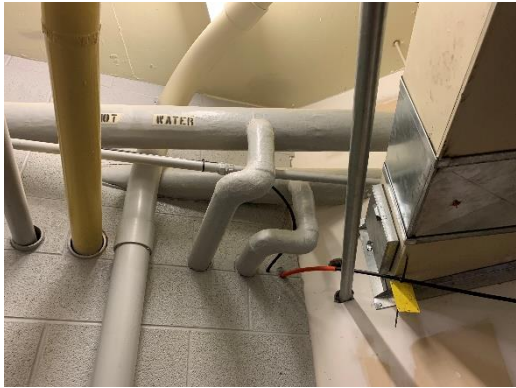
Material and Application	Asbestos Type/Friability	Photo
<p>Parging cement is present on pipe fittings (elbows, valves, tees, hangers etc.).</p> <p>Pipes insulated with asbestos-containing insulations may be present in inaccessible spaces such as above solid ceilings, in chases, in column enclosures and within shafts</p>	Chrysotile/Friable

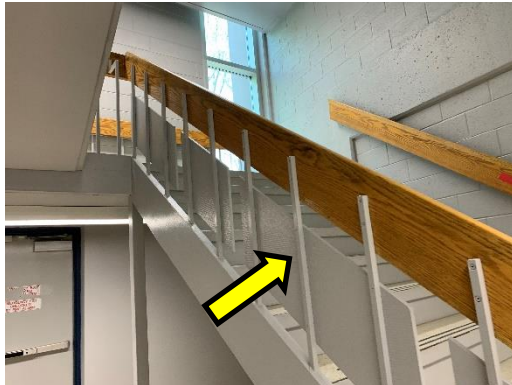
Material and Application	Asbestos Type/Friability	Photo
Transite board is present as panels on stair rails.	Presumed/Non-friable

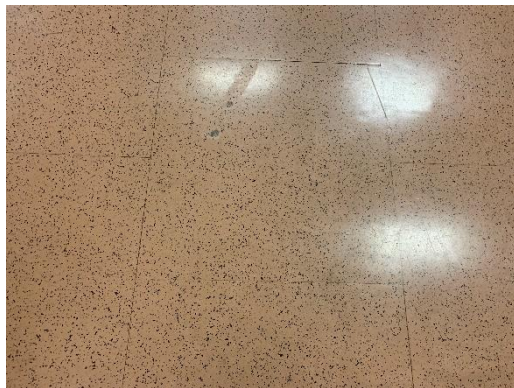
Vinyl floor tiles, 12"x12", pink with black speck, are present.	Presumed/Non-friable (tile) Presumed/Non-friable (mastic)

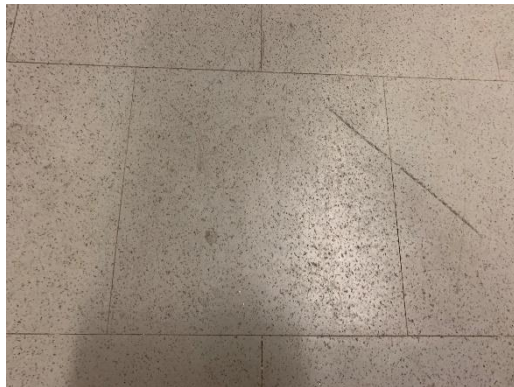
Vinyl floor tiles, 12"x12", grey with black speck, are present.	Presumed/Non-friable (tile) Presumed/Non-friable (mastic)

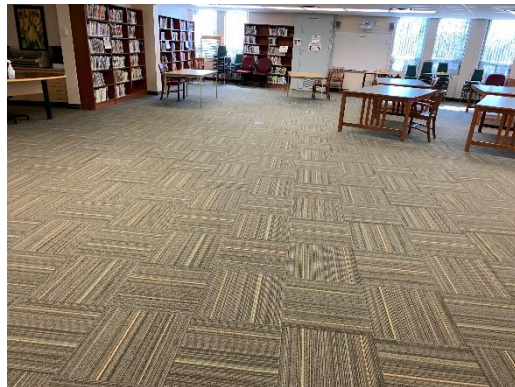
Material and Application	Asbestos Type/Friability	Photo
Mastic under carpet tiles in the Library (Location 1014) is presumed to contain asbestos.	Presumed/Non-friable (mastic)
