# Asbestos Reassessment

Our Lady of the Assumption  
20 Highway 55, Stoney Creek,  
Ontario

August 12, 2022

Pinchin File: 303992.004

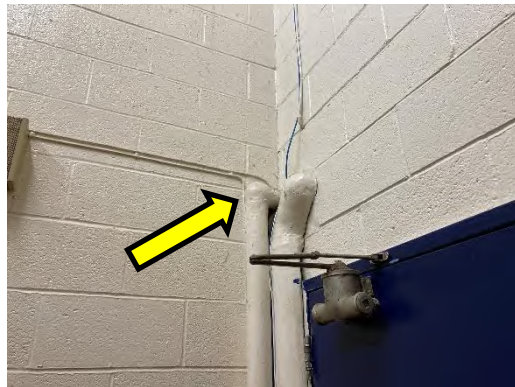
Material and Application	Asbestos Type/Friability	Photo
Parging cement is present on pipe fittings (elbows, valves, tees, hangers etc.)	Chrysotile/Friable

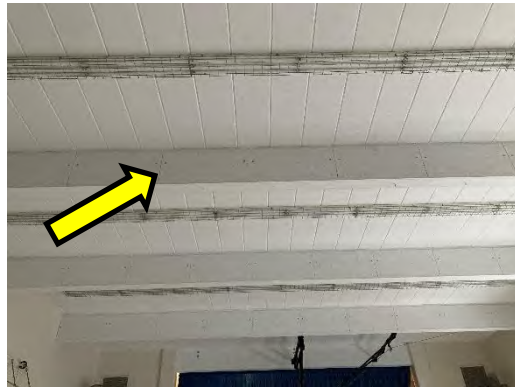
Material and Application	Asbestos Type/Friability	Photo
24"x48" lay-in ceiling tiles, with a short fissure random pattern are present in the Gymnasium (Location 101).	Presumed/Non-friable

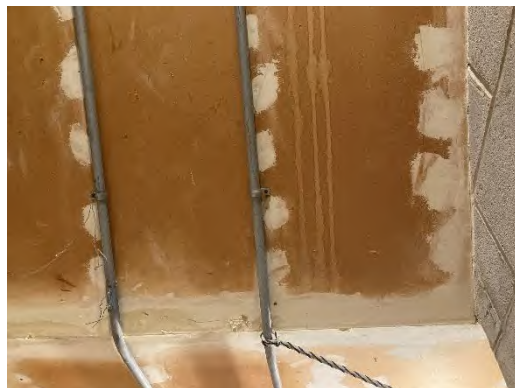
Remaining ceiling tiles are presumed to be non-asbestos based on previous sampling or the material of manufacture (fibreglass).	None	
Plaster present on walls and ceilings does not contain asbestos.	None	
Drywall joint compound is present on wall and ceiling finishes.	Chrysotile/Non-friable

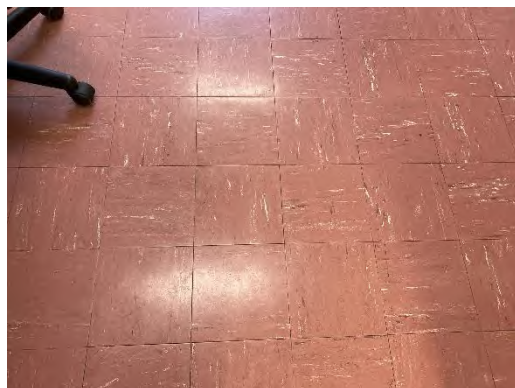
Vinyl floor tiles, 9"x9" red with white streak are present.	Chrysotile/Non-friable (tile) Presumed/Non-friable (mastic)

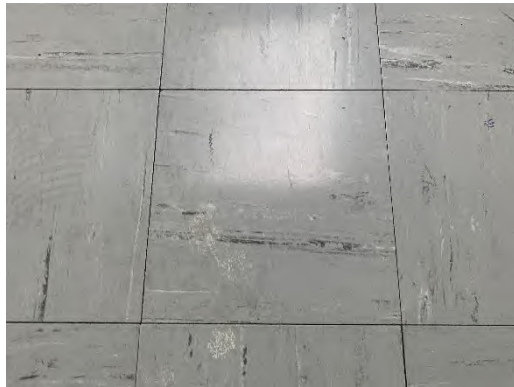
Material and Application	Asbestos Type/Friability	Photo
Vinyl floor tiles, 9"x9" grey with white and black fleck are present.	Presumed/Non-friable (tile)  Presumed/Non-friable (mastic)

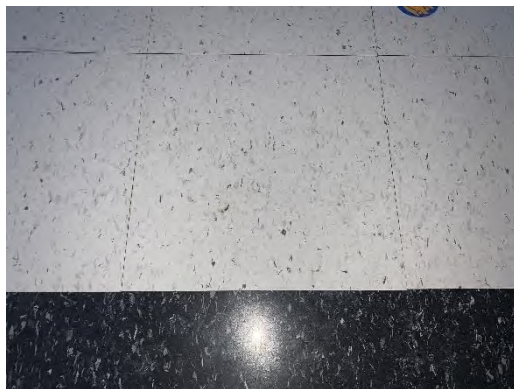
Vinyl floor tiles, 12"x12" cream with rose fleck are present.	Presumed/Non-friable (tile)  Presumed/Non-friable (mastic)

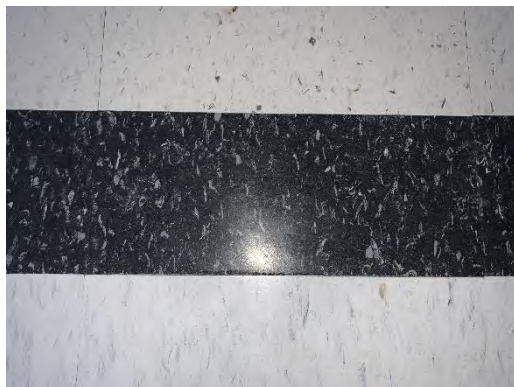
Vinyl floor tiles, 12"x12" black dense fleck are present.	Presumed/Non-friable (tile)  Presumed/Non-friable (mastic)

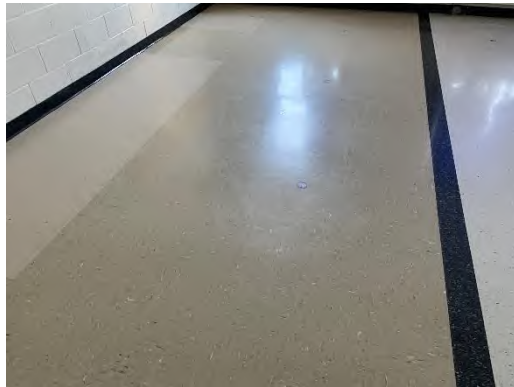
Material and Application	Asbestos Type/Friability	Photo
Vinyl floor tiles, 12"x12" beige with brown and white streak are present.	Presumed/Non-friable (tile)  Presumed/Non-friable (mastic)

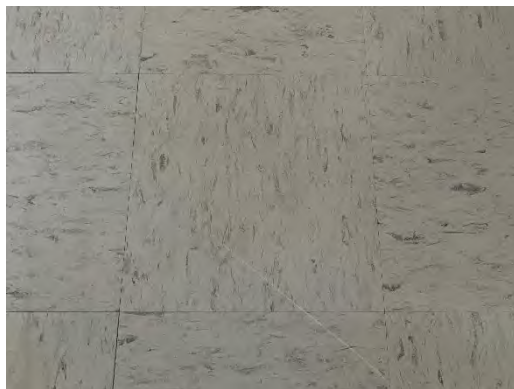
Vinyl floor tiles, 12"x12" white with black streak are present.	Presumed/Non-friable (tile)  Presumed/Non-friable (mastic)

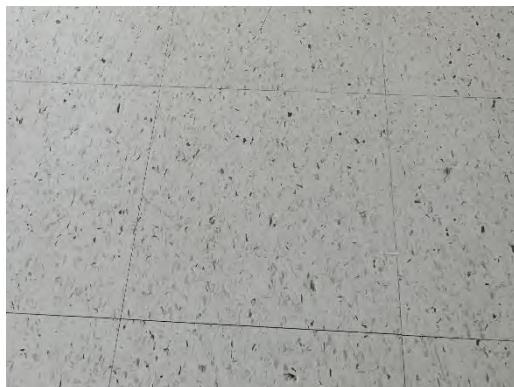
Vinyl floor tiles, 12"x12" white with black and grey fleck are present.	Presumed/Non-friable (tile)  Presumed/Non-friable (mastic)

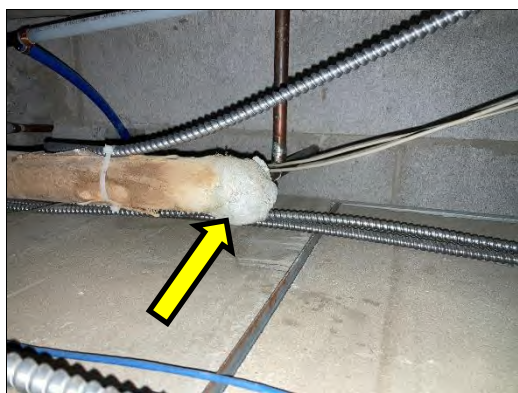
Material, Quantity, Condition and Photo #	Location Name (Location #)	Recommended Procedure
Pipe insulation, 1 fitting, poor condition, Photo 1	Corridor (Location 102)	Asbestos precautions for entry into ceiling space which may disturb asbestos in poor condition.
