# Asbestos Reassessment

Our Lady of Lourdes  
420 Mohawk Road East,  
Hamilton, Ontario

**Hamilton-Wentworth Catholic  
District School Board**

August 23, 2022

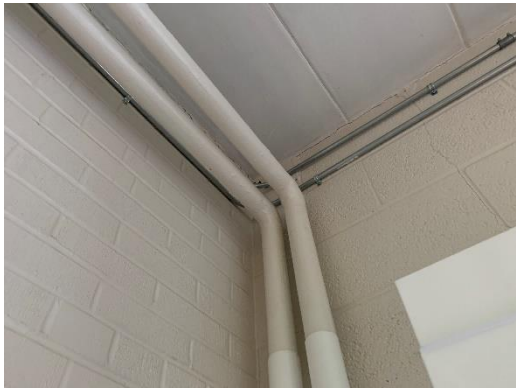
Material and Application	Asbestos Type/Friability	Photo
Parging cement is present on pipe fittings (elbows, valves, tees, hangers etc.)	Chrysotile/ Friable

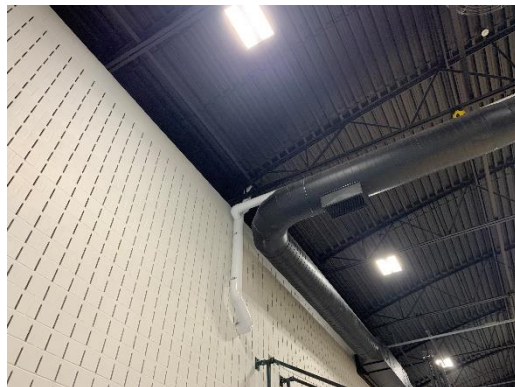
Material and Application	Asbestos Type/Friability	Photo
Non-asbestos drywall joint compound is present on wall and ceiling finishes.	None	
Transite pipe is present as rainwater leaders.	Presumed/Non-friable

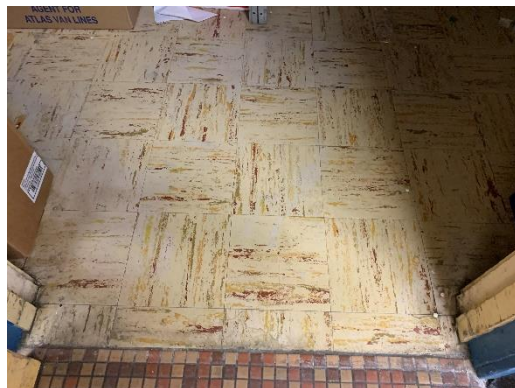
Vinyl floor tiles, 9"x9", beige with grey, yellow, brown streak, are present.	Chrysotile/Non-friable (tile) None (mastic)

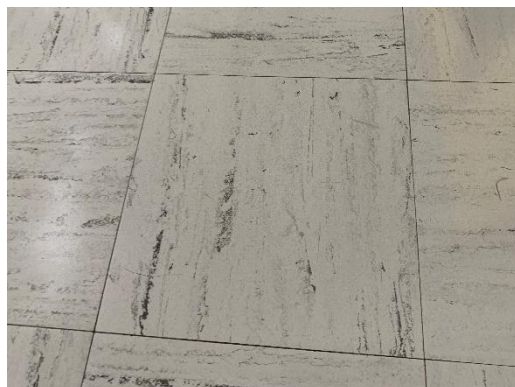
Vinyl floor tiles, 9"x9", white with black streak, are present.	Chrysotile/Non-friable (tile) None (mastic)

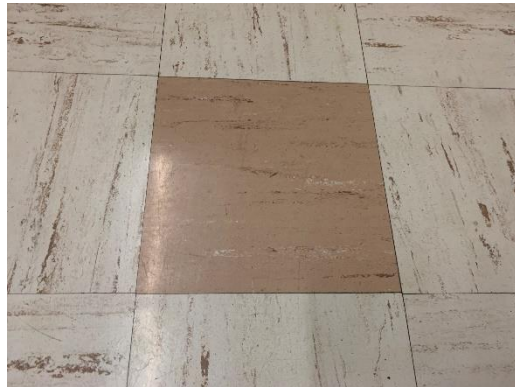
Material and Application	Asbestos Type/Friability	Photo
Vinyl floor tiles, 9"x9" tan with brown and white streak are present.	Chrysotile/Non-friable (tile) None (mastic)

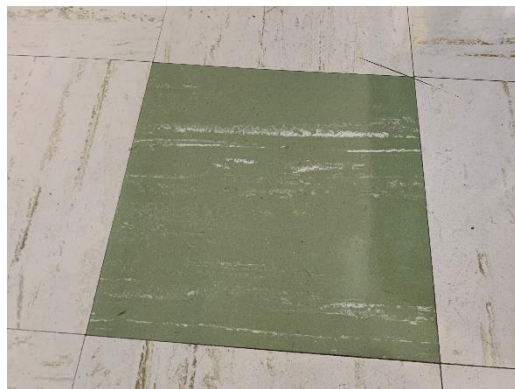
Vinyl floor tiles, 9"x9" green with white streak are present.	Presumed/Non-friable (tile) Presumed/Non-friable (mastic)

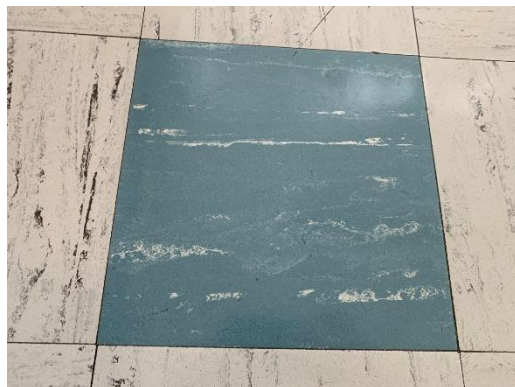
Vinyl floor tiles, 9"x9" blue with white streak are present.	Presumed/Non-friable (tile) None (mastic)

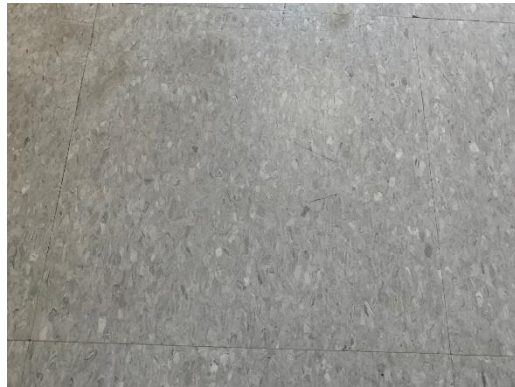
Material and Application	Asbestos Type/Friability	Photo
Vinyl floor tiles, 12"x12" grey dense fleck are present.	Presumed/Non-friable (tile)  Presumed/Non-friable (mastic)

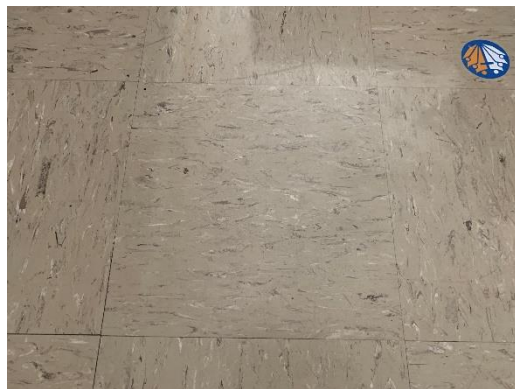
Vinyl floor tiles, 12"x12" beige with grey and pink fleck are present.	Presumed/Non-friable (tile)  Presumed/Non-friable (mastic)

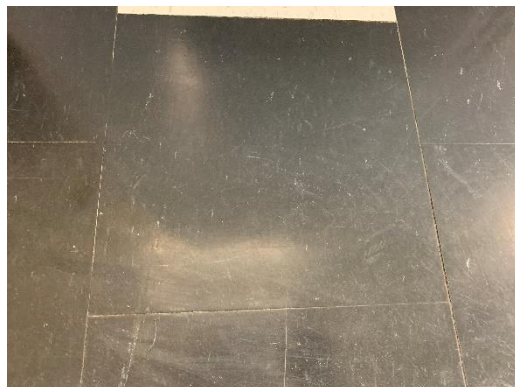
Vinyl floor tiles, 12"x12" black are present.	Presumed/Non-friable (tile)  Presumed/Non-friable (mastic)

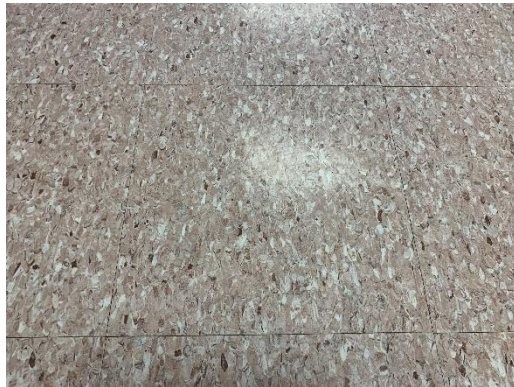
Material and Application	Asbestos Type/Friability	Photo
Vinyl floor tiles, 12"x12" beige with grey and white marble are present.	None (tile) Presumed/Non-friable (mastic)

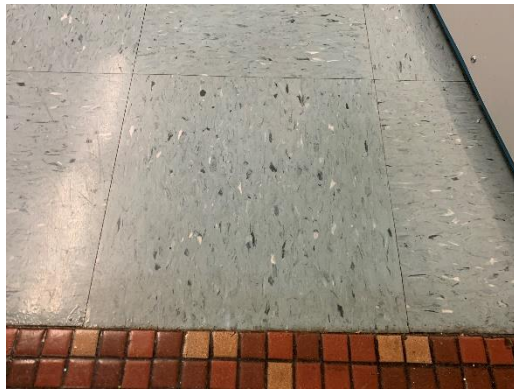
Vinyl floor tiles, 12"x12" grey with white and black dense fleck are present.	None (tile) Presumed/Non-friable (mastic)

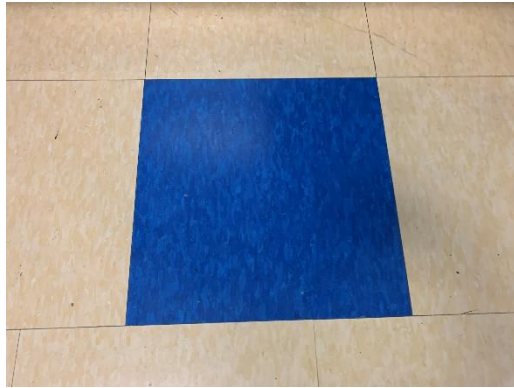
Vinyl floor tiles, 12"x12" bright blue dense fleck are present.	None (tile) Presumed/Non-friable (mastic)

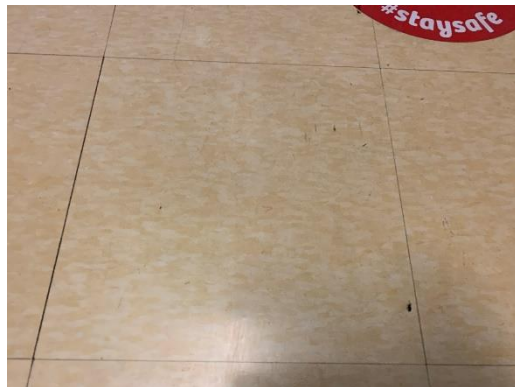
Material and Application	Asbestos Type/Friability	Photo
Vinyl floor tiles, 12"x12" beige oatmeal are present.	None (tile) None (mastic)

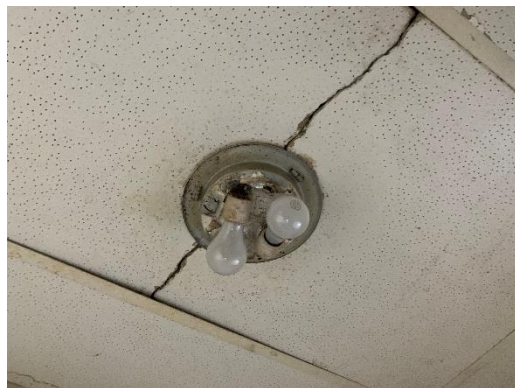
Paper heat shields in light fixtures are present.	Presumed/Non-friable
