Asbestos Reassessment

Our Lady of Peace
252 Dewitt Road, Stoney Creek,
Ontario

August 12, 2022

Pinchin File: 303992.004

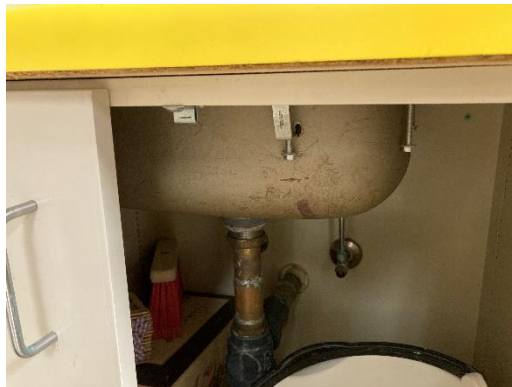
Material and Application	Asbestos Type/Friability	Photo
Vinyl floor tiles, 12"x12", pink with pink and white fleck are present.	None (tile) None (mastic)	
Asbestos-containing gold sink undercoating is present.	Chrysotile/Non-friable

Remove asbestos-containing materials (ACM) prior to alteration or maintenance work if ACM may be disturbed by the work. Follow appropriate asbestos precautions for the classification of work being performed.
