Asbestos Reassessment

Regina Mundi
675 Mohawk Road West,
Hamilton, Ontario

August 29, 2022

Pinchin File: 303992.004

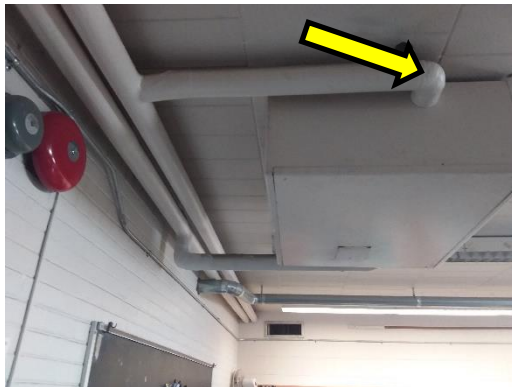
Material and Application	Asbestos Type/Friability	Photo
Parging cement is present on pipe fittings (elbows, valves, tees, hangers etc.)	Chrysotile/Friable

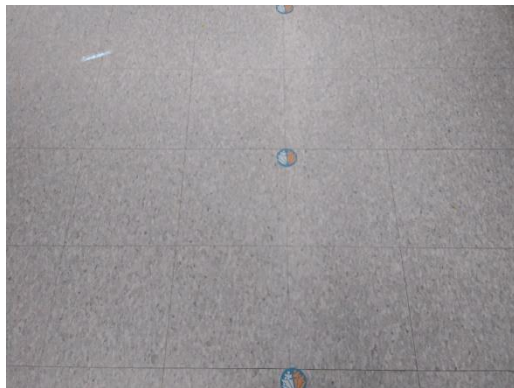
Material and Application	Asbestos Type/Friability	Photo
Mastic underneath new vinyl floor tiles in the General Purpose Room (Location 2030) contains asbestos.	None (tile) Confirmed/Non-friable (mastic)	 
Vinyl floor tiles, 12"x12", grey dense fleck, are present.	Presumed/Non-friable (tile) Presumed/Non-friable (mastic)

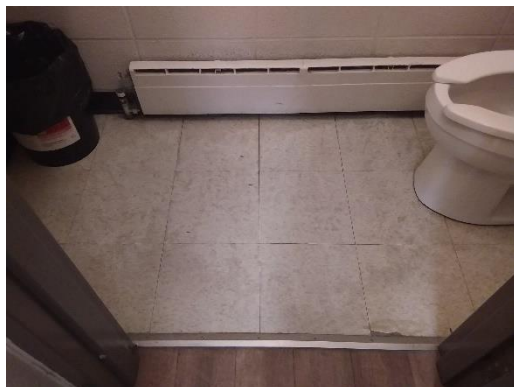
Vinyl floor tiles, 12"x12", beige dense fleck, are present.	Presumed/Non-friable (tile) Presumed/Non-friable (mastic)

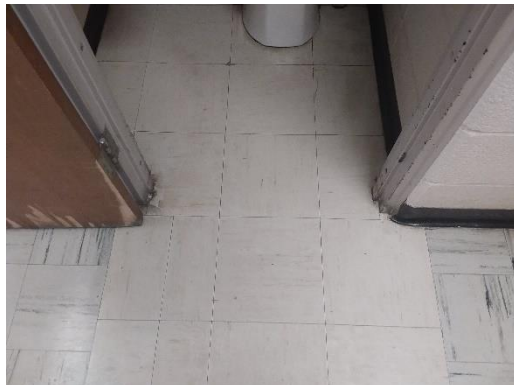
Material and Application	Asbestos Type/Friability	Photo
Vinyl floor tiles, 12"x12", tan with brown streak, are present.	Presumed/Non-friable (tile) Presumed/Non-friable (mastic)

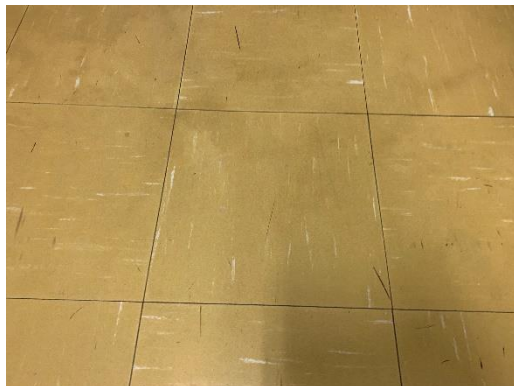
Vinyl floor tiles, 12"x12", yellow with white streak, are present.	Presumed/Non-friable (tile) Presumed/Non-friable (mastic)

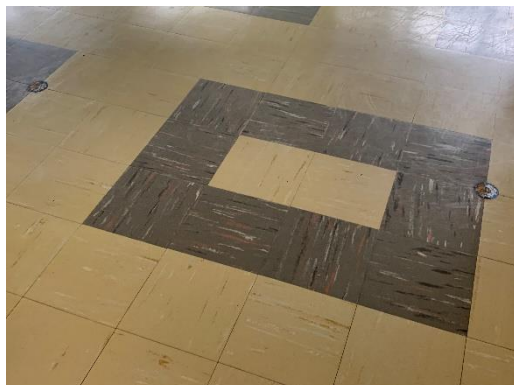
Vinyl floor tiles, 9"x9", yellow with white streak, are present.	Presumed/Non-friable (tile) Presumed/Non-friable (mastic)

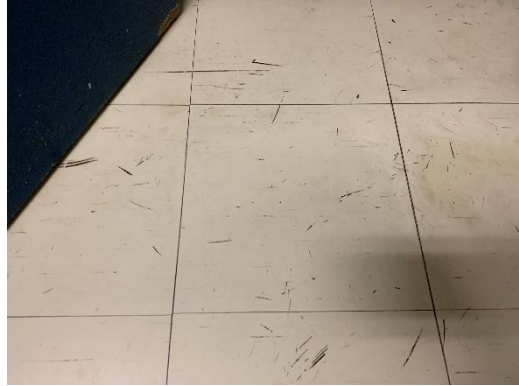
Material and Application	Asbestos Type/Friability	Photo
Vinyl floor tiles, 9"x9", light grey with black streak, are present.	Presumed/Non-friable (tile) Presumed/Non-friable (mastic)

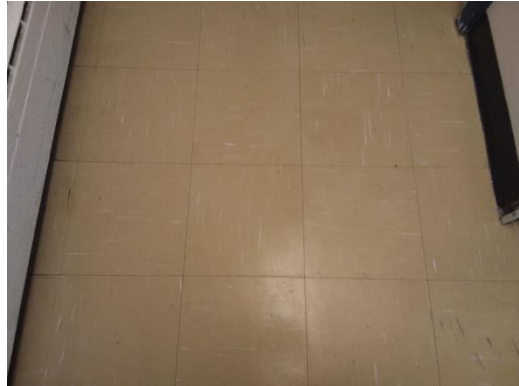
Vinyl floor tiles, 9"x9", cream and white streak, are present.	Presumed/Non-friable (tile) Presumed/Non-friable (mastic)

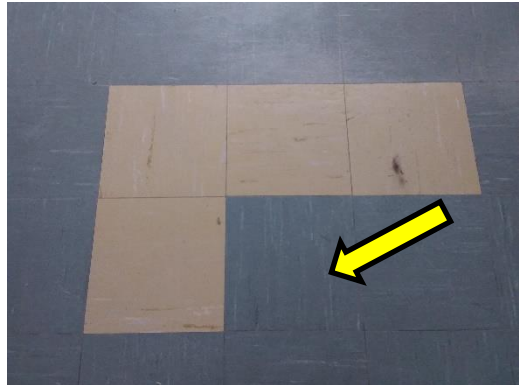
Vinyl floor tiles, 9"x9", green with white streak, are present.	Presumed/Non-friable (tile) Presumed/Non-friable (mastic)

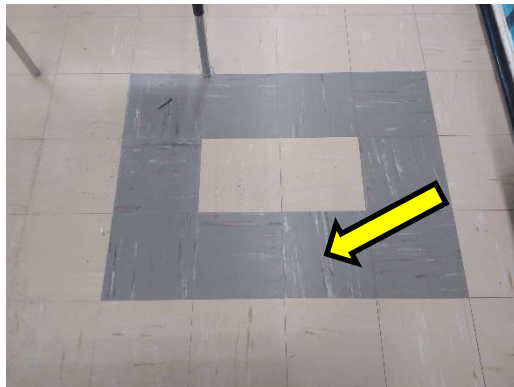
Material and Application	Asbestos Type/Friability	Photo
Vinyl floor tiles, 9"x9", grey with white streak, are present.	Presumed/Non-friable (tile) Presumed/Non-friable (mastic)

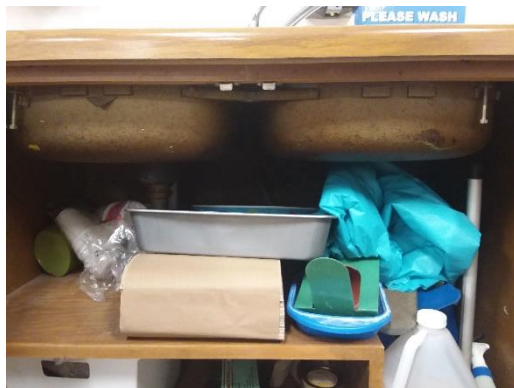
<p>Remaining vinyl floor tiles were presumed to be non-asbestos based on historical knowledge of the date of installation.</p> <p>Mastic underneath new flooring (laminates, vinyl floor tiles) is presumed to contain asbestos until further sampling proves otherwise.</p>	<p>None (tile)</p> <p>Presumed/Non-friable (mastic)</p>	
Gold mastic is present as a sink undercoating.	Presumed/Non-friable

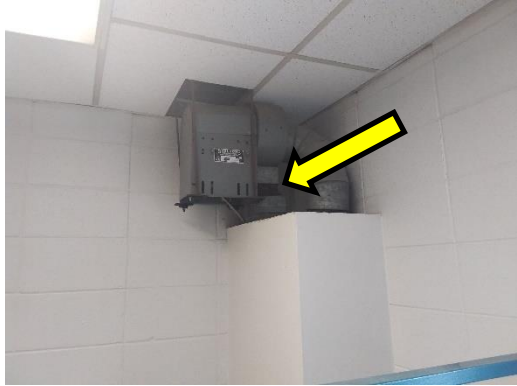
Material and Application	Asbestos Type/Friability	Photo
Duct expansion joint is present.	Presumed/Non-friable

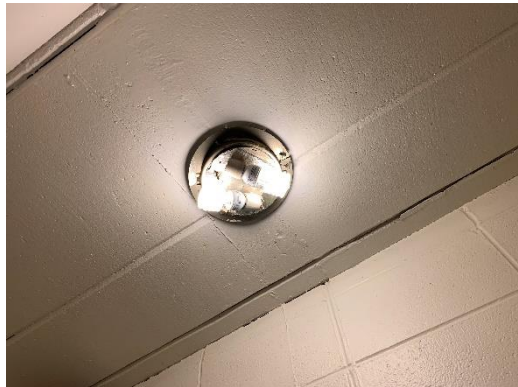
Paper heat shields are present in light fixtures.	Presumed/Non-friable

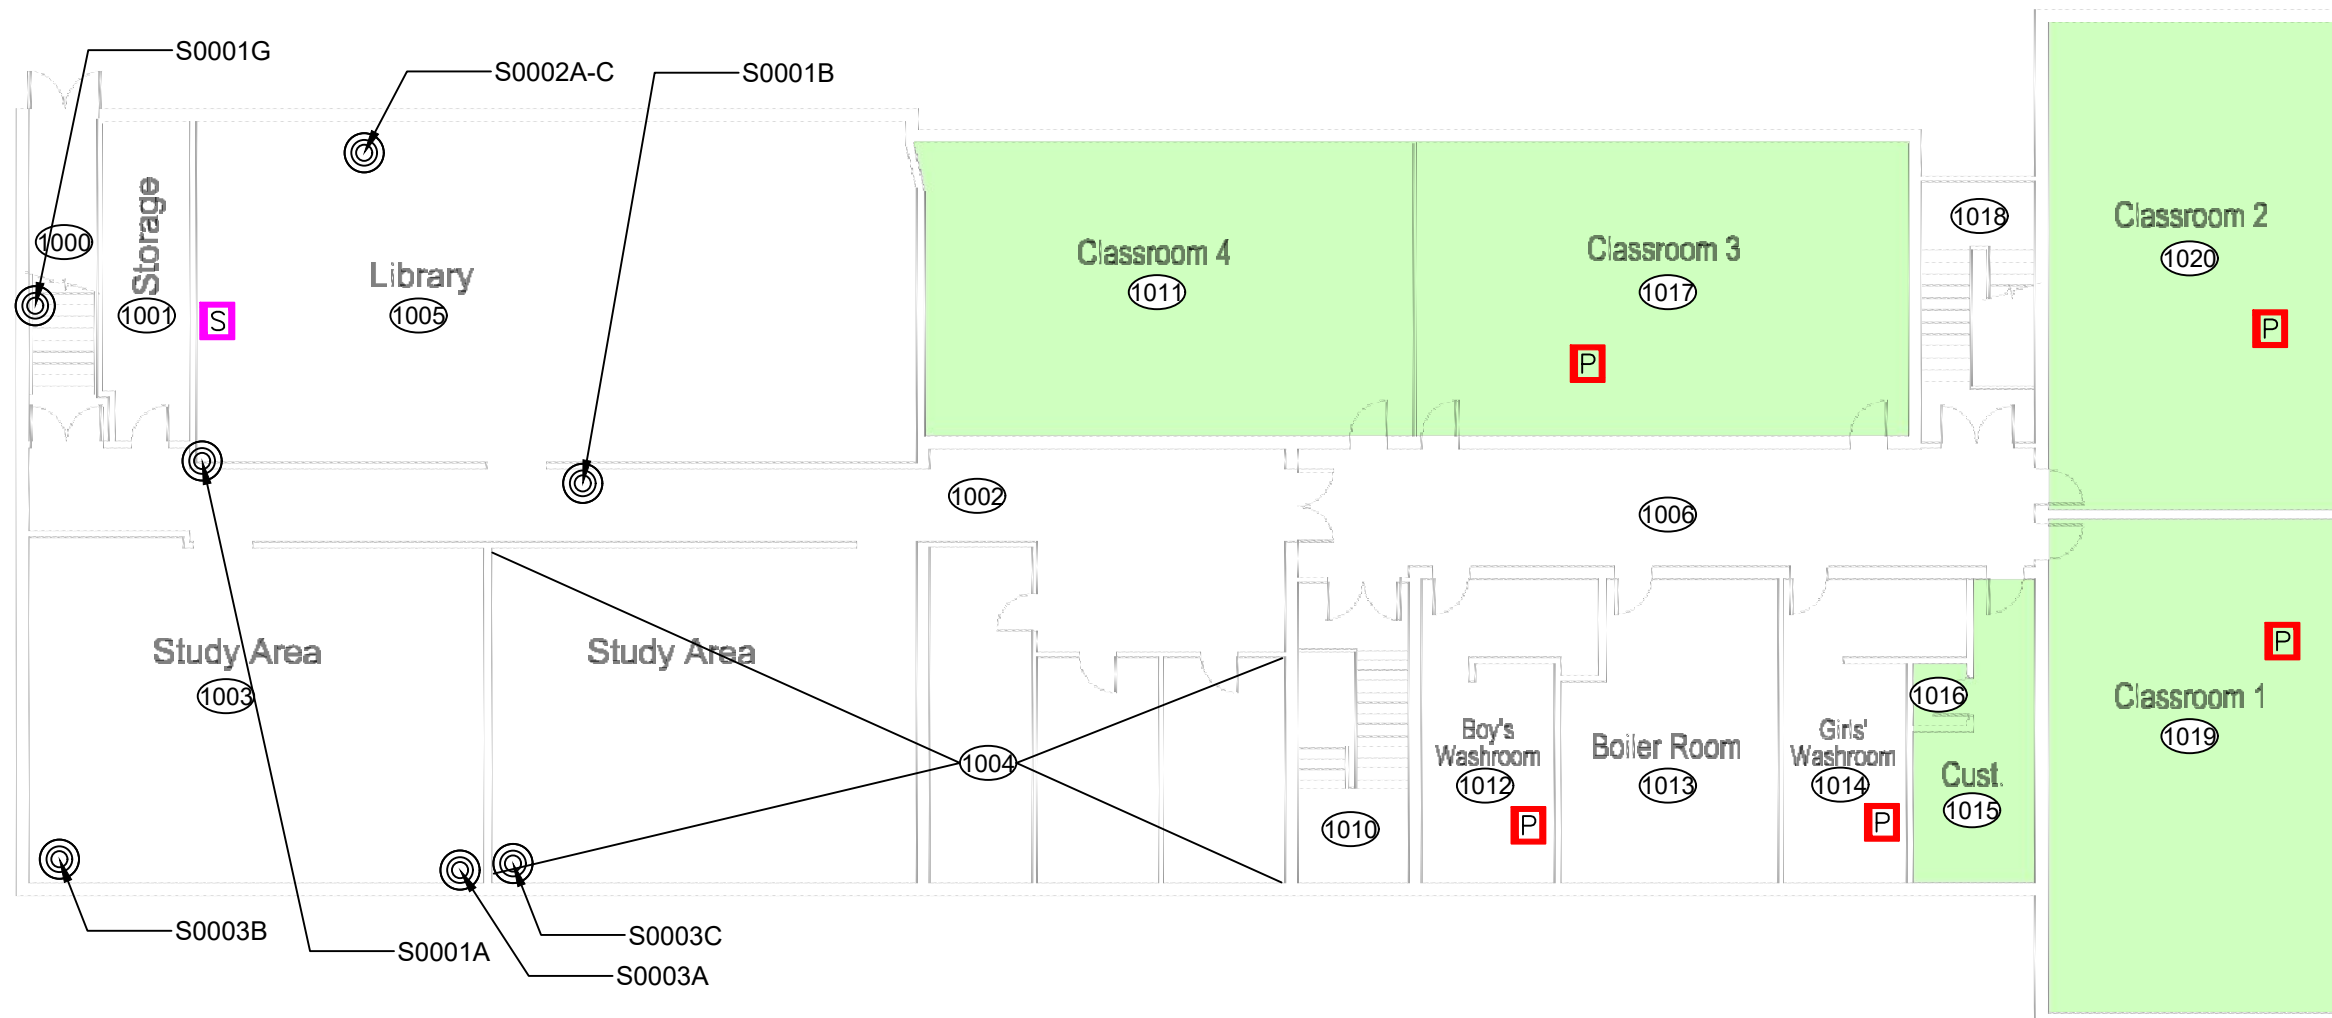
TITLE:
ASBESTOS REASSESSMENT
FLOOR LEVEL 1

NOTE:
ASBESTOS-CONTAINING DRYWALL ARE PRESENT ON WALLS AND CEILING FINISHES THROUGHOUT THE BUILDING
