# Asbestos Reassessment

Sacred Heart of Jesus  
5 Hamilton Avenue, Hamilton,  
Ontario

August 30, 2022

Pinchin File: 303992.004

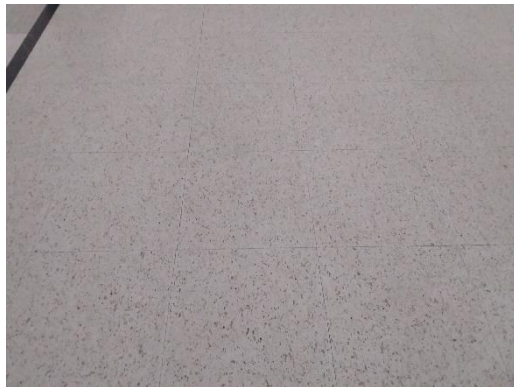
Material and Application	Asbestos Type/Friability	Photo
Vinyl floor tiles, 12"x12", white with black specks, are present.	Presumed/Non-friable (tile)  Presumed/Non-friable (mastic)

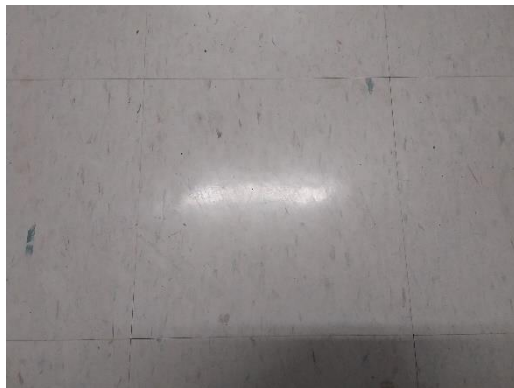
Vinyl floor tiles, 12"x12", white with blue/red, are present.	Presumed/Non-friable (tile)  Presumed/Non-friable (mastic)

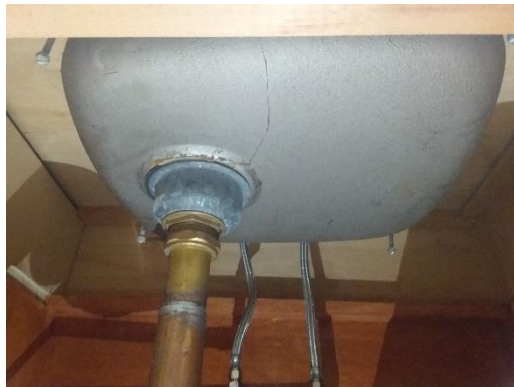
Remaining vinyl floor tiles were presumed to be non-asbestos based on historical knowledge of the date of installation (2002).	None	
Gold mastic is present as a sink undercoating.	Presumed/Non-friable

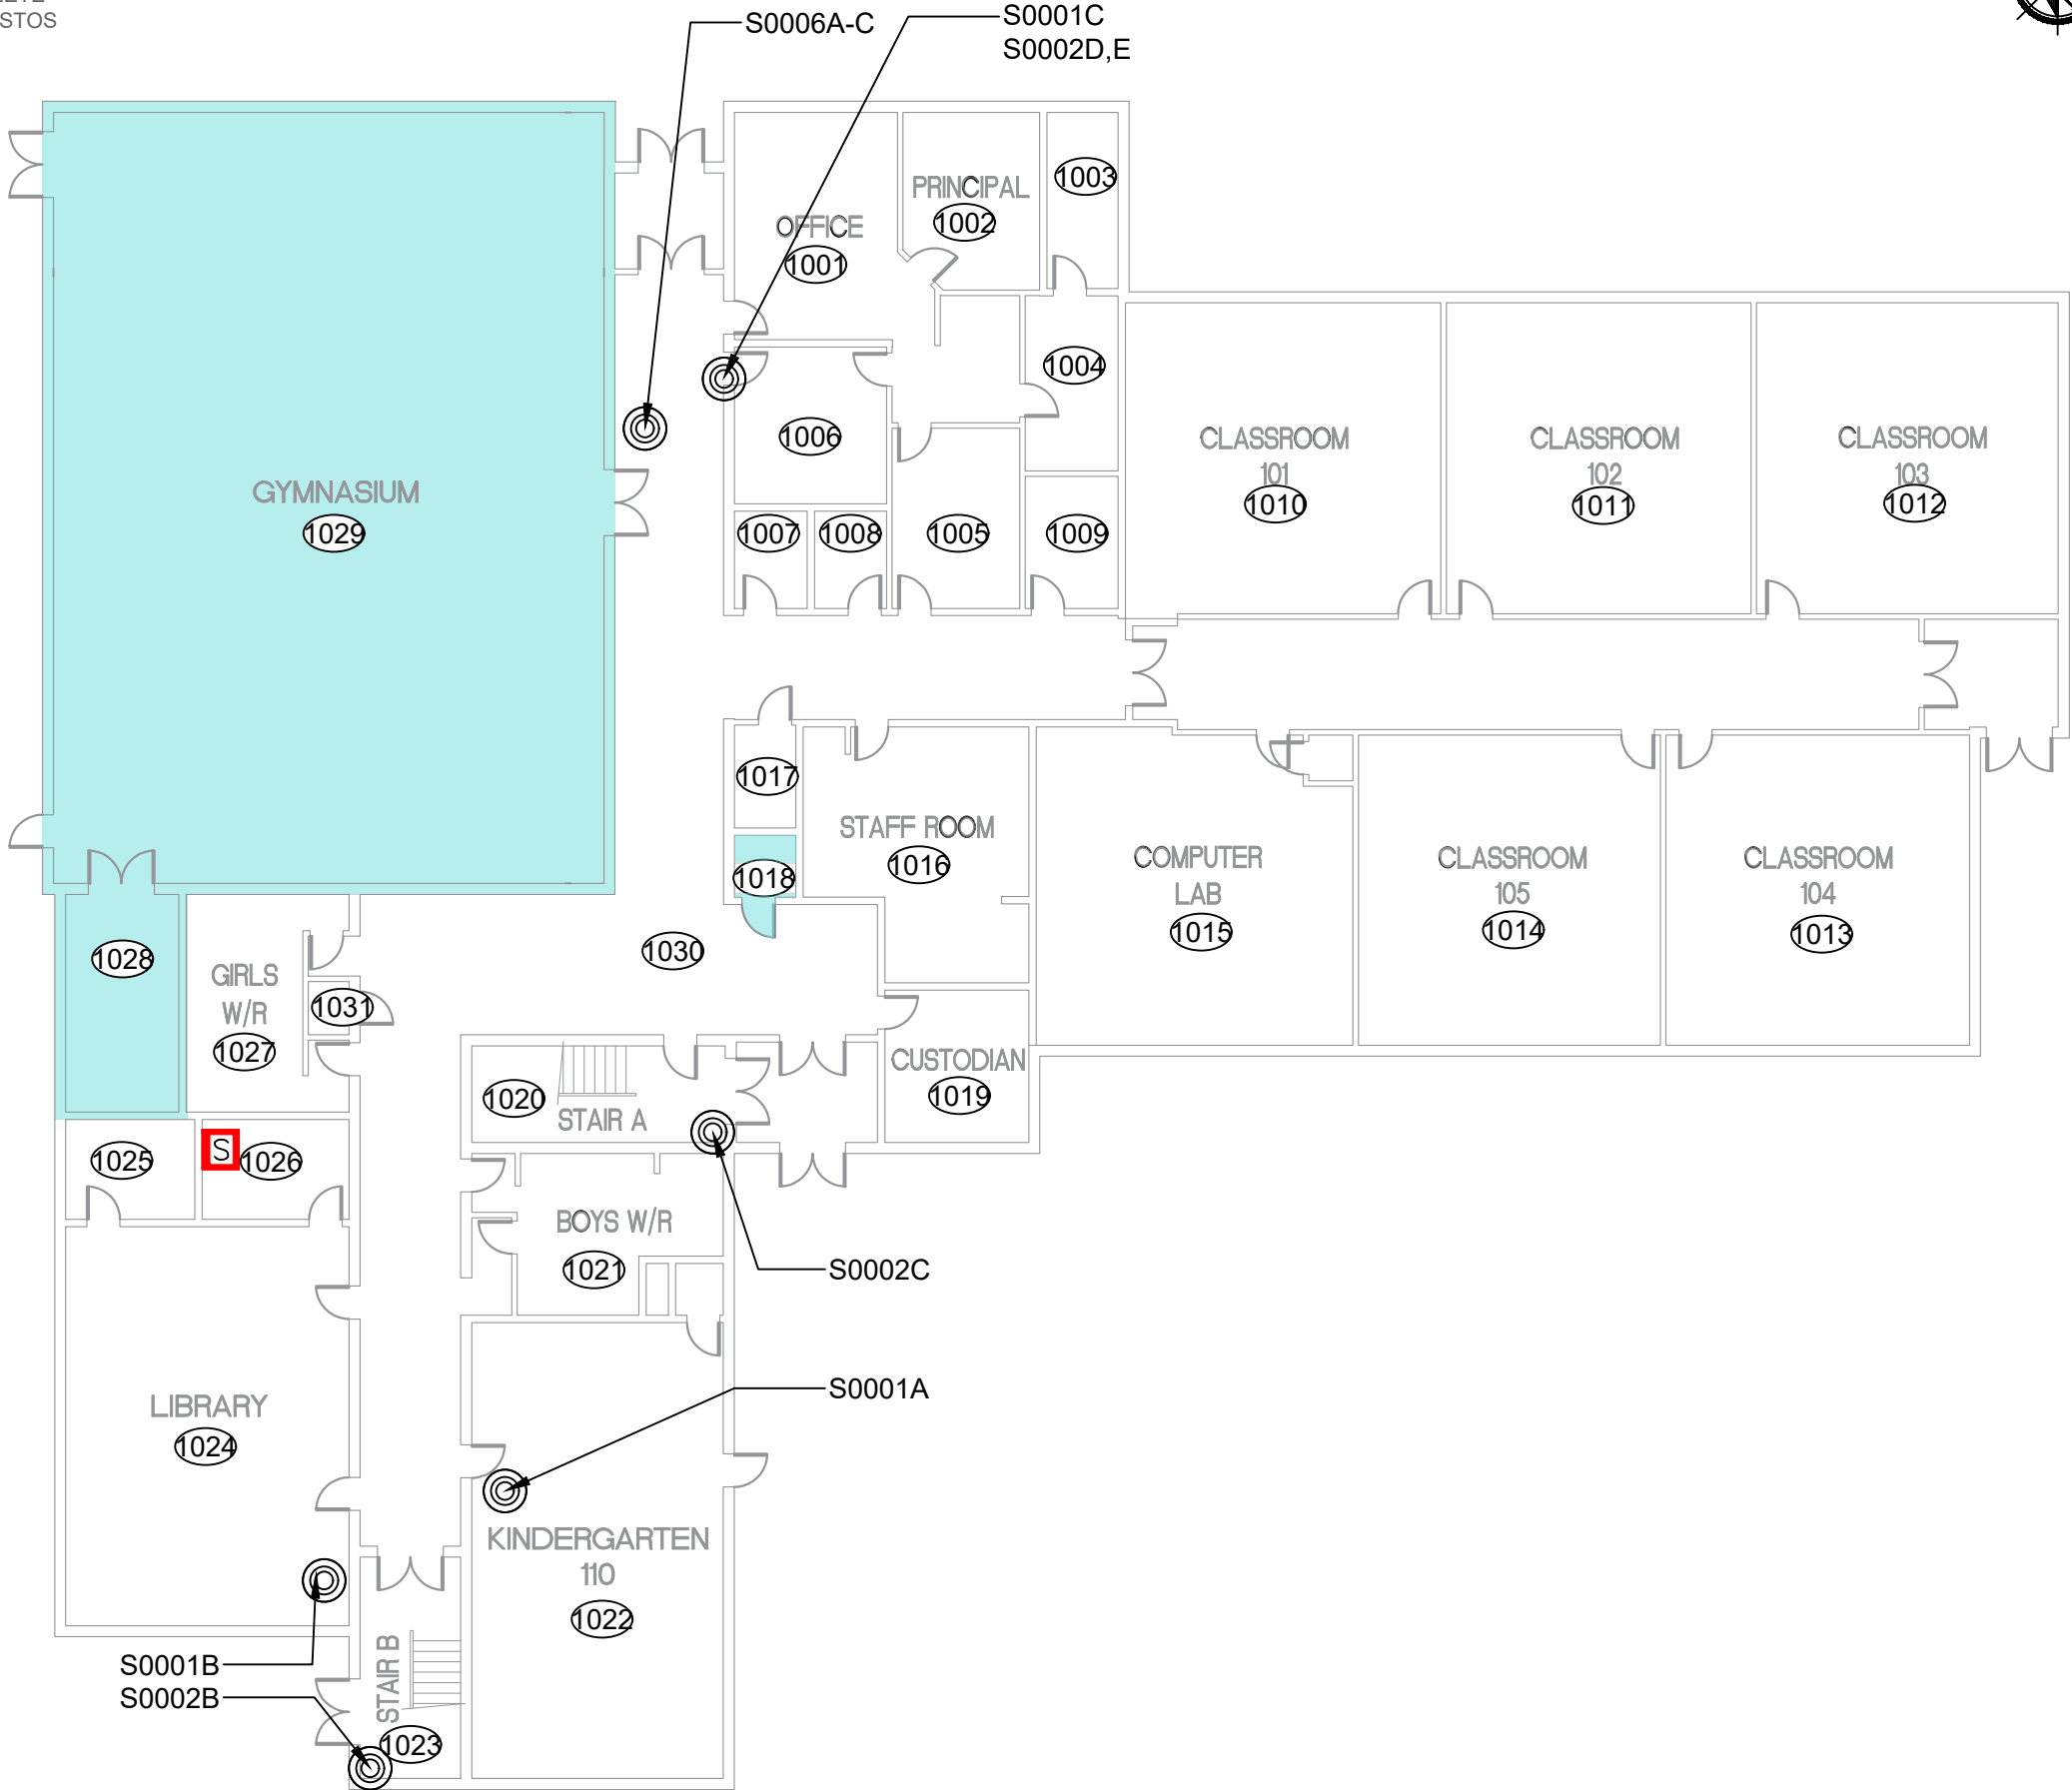
TITLE:  
ASBESTOS REASSESSMENT  
FLOOR LEVEL 1

S SINK UNDERCOATING

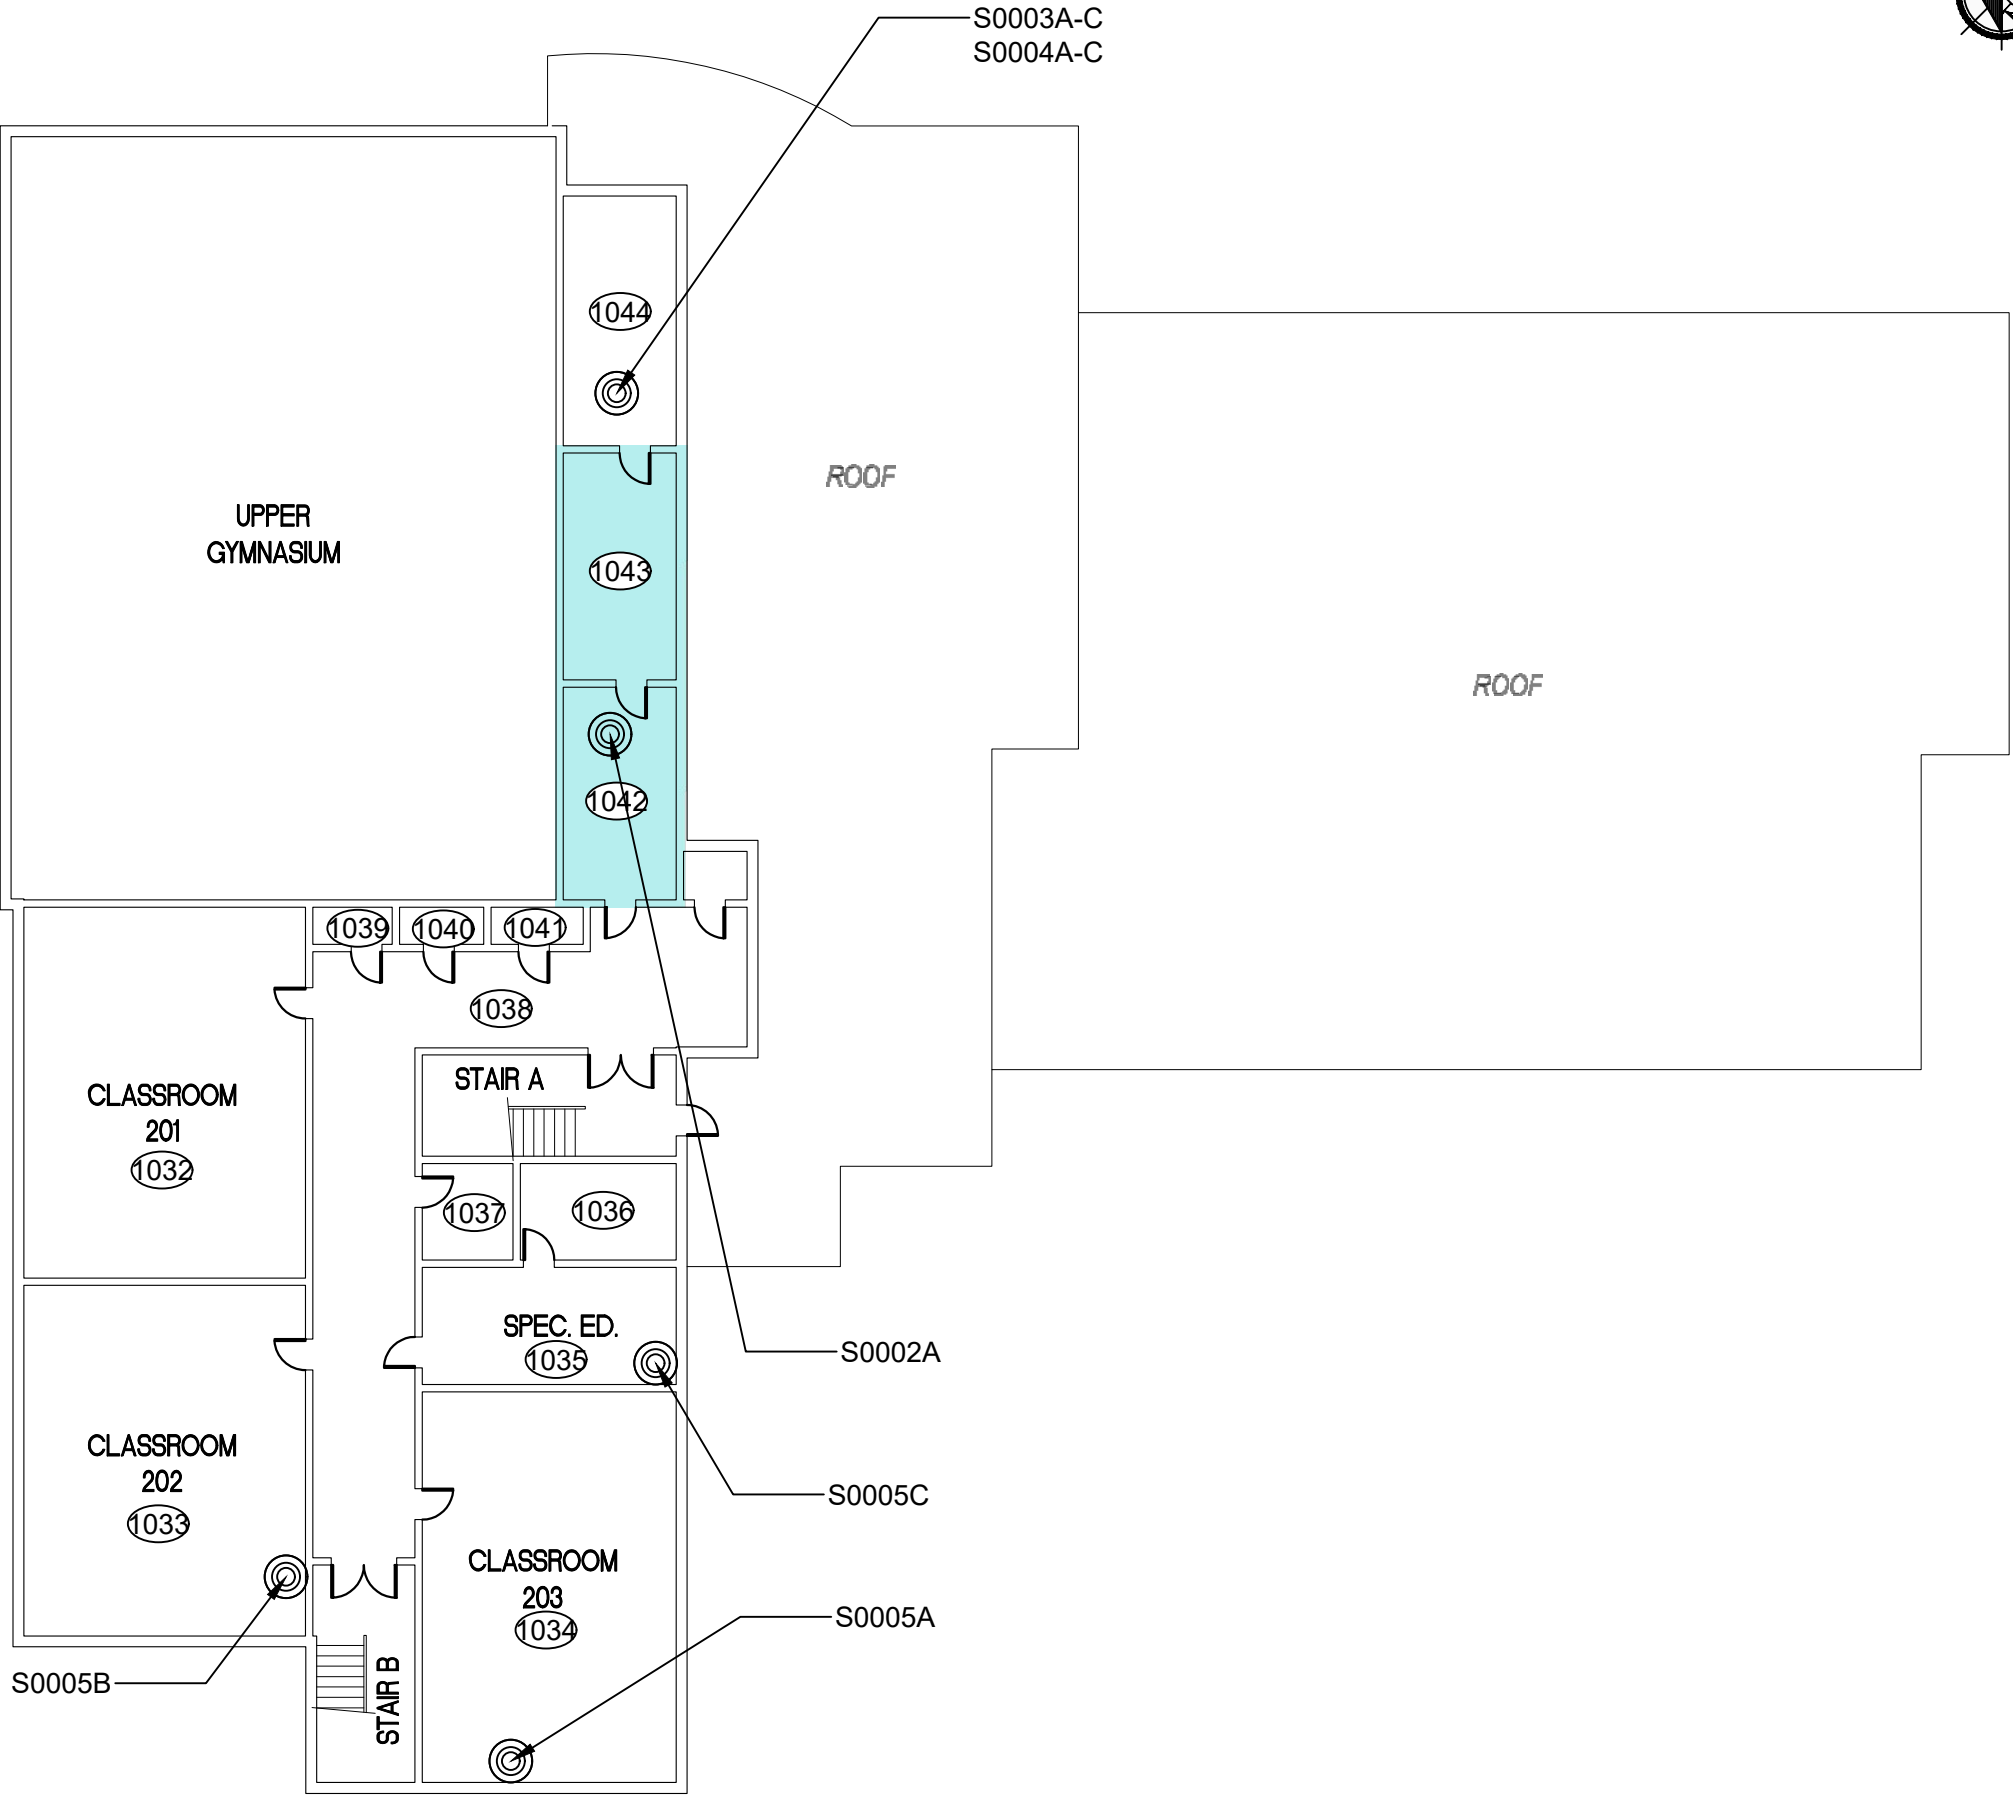
TITLE:  
ASBESTOS REASSESSMENT  
FLOOR LEVEL 2

- VINYL FLOOR TILES AND MASTIC
- S SINK UNDERCOATING
