Asbestos Reassessment

St. Charles Barlake
60 Barlake Avenue, Hamilton,
Ontario

August 12, 2022

Pinchin File: 303992.004

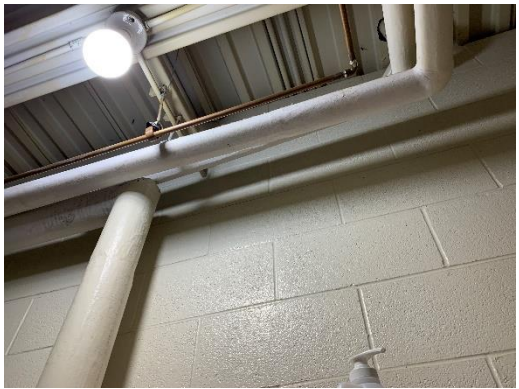
Material and Application	Asbestos Type/Friability	Photo
Parging cement is present on pipe fittings (elbows, valves, tees, hangers etc.)	Chrysotile/ Friable

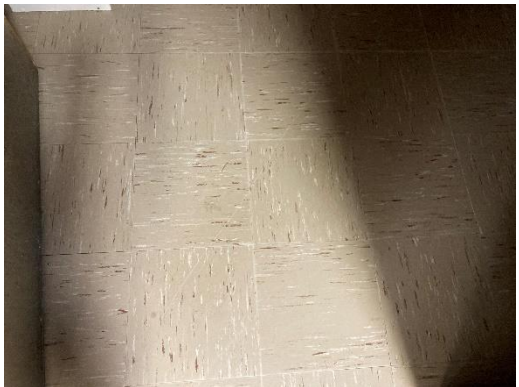
Material and Application	Asbestos Type/Friability	Photo
random pinhole pattern are present.		
Smooth plaster present on ceilings does not contain asbestos.	None	
Drywall joint compound present as a wall and ceiling finish does not contain asbestos.	None	
Vinyl floor tiles, 12"x12", beige with brown and white streaks, are present.	Chrysotile/Non-friable (tile) None (mastic)

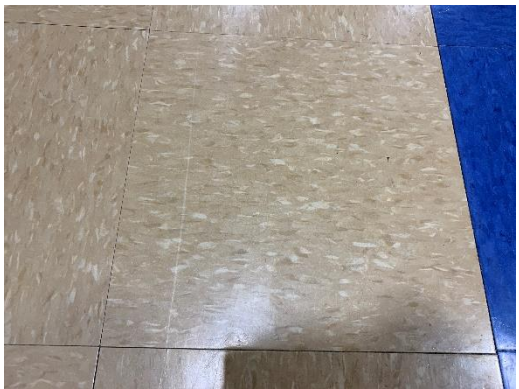
Vinyl floor tiles, 12"x12", beige dense fleck, are present.	None (tile) Presumed/Non-friable (mastic)

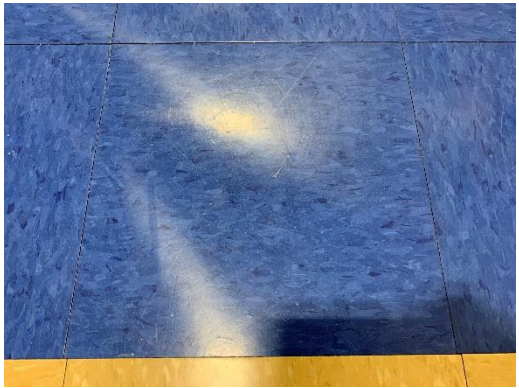
Vinyl floor tiles, 12"x12", blue dense fleck, are present.	None (tile) Presumed/Non-friable (mastic)

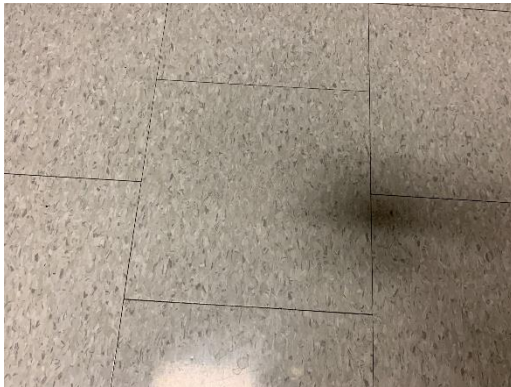
Material and Application	Asbestos Type/Friability	Photo
Vinyl floor tiles, 12"x12", light grey multi fleck, are present.	Presumed/Non-friable (tile) Presumed/Non-friable (mastic)

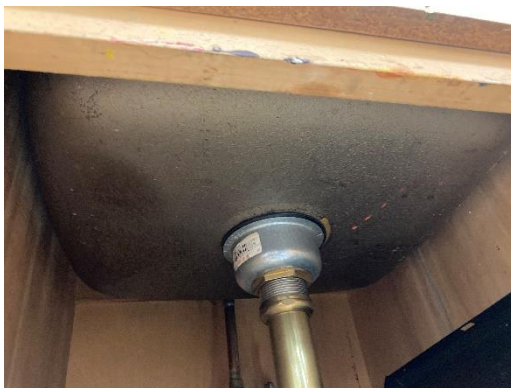
Gold mastic is present as a sink undercoating	Presumed/Non-friable
