Asbestos Reassessment

St. Charles Centre
45 Young Street, Hamilton,
Ontario

Pinchin File: 303922.004

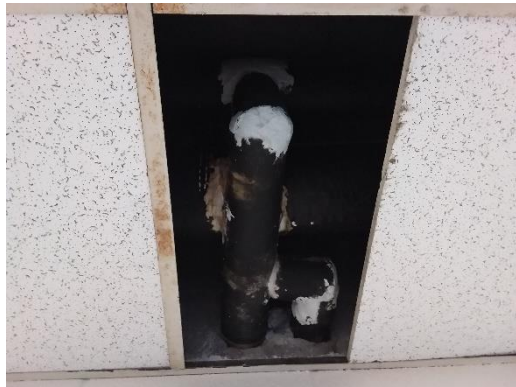
Material and Application	Asbestos Type/Friability	Photo
Parging cement is present on pipe fittings (elbows, valves, tees, hangers etc.)	Chrysotile/Friable

Material, Quantity & Condition	Location Name (Location #)	Recommended Procedure
Pipe insulation, 1 fitting, poor condition	Women's Washroom (Location 1008)	Asbestos precautions for work in ceiling space which may disturb asbestos in poor condition.

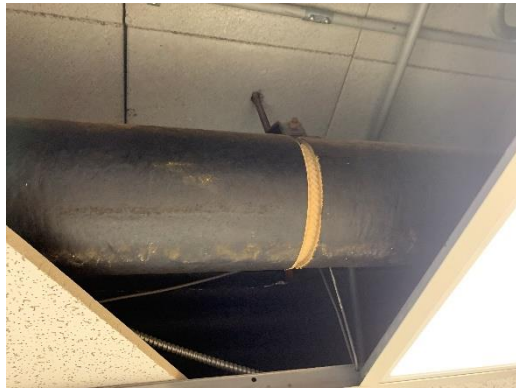
Sweatwrap insulation (brown layered paper) is present on straight sections of pipes.	None

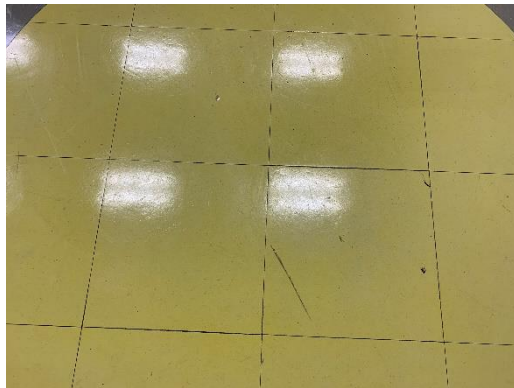
Material and Application	Asbestos Type/Friability	Photo
Remaining pipes are either uninsulated or insulated with non-asbestos fibreglass or elastomeric insulation (Armaflex).	None	
Ducts are either uninsulated or insulated with non-asbestos fibreglass.	None	
Mechanical equipment is either uninsulated or insulated with non-asbestos fibreglass.	None	
All ceiling tiles are presumed to be non-asbestos based on the date of manufacture determined from the date stamp applied to the top of the tiles.	None	
Vinyl floor tiles, 9"x9", yellow, are present.	Presumed/Non-friable (tile) Presumed/Non-friable (mastic)

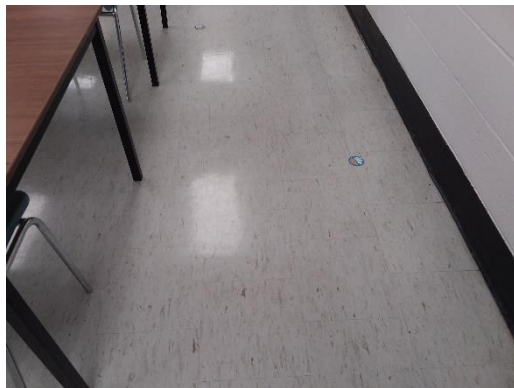
Vinyl floor tiles, 12"x12", white with green and beige streak, are present.	Presumed/Non-friable (tile) Presumed/Non-friable (mastic)

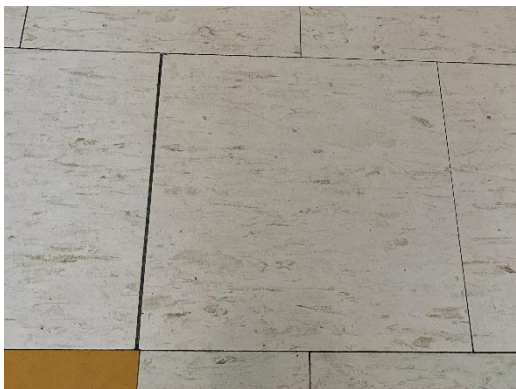
Material and Application	Asbestos Type/Friability	Photo
Vinyl floor tiles, 12"x12", white with black fleck, are present.	Presumed/Non-friable (tile) Presumed/Non-friable (mastic)	 
Vinyl floor tiles, 12"x12", beige with tan streaks, are present.	Presumed/Non-friable (tile) Presumed/Non-friable (mastic)
