Asbestos Reassessment

St. Charles Main/Wilma's Place
770 Main Street East, Hamilton,
Ontario

August 29, 2022

Pinchin File: 303992.004

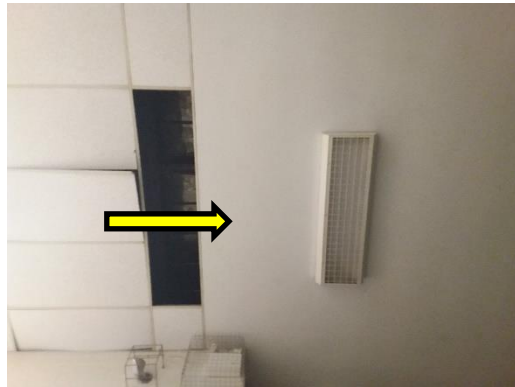
Material and Application	Asbestos Type/Friability	Photo
Textured plaster present on the ceiling of the Gymnasium (Location 1015).	Presumed/Friable

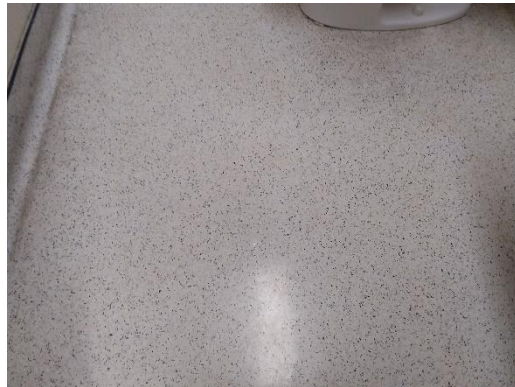
Non-asbestos drywall joint compound is present on wall and ceiling finishes.	None	
Asbestos in drywall joint compound was banned in Canada in 1980. Drywall joint compound in the Former Kindergarten and ECE areas as well as the Men's Washroom (Location 2011) was installed after 1986 (1980 plus a reasonable non-compliance period based on our experience) and is assumed to contain no asbestos.	None	
Vinyl sheet flooring, with a white with black flecks pattern is present.	Presumed/Potentially Friable

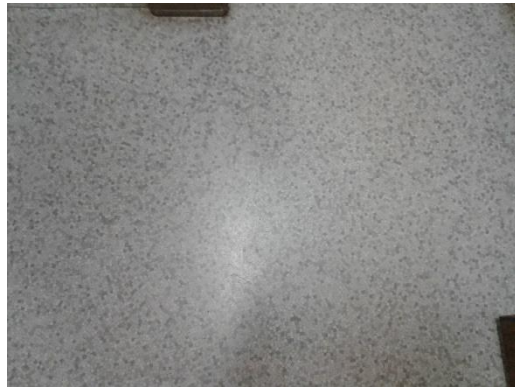
Material and Application	Asbestos Type/Friability	Photo
Vinyl sheet flooring, with a grey squares pattern is present.	Presumed/Potentially Friable

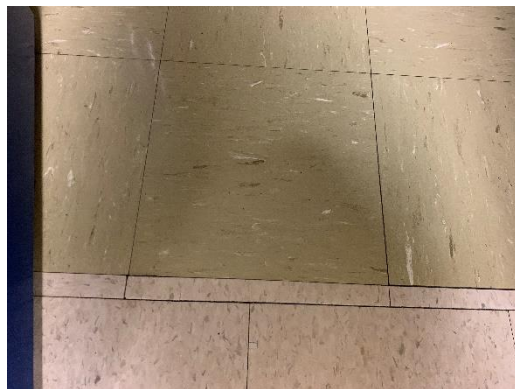
Vinyl floor tiles, 12"x12", taupe with brown and white streaks, are present.	Chrysotile/Non-friable (tile) Chrysotile/Non-friable (mastic)

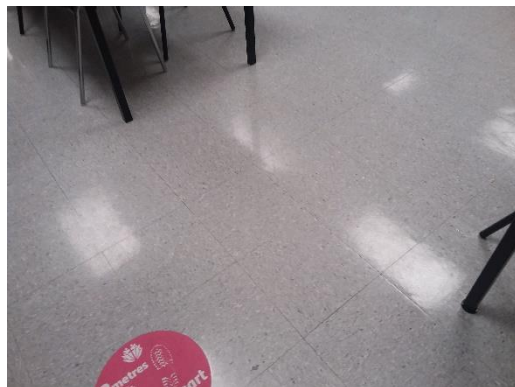
Vinyl floor tiles, 12"x12", white with grey, are present.	Presumed/Non-friable (tile) Presumed/Non-friable (mastic)

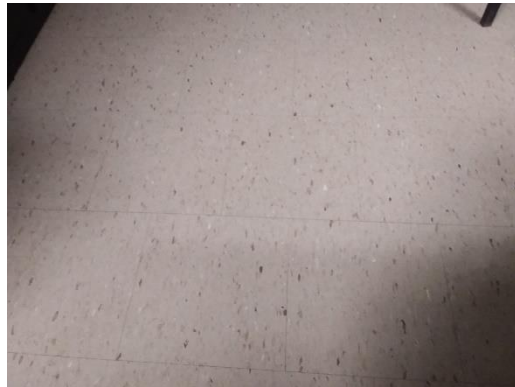
Material and Application	Asbestos Type/Friability	Photo
Vinyl floor tiles, 12"x12", pink with flecks, are present.	Presumed/Non-friable (tile) Presumed/Non-friable (mastic)
