Asbestos Reassessment

St. Charles Mountain
150 East 5th Street, Hamilton,
Ontario

August 30, 2022

Pinchin File: 303992.004

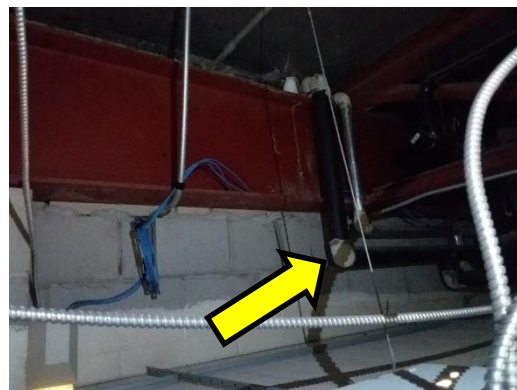
Material and Application	Asbestos Type/Friability	Photo
Parging cement is present on pipe fittings (elbows, valves, tees, hangers etc.).	Chrysotile/Friable

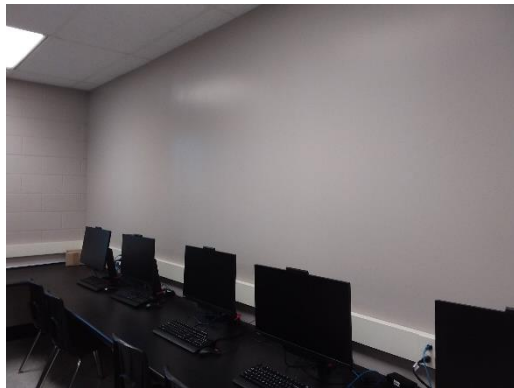
Material and Application	Asbestos Type/Friability	Photo
Non-asbestos texture finish is present on an Exterior (Location 1000) soffit.	None	
Drywall joint compound is present on wall and ceiling finishes.	Chrysotile/Non-friable

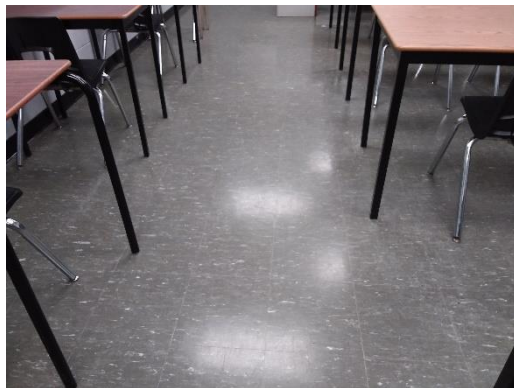
Vinyl floor tiles, 12"x12", dark green with white streaks, are present.	Chrysotile/Non-friable (tile) Chrysotile/Non-friable (mastic)

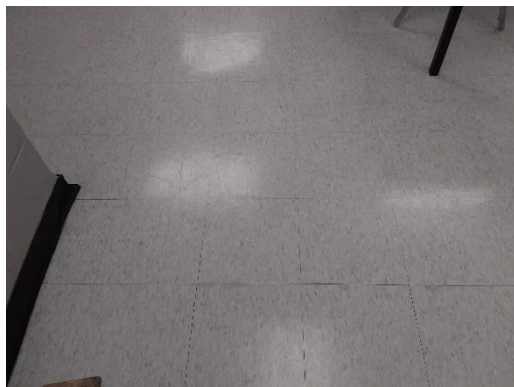
Vinyl floor tiles, 12"x12", beige marble, are present.	Presumed/Non-friable (tile) Presumed/Non-friable (mastic)

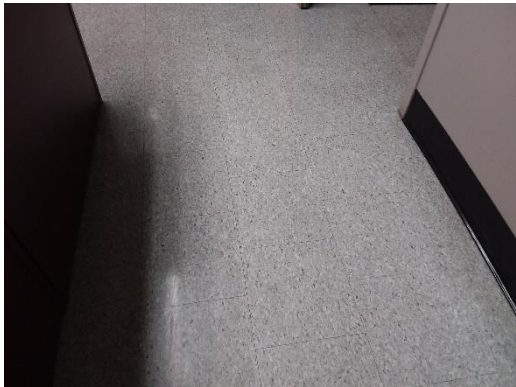
Material and Application	Asbestos Type/Friability	Photo
Vinyl floor tiles, 12"x12", light grey multi-fleck, are present.	Presumed/Non-friable (tile) Presumed/Non-friable (mastic)

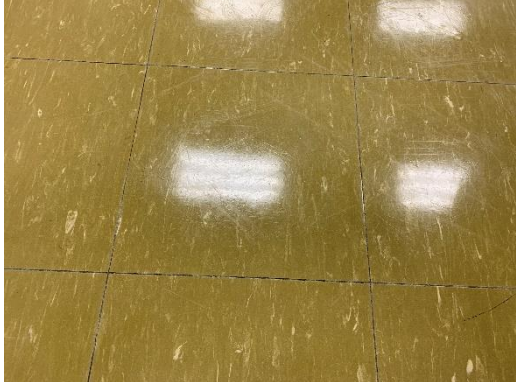
Vinyl floor tiles, 12"x12", beige with tan streaks, are present.	Presumed/Non-friable (tile) Presumed/Non-friable (mastic)

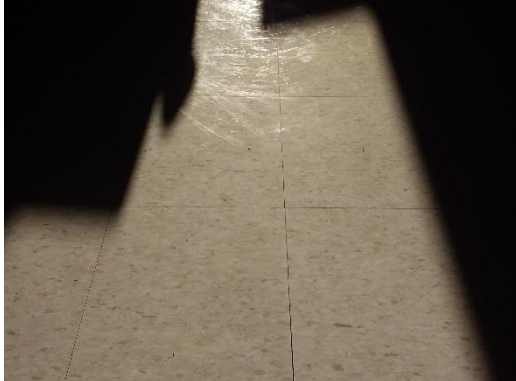
Vinyl floor tiles, 12"x12", beige with brown streaks, are present.	Presumed/Non-friable (tile) Presumed/Non-friable (mastic)

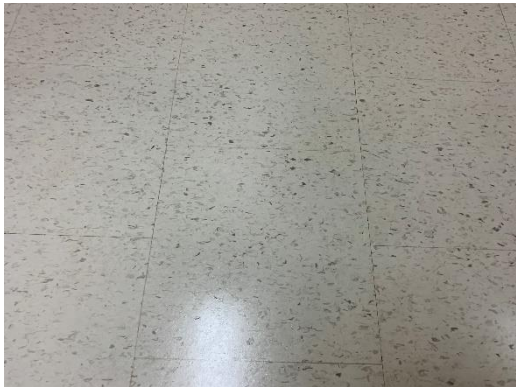
Material and Application	Asbestos Type/Friability	Photo
Vinyl floor tiles, 12"x12", white with black fleck, are present.	Presumed/Non-friable (tile) Presumed/Non-friable (mastic)

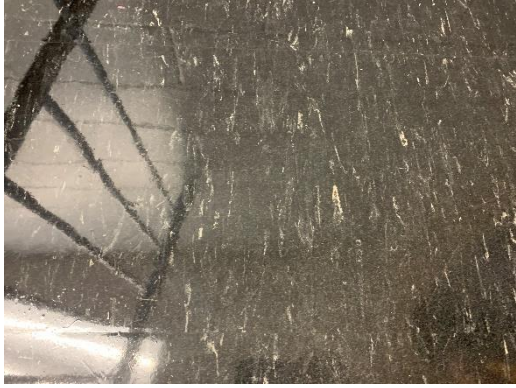
Vinyl floor tiles, 12"x12", black with white fleck, are present.	Presumed/Non-friable (tile) Presumed/Non-friable (mastic)

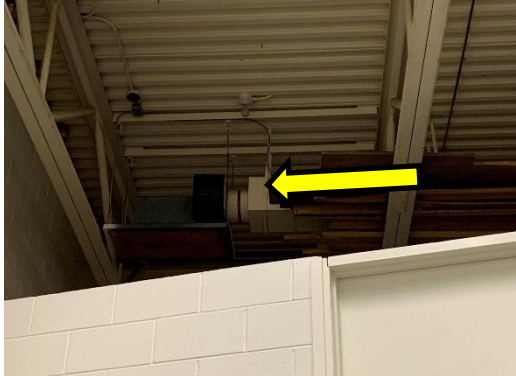
Textile vibration damper is present.	Presumed/Non-Friable

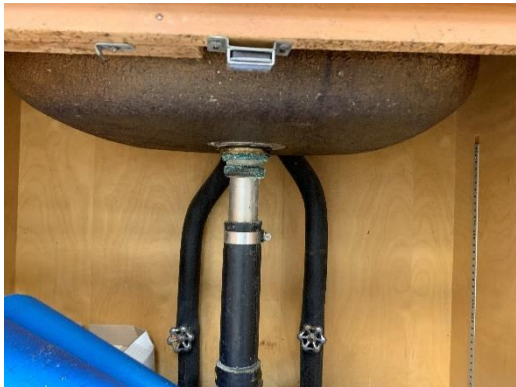
Material and Application	Asbestos Type/Friability	Photo
Black mastic is present as a sink undercoating.	Presumed/Non-Friable

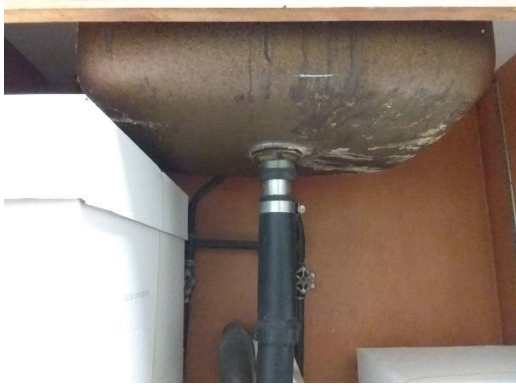
Gold mastic is present as a sink undercoating.	Presumed/Non-Friable

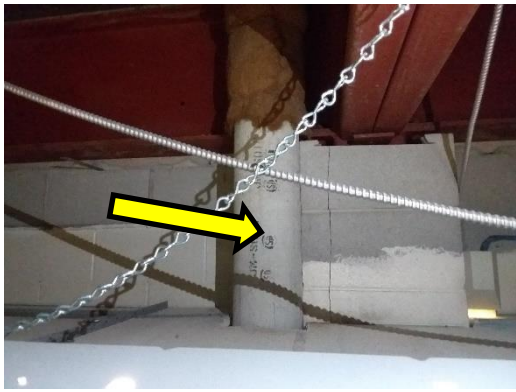
Transite is present as rainwater leaders.	Presumed/Non-Friable

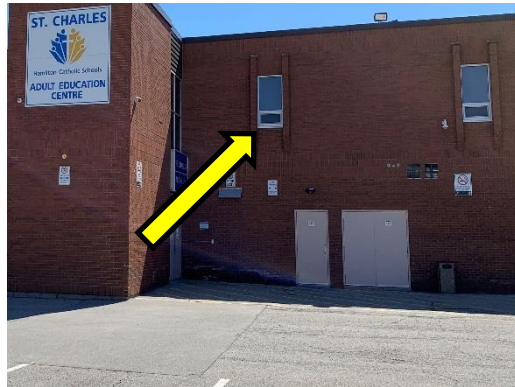
Material and Application	Asbestos Type/Friability	Photo
Grey window putty is present between glazing and frames on exterior (Location 1000).	Chrysotile/Non-friable
