# Asbestos Reassessment

St. Jean de Brebeuf  
200 Acadia Drive, Hamilton,  
Ontario

**Hamilton-Wentworth Catholic  
District School Board**

August 30, 2022

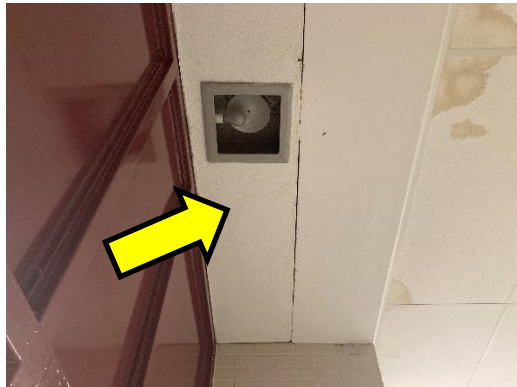
| Material and Application | Asbestos Type/Friability | Photo |
|---|---|---|
| <p>Texture finish is present on plaster ceilings in the Chapel (Location 1055) and plaster walls at the Catwalks (Location 2055).</p> <p>Texture finish is also present on soffits and columns at the former Main Entrance (Location 1037) and on the soffit in the Hallway (Location 1041).</p> <p>Overspray from the asbestos-containing texture coat is presumed to be present above the ceiling at light fixture openings, on the deck, ducts and within junction boxes.</p> | Chrysotile/Friable | |

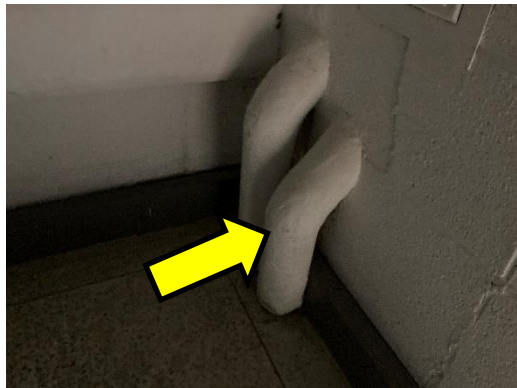
| Material and Application | Asbestos Type/Friability | Photo |
|---|---|---|
| <p>Parging cement is present on pipe fittings (elbows, valves, tees, hangers etc.)</p> | Chrysotile/Friable | |

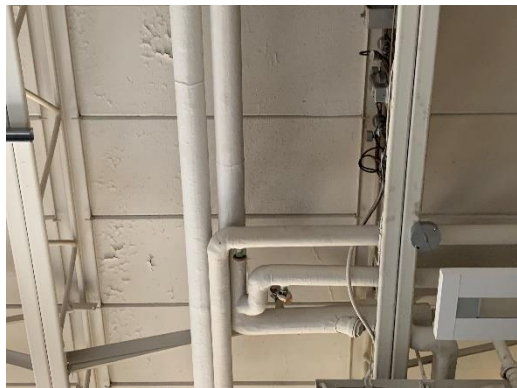
| Material and Application | Asbestos Type/Friability | Photo |
|---|---|---|
| <p>A white corrugated paper insulation (trade name Aircell), containing chrysotile asbestos, is present on straight sections of domestic water and heating system pipes.</p> | Chrysotile/Friable | |

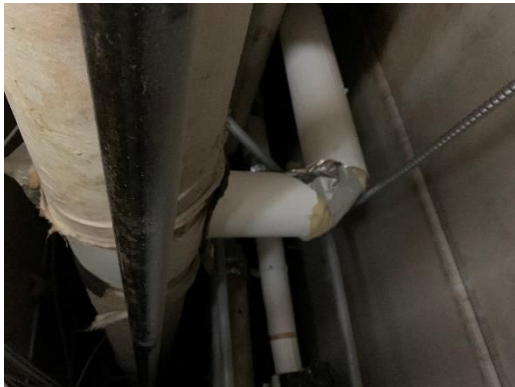
| Material and Application | Asbestos Type/Friability | Photo |
|---|---|---|
| Sweatwrap covered with parging cement, containing asbestos, over all seams and butt joints on the insulation, is present on straight sections of pipes. | Chrysotile/Friable | |

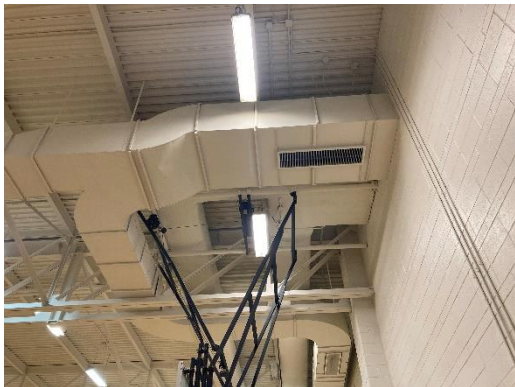
| Material and Application | Asbestos Type/Friability | Photo |
|---|---|---|
| Ducts are presumed to be insulated with fiberglass and parging cement in the Gymnasium (Location 1100) but were not confirmed due to the elevated height of the material. | Presumed/Friable | |

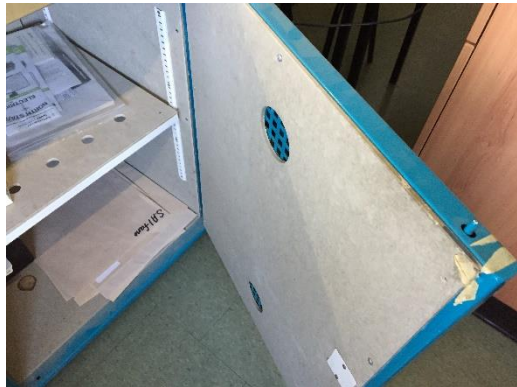
| Material and Application | Asbestos Type/Friability | Photo |
|---|---|---|
| Transite board is present in fume hoods and acid/base storage cabinets. | Presumed/Non-friable | |

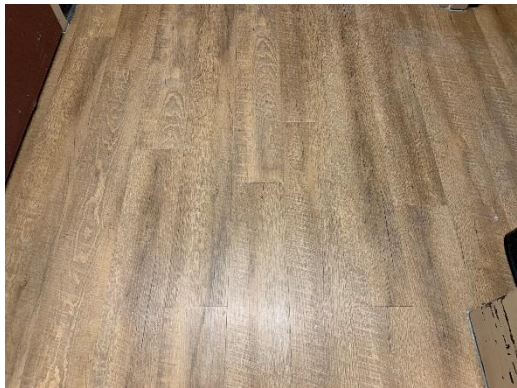
| Material and Application | Asbestos Type/Friability | Photo |
|---|---|---|
| Vinyl sheet flooring, with a faux wood pattern is present. | Presumed/Potentially Friable (mastic) | |

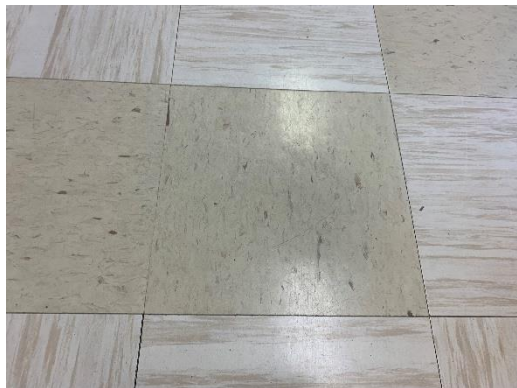
| Material and Application | Asbestos Type/Friability | Photo |
|---|---|---|
| Vinyl floor tiles, 12"x12", beige with tan streak, are present. | Chrysotile/Non-friable (tile)<br>Chrysotile/Non-friable (mastic) | |

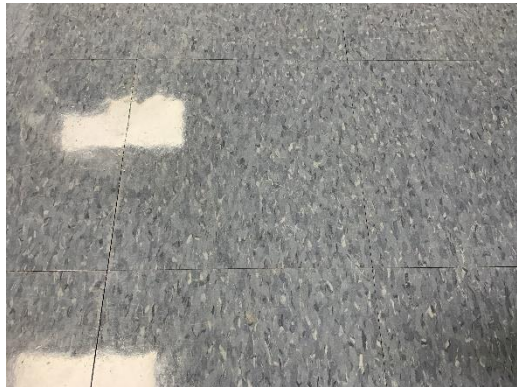
| Material and Application | Asbestos Type/Friability | Photo |
|---|---|---|
| Vinyl floor tiles, 12"x12", blue dense fleck, are present. | Presumed/Non-friable (tile)<br>Presumed/Non-friable (mastic) | |

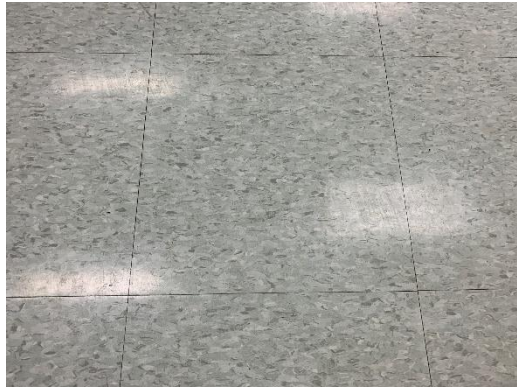
| Material and Application | Asbestos Type/Friability | Photo |
|---|---|---|
| Vinyl floor tiles, 12"x12", grey dense fleck, are present. | Presumed/Non-friable (tile)<br>Presumed/Non-friable (mastic) | |

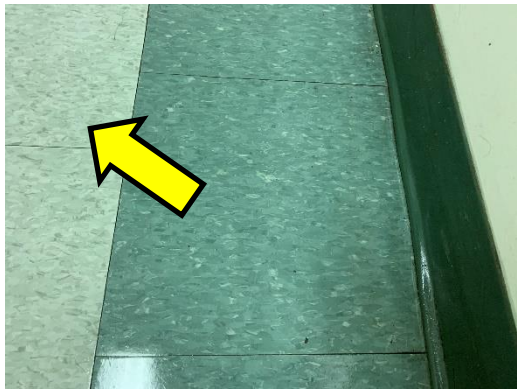
| Material and Application | Asbestos Type/Friability | Photo |
|---|---|---|
| Vinyl floor tiles, 12"x12", green dense fleck, are present. | Presumed/Non-friable (tile)<br>Presumed/Non-friable (mastic) | |

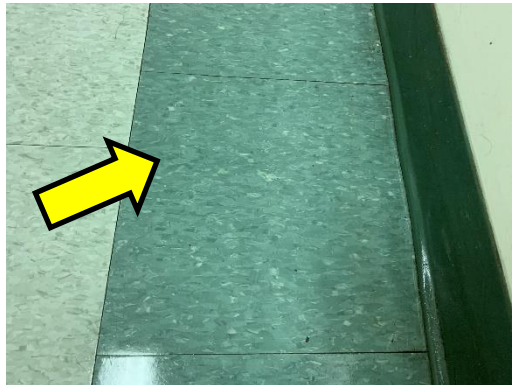
| Material and Application | Asbestos Type/Friability | Photo |
|---|---|---|
| Vinyl floor tiles, 12"x12", evergreen dense fleck, are present. | Presumed/Non-friable (tile)<br>Presumed/Non-friable (mastic) | |

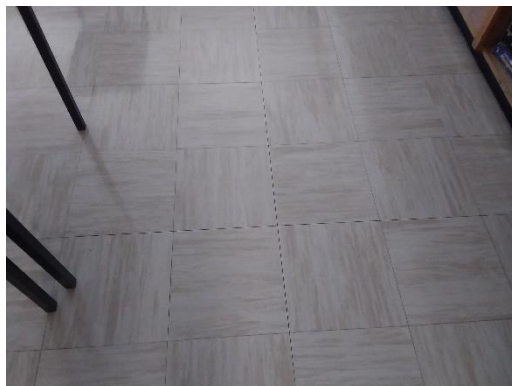
| Material and Application | Asbestos Type/Friability | Photo |
|---|---|---|
| Vinyl floor tiles, 12"x12", beige with brown streak, are present. | Presumed/Non-friable (tile)<br>Presumed/Non-friable (mastic) | |

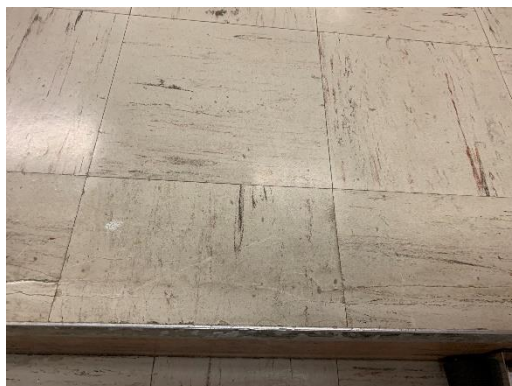
| Material and Application | Asbestos Type/Friability | Photo |
|---|---|---|
| Vinyl floor tiles, 9"x9", beige with brown streak, are present. | Presumed/Non-friable (tile)<br>Presumed/Non-friable (mastic) | |

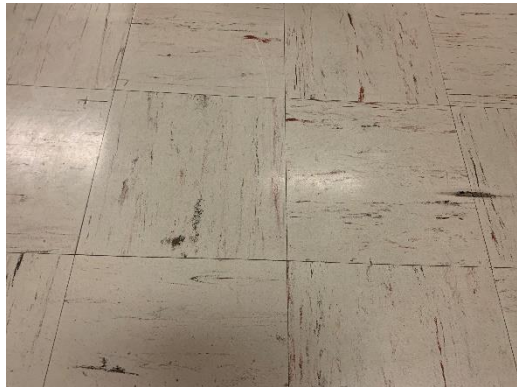
| Material and Application | Asbestos Type/Friability | Photo |
|---|---|---|
| Vinyl floor tiles, 9"x9", white with multi-colour streak, are present. | Presumed/Non-friable (tile)<br><br>Presumed/Non-friable (mastic) | |

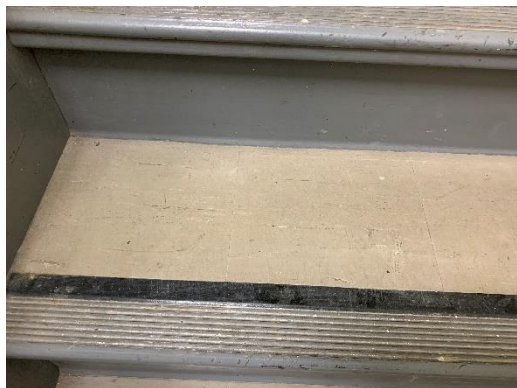
| Material and Application | Asbestos Type/Friability | Photo |
|---|---|---|
| Vinyl floor tiles, 9"x9", brown with white streak, are present. | Presumed/Non-friable (tile)<br><br>Presumed/Non-friable (mastic) | |

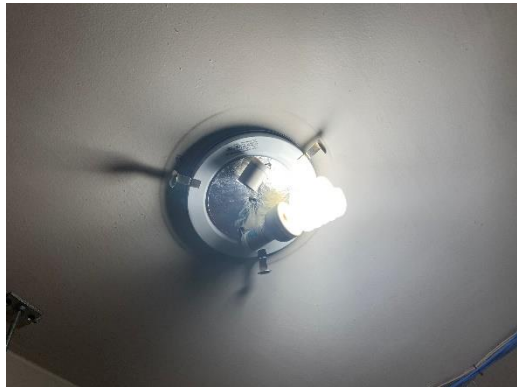
| Material and Application | Asbestos Type/Friability | Photo |
|---|---|---|
| Foil faced heat shield paper is present in incandescent light fixtures. | Chrysotile/Friable | |

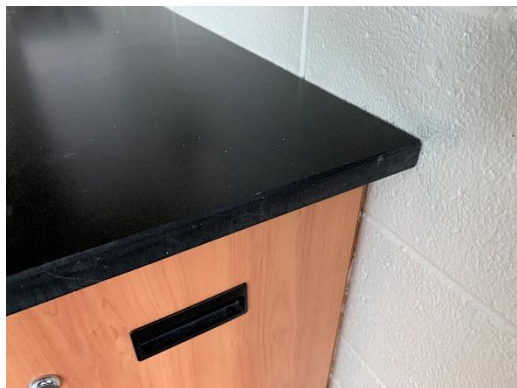
| Material and Application | Asbestos Type/Friability | Photo |
|---|---|---|
| Bakelite is present as sinks and countertops. | Presumed/Non-Friable | |

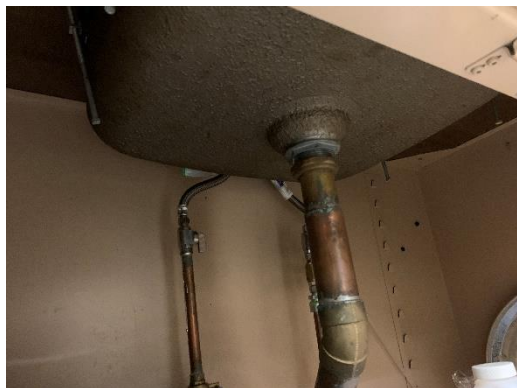
| Material and Application | Asbestos Type/Friability | Photo |
|---|---|---|
| Gold mastic is present as a sink undercoating. | Presumed/Non-Friable | |
