Asbestos Reassessment

St. Kateri Tekakwitha
22 Queensbury Drive, Hamilton,
Ontario

August 26, 2022

Pinchin File: 303992.004

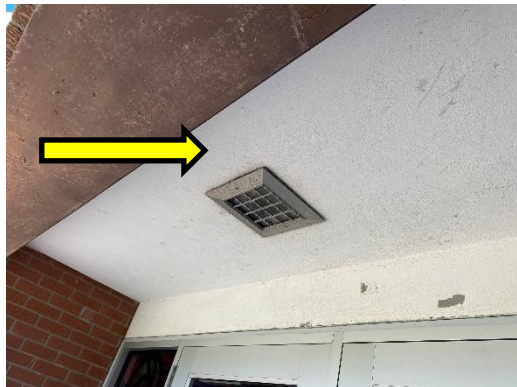
Material and Application	Asbestos Type/Friability	Photo
Textured plaster is present as a ceiling/soffit finish	Chrysotile/Potentially Friable

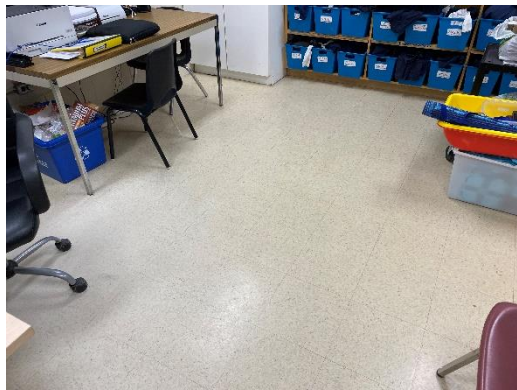
Vinyl floor tiles, 12"x12", cream with purple streaks are present.	Presumed/Non-friable (tile) Presumed/Non-friable (mastic)

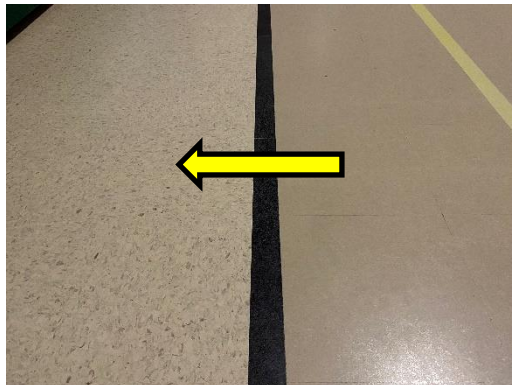
Material and Application	Asbestos Type/Friability	Photo
Vinyl floor tiles, 12"x12", white with black streaks are present.	Presumed/Non-friable (tile) Presumed/Non-friable (mastic)

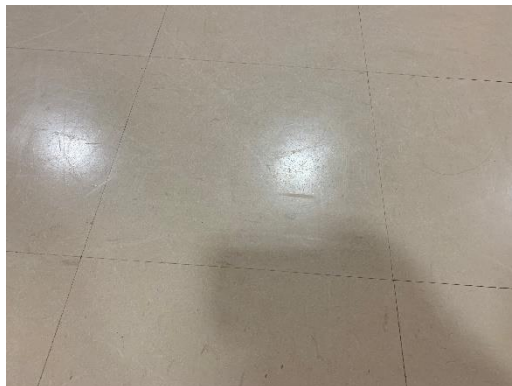
Vinyl floor tiles, 12"x12", beige are present.	Presumed/Non-friable (tile) Presumed/Non-friable (mastic)

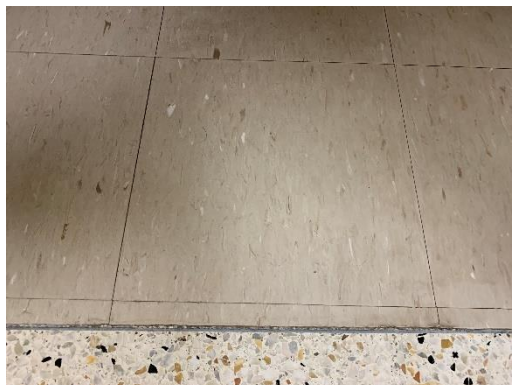
Vinyl floor tiles, 12"x12", beige with multi-coloured streaks are present.	Presumed/Non-friable (tile) Presumed/Non-friable (mastic)
