Asbestos Reassessment

St. Ann (Ancaster)
24 Fiddlers Green, Ancaster,
Ontario

**Hamilton-Wentworth Catholic
District School Board**

August 12, 2022

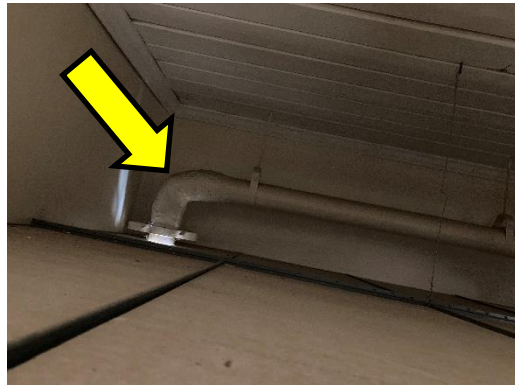
Material and Application	Asbestos Type/Friability	Photo
Parging cement is present on pipe fittings (elbows, valves, tees, hangers etc.)	Presumed/Friable

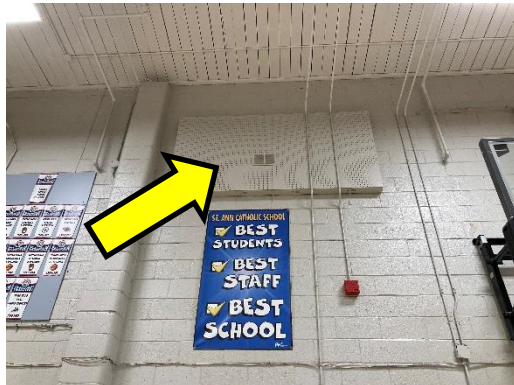
Material and Application	Asbestos Type/Friability	Photo
based on our experience) and is assumed to contain no asbestos.		
Transite board is present as acoustic panels in the Gymnasium (Location 130).	Presumed/Non-friable

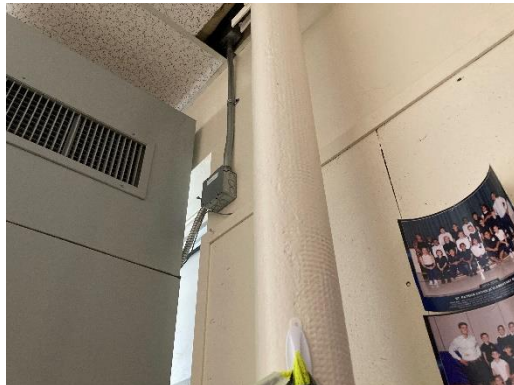
Transite pipe is present as rainwater leaders.	Presumed/Non-friable

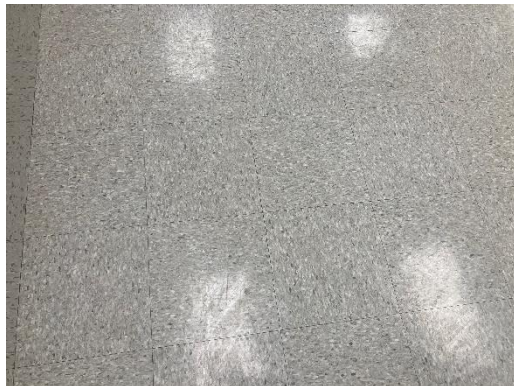
Vinyl sheet flooring is presumed to be non-asbestos based on the date of installation.	None	
Vinyl floor tiles, 12"x12", grey oatmeal, are present.	None (tile) Chrysotile/Non-friable (mastic)

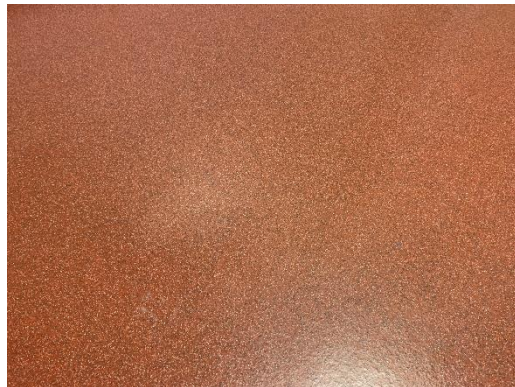
Material and Application	Asbestos Type/Friability	Photo
Vinyl floor tiles, 12"x12", red with dark red, are present.	Presumed/Non-friable (tile) Presumed/Non-friable (mastic)

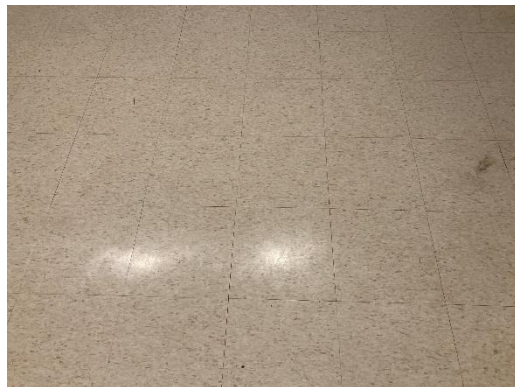
Vinyl floor tiles, 12"x12", beige with brown fleck, are present.	Presumed/Non-friable (tile) Presumed/Non-friable (mastic)
