# Asbestos Reassessment

St. Anthony Daniel  
75 Anson Avenue, Hamilton,  
Ontario

**Hamilton-Wentworth Catholic  
District School Board**

August 26, 2022

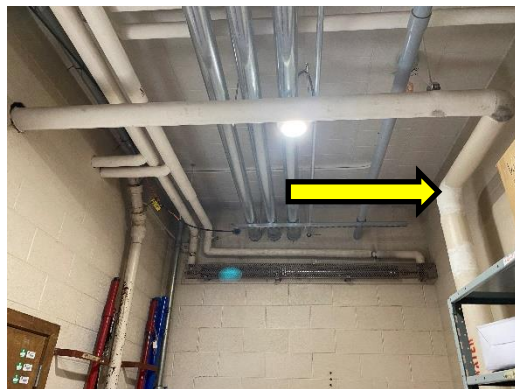
Material and Application	Asbestos Type/Friability	Photo
Non-asbestos texture finish is present on the concrete deck	None	
Parging cement is present on pipe fittings (elbows, valves, tees, hangers etc.)	Chrysotile/Friable

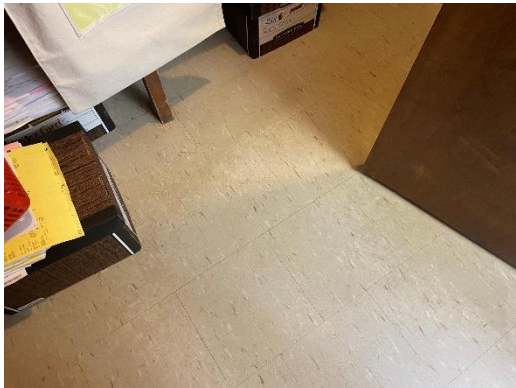
Material and Application	Asbestos Type/Friability	Photo
All ceiling tiles are presumed to be non-asbestos based on previous sampling, the date of manufacture determined from the date stamp applied to the top of the tiles, or the age of the materials determined from the age of the building or the renovation	None	
Plaster present on walls and ceilings does not contain asbestos.	None	
Non-asbestos drywall joint compound is present on wall and ceiling finishes.	None	
Vinyl floor tiles, 12"x12" light brown with brown and white streaks are present.	Chrysotile/Non-friable (tile)  Chrysotile/Non-friable (mastic)

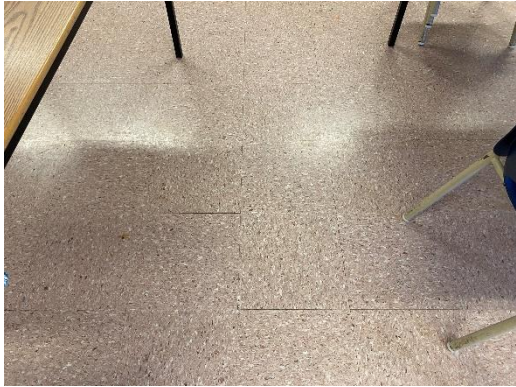
Vinyl floor tiles, 12"x12" pink oatmeal are present.	None (tile)  Chrysotile/Non-friable (mastic)

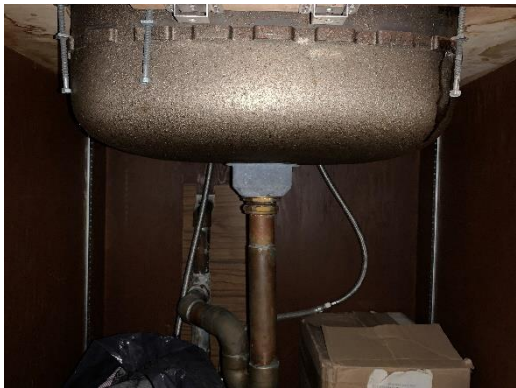
Material and Application	Asbestos Type/Friability	Photo
Remaining vinyl floor tiles are non-asbestos by sample analysis or were presumed to be non-asbestos based on historical knowledge of the date of installation (installed after 1992).	None	
Gold sink undercoating is present.	Presumed/Non-friable
