Asbestos Reassessment

St. Augustine
25 Alma Street, Dundas, Ontario

August 12, 2022

Pinchin File: 303992.004

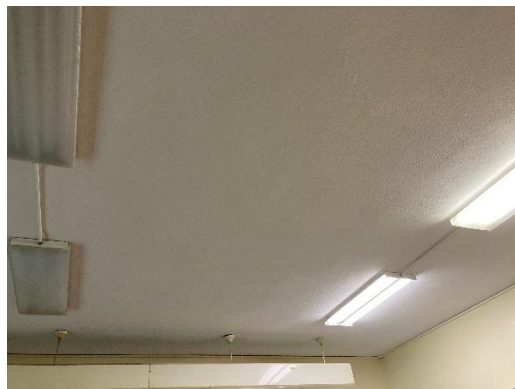
Material and Application	Asbestos Type/Friability	Photo
Non-asbestos containing fireproofing is present on structural steel including beams, trusses, joists, corrugated steel deck, concrete deck, columns.	None	
Texture finish is present on ceilings.	Chrysotile/Friable

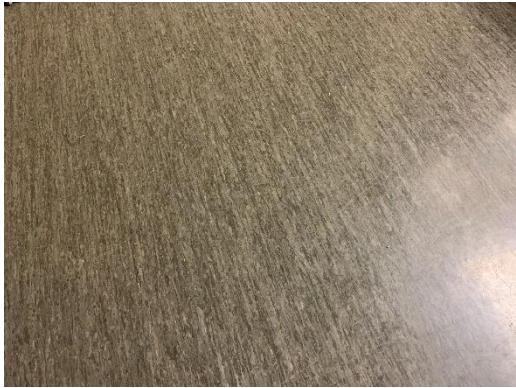
Material and Application	Asbestos Type/Friability	Photo
Asbestos in drywall joint compound was banned in Canada in 1980. Drywall joint compound in the post-1990 addition was installed after 1986 (1980 plus a reasonable non-compliance period based on our experience) and is assumed to contain no asbestos.	None	
Vinyl sheet flooring, with a streaked black pattern is present.	Presumed/Potentially Friable

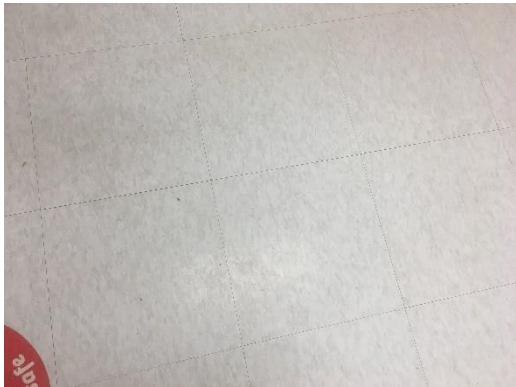
<p>Vinyl floor tiles, 12"x12", grey with grey flecks, are present.</p> <p>Remedial reports are not available, therefore presumed asbestos-containing vinyl floor tiles and/or mastic may be present beneath new non-asbestos vinyl floor tiles.</p>	<p>None based on date of install, 2021 (tile)</p> <p>Presumed/Non-friable (tile and/or mastic underneath new non-asbestos tile)</p>

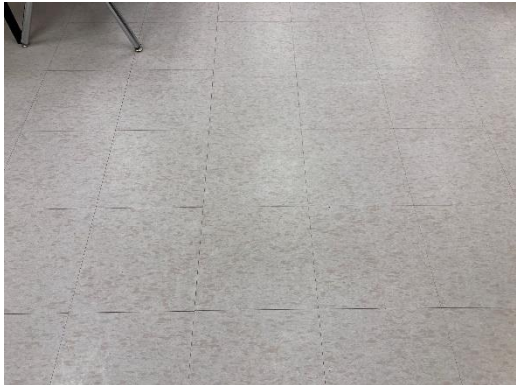
Material and Application	Asbestos Type/Friability	Photo
Vinyl floor tiles, 12"x12", pink dense fleck, are present.	Presumed/Non-friable (tile) Presumed/Non-friable (mastic)

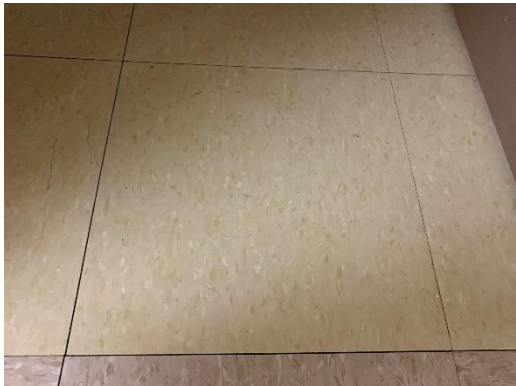
Vinyl floor tiles, 12"x12", beige with white fleck, are present.	Presumed/Non-friable (tile) Presumed/Non-friable (mastic)

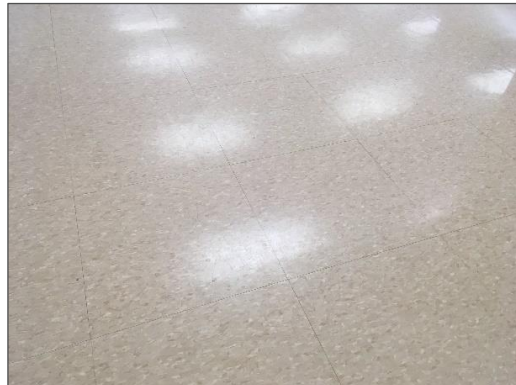
Vinyl floor tiles, 12"x12", pink with white fleck, are present.	Presumed/Non-friable (tile) Presumed/Non-friable (mastic)

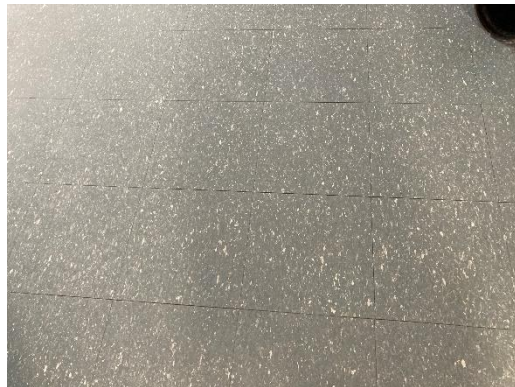
Material and Application	Asbestos Type/Friability	Photo
Vinyl floor tiles, 12"x12", grey dense fleck, are present.	Presumed/Non-friable (tile) Presumed/Non-friable (mastic)

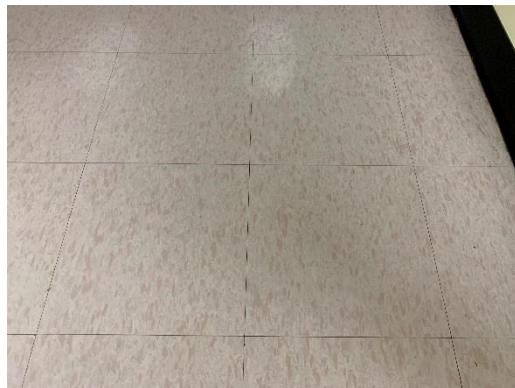
Vinyl floor tiles, 12"x12", pink with dark pink fleck, are present.	Presumed/Non-friable (tile) Presumed/Non-friable (mastic)
