Asbestos Reassessment

St. Clare of Assisi
185 Glenashton Drive, Stoney
Creek, Ontario

August 18, 2022

Pinchin File: 303992.004

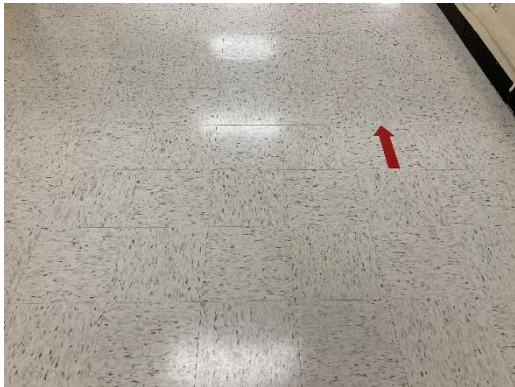
Material and Application	Asbestos Type/Friability	Photo
Vinyl floor tiles and mastic, 12"x12" grey with dark grey flecks, are present.	None (tile) Presumed (mastic)/non-friable

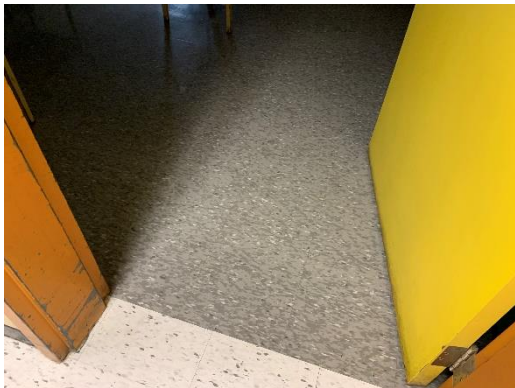
Vinyl floor tiles and mastic, 12"x12" grey oatmeal, are present.	None (tile) Presumed (mastic)/non-friable

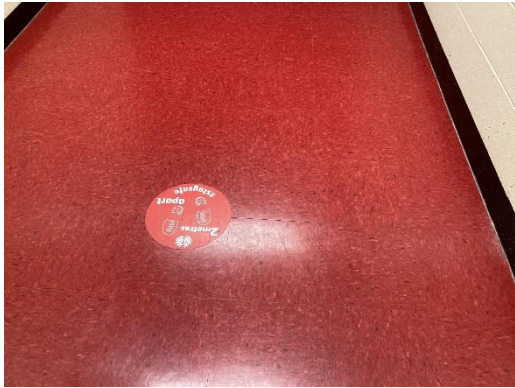
Vinyl floor tiles and mastic, 12"x12" red, are present in the Gymnasium (Location 1006).	None (tile) Chrysotile (mastic)

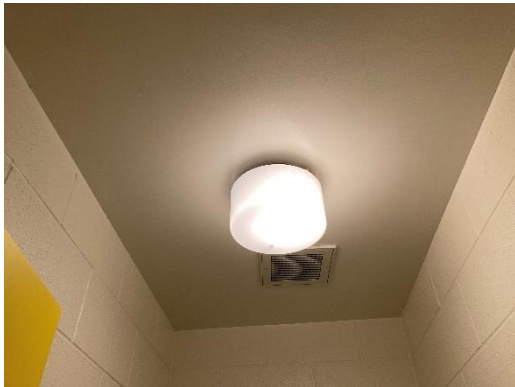
Material and Application	Asbestos Type/Friability	Photo
Paper heat shields in light fixtures are present.	Presumed/Non-friable

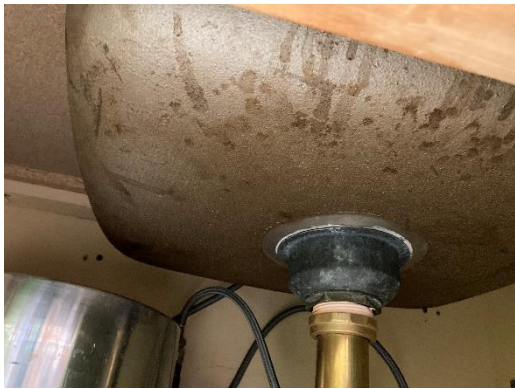
Gold sink undercoating is present.	Presumed/Non-friable

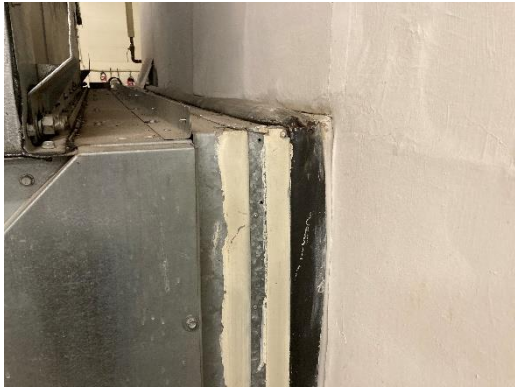
Vibration dampeners on HVAC equipment are present.	Presumed/Non-friable
