Asbestos Reassessment

St. David
33 Cromwell Crescent, Hamilton,
Ontario

**Hamilton-Wentworth Catholic
District School Board**

August 23, 2022

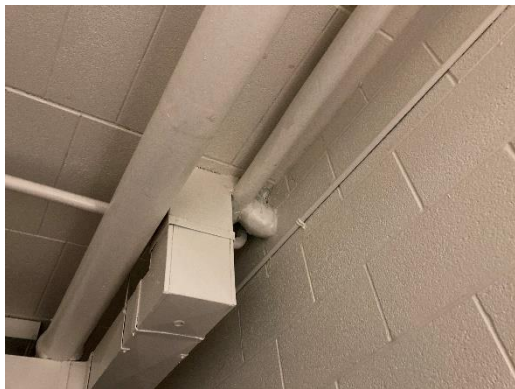
Material and Application	Asbestos Type/Friability	Photo
Non-asbestos texture finish is present on drywall walls in the Chapel (Location 1016).	None	
Parging cement is present on pipe fittings (elbows, valves, tees, hangers etc.)	None

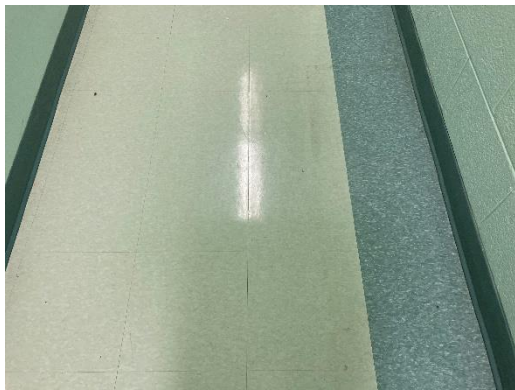
Material and Application	Asbestos Type/Friability	Photo
Mechanical equipment is either uninsulated or insulated with non-asbestos fibreglass.	None	
All ceiling tiles are presumed to be non-asbestos based on the date of manufacture determined from the date stamp applied to the top of the tiles, the age of the materials determined from the age of the building or the renovation, or by sample analysis.	None	
Plaster present on walls and ceilings does not contain asbestos.	None	
Non-asbestos drywall joint compound is present on wall and ceiling finishes.	None	
Vinyl floor tiles, 12"x12" light green multi-fleck and 12"x12" green multi-fleck, are present	None (tile) None (mastic)

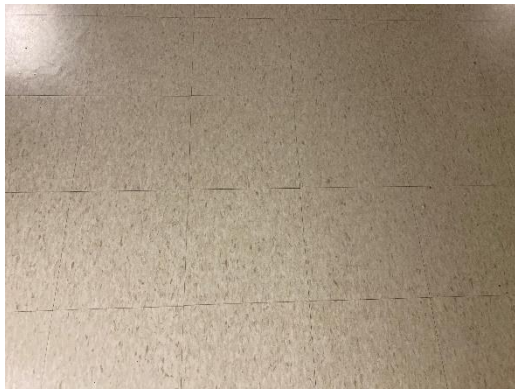
<p>Remaining vinyl floor tiles were presumed to be non-asbestos based on historical knowledge of the date of installation or by sample analysis.</p> <p>Mastic under non-asbestos vinyl floor tiles is presumed to contain asbestos until sampling proves otherwise.</p>	None (tile) Presumed/Non-friable (mastic)
