Asbestos Reassessment

St. Eugene
120 Parkdale Avenue South,
Hamilton, Ontario

August 23, 2022

Pinchin File: 303992.004

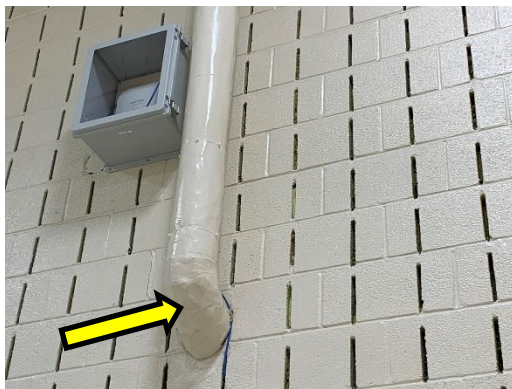
Material and Application	Asbestos Type/Friability	Photo
Non-asbestos texture finish was previously identified in the Entrance/Stairwell.	None	
Parging cement is present on pipe fittings (elbows, valves, tees, hangers etc.)	Chrysotile/Friable

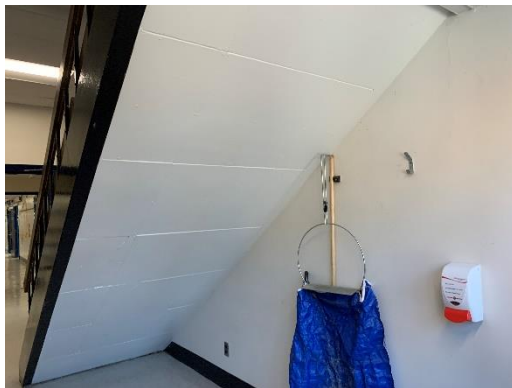
Material and Application	Asbestos Type/Friability	Photo
Brown puck adhesive, once present on the backside of the glue-on ceiling tiles, remains present above new ceiling tiles.	None	
An intrusive investigation of accessible masonry block walls was conducted in 2020, and no vermiculite was present in locations investigated.	None	
All ceiling tiles were determined to be non-asbestos by sample analysis or are presumed to be non-asbestos based on the date of manufacture determined from the date stamp applied to the top of the tiles or the age of the materials determined from the age of the building renovation.	None	
Plaster present on walls and ceilings does not contain asbestos.	None	
Non-asbestos drywall joint compound is present on wall and ceiling finishes.	None	
Transite board is present as a ceiling finish in stairwells.	Presumed/Non-friable

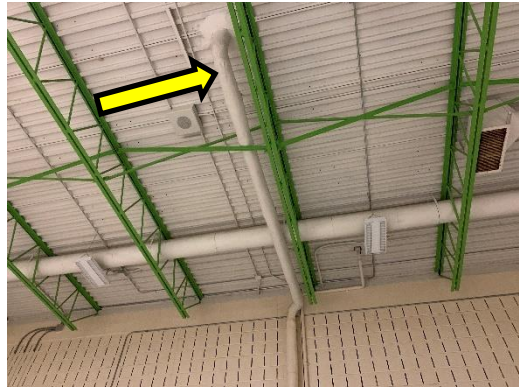
Material and Application	Asbestos Type/Friability	Photo
Transite pipe is present as rainwater leaders.	Presumed/Non-friable

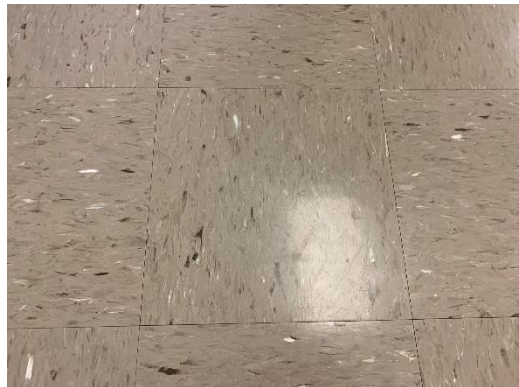
Vinyl floor tiles, 12"x12", grey multi-fleck, are present.	None (tile) Chrysotile/Non-friable (mastic)

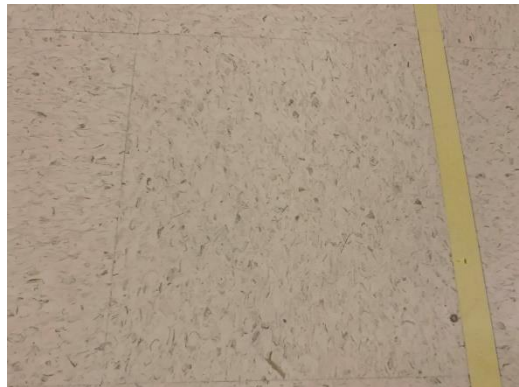
Vinyl floor tiles, 12"x12", cream, are present.	None (tile) Chrysotile/Non-friable (mastic)

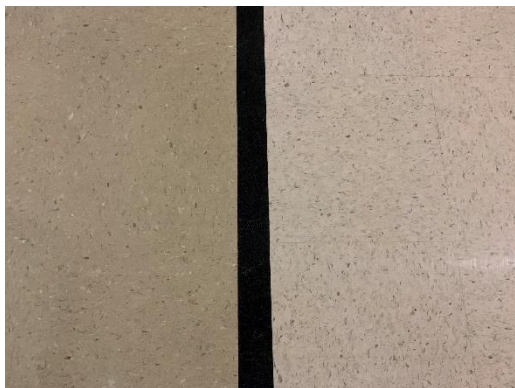
Material and Application	Asbestos Type/Friability	Photo
Vinyl floor tiles, 12"x12", brown/cream, are present.	None (tile) Chrysotile/Non-friable (mastic)

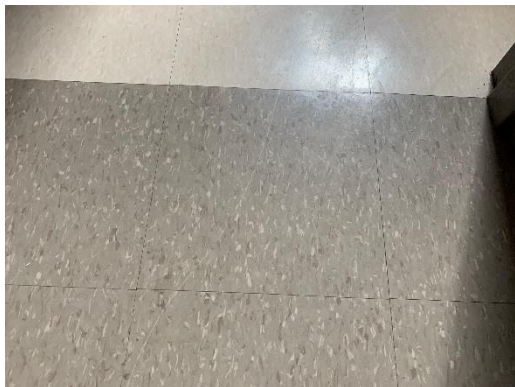
Vinyl floor tiles, 12"x12", grey oatmeal, are present.	None (tile) Chrysotile/Non-friable (mastic)

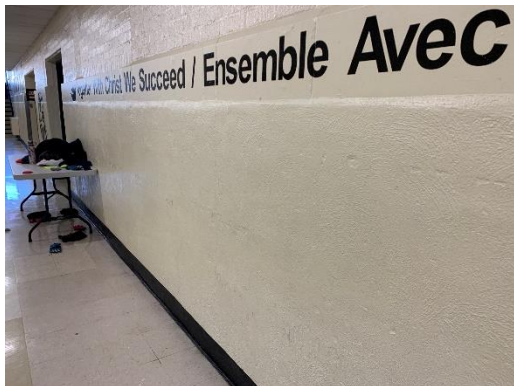
Material and Application	Asbestos Type/Friability	Photo
<p>based on historical knowledge of the date of installation.</p> <p>Mastic underneath newer tiles are presumed to contain asbestos until sampling proves otherwise.</p>	Presumed/Non-friable (mastic)	
Textured paint/primer is present on walls.	None	
<p>A coating/compound is underneath the paint in the Corridor (Location 4010). This coating/compound is presumed to be throughout the school until further sampling confirms otherwise.</p>	Chrysotile/Non-friable

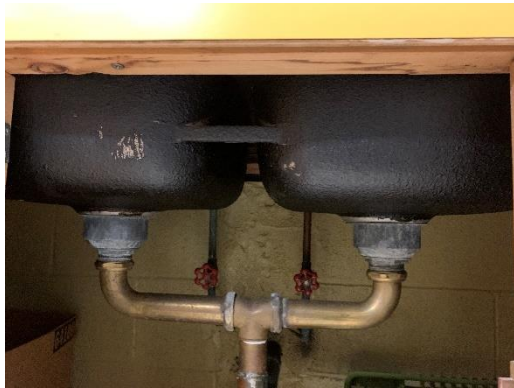
Black sink undercoating is present.	Chrysotile/Non-friable
