Asbestos Reassessment

St. Francis Xavier
298 Hamilton Regional Road 8,
Stoney Creek, Ontario

**Hamilton-Wentworth Catholic
District School Board**

August 18, 2022

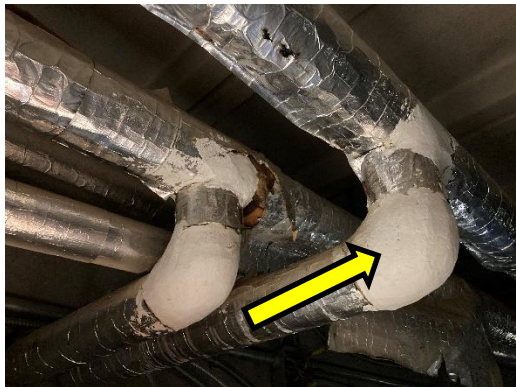
Material and Application	Asbestos Type/Friability	Photo
Non-asbestos fireproofing is present on structural steel including beams, trusses, joists, corrugated steel deck, concrete deck, columns.	None	
Parging cement is present on pipe fittings (elbows, valves, tees, hangers etc.)	Chrysotile/Friable

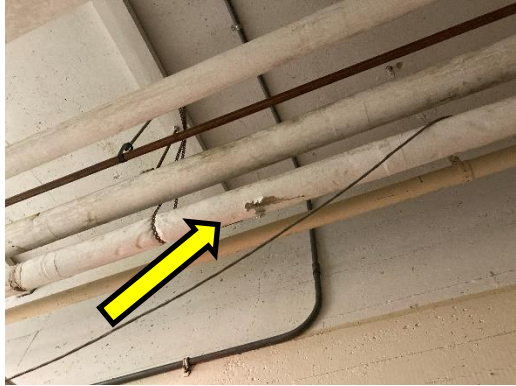
Material and Application	Asbestos Type/Friability	Photo
A white corrugated paper insulation (trade name Aircell) is present on straight sections of domestic water system pipes.	Chrysotile/Friable

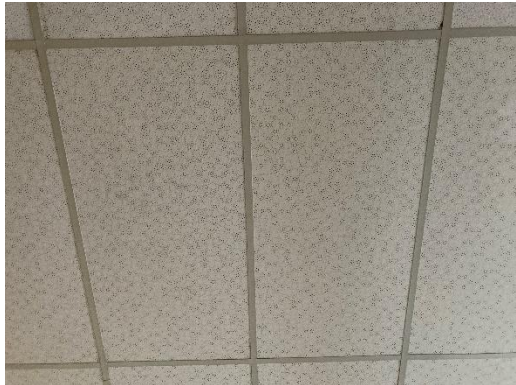
Remaining pipes are either uninsulated or insulated with non-asbestos fibreglass or elastomeric insulation (Armaflex).	None	
Ducts are either uninsulated or insulated with non-asbestos fibreglass (foil-faced or canvas).	None	
Mechanical equipment is either uninsulated or insulated with non-asbestos fibreglass.	None	
24"x48" lay-in ceiling tiles, with a honeycomb pattern are present.	Amosite/Non-friable

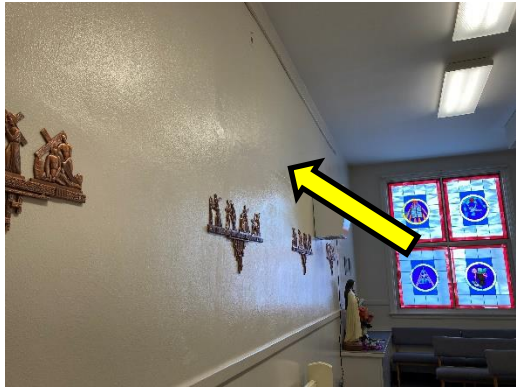
Material and Application	Asbestos Type/Friability	Photo
12"x12" lay-in ceiling tiles, with a long fissure random pinhole pattern are present.	None	
24"x24" lay-in ceiling tiles, with a small pinhole pattern are present.	None	
Remaining ceiling tiles are presumed to be non-asbestos based on the date of manufacture determined from the date stamp applied to the top of the tiles or the age of the materials determined from the age of the renovation.	None	
Textured plaster, containing asbestos, is present on walls in Classroom 24 (Location 2007), Chapel (Location 2008) and Classroom 25 (Location 2009).	Chrysotile/Potentially Friable

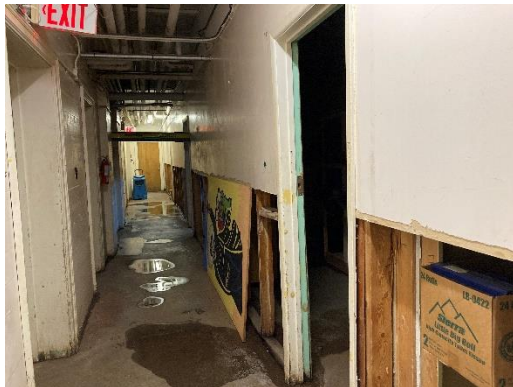
Material and Application	Asbestos Type/Friability	Photo
Drywall joint compound is present on wall and ceiling finishes throughout the building.	Chrysotile/Non-friable

Additional notes on the asbestos-containing drywall joint compound discussed above:

- Drywall (gypsum board) and drywall joint compound is present as a wall and ceiling finish throughout the building. As per the methodology, drywall joint compound is sampled at exterior walls, columns or other locations that are unlikely to have been renovated in an attempt to determine the presence of asbestos in the original drywall compound. A total of 6 samples of drywall joint compound were collected (samples S001A-C, lab reference no. IATL 312128 and samples S0018A-C, lab reference no. 71918392) and it was found that one sample contains chrysotile asbestos. The asbestos-positive results indicate that at minimum, the original drywall joint compound application contains asbestos and that any concealed drywall joint compound behind newer non-asbestos drywall joint compound should be presumed to contain asbestos. Further sampling may be considered in an attempt to delineate asbestos-containing drywall compound from newer, non-asbestos drywall compound.

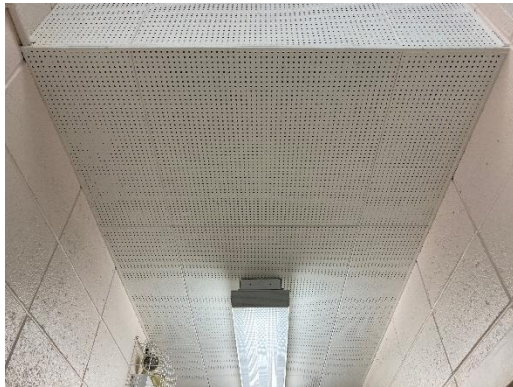
Non-asbestos drywall joint compound is present on remaining wall and ceiling finishes throughout the building.	None	
Transite board is present as ceiling tiles.	Presumed/Non-friable

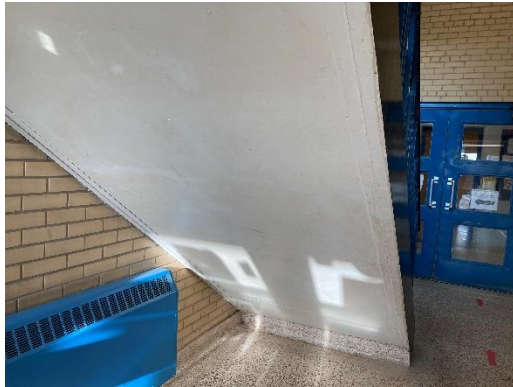
Transite board is present beneath the stairs in the Stairwell (Location 1028).	Presumed/Non-friable

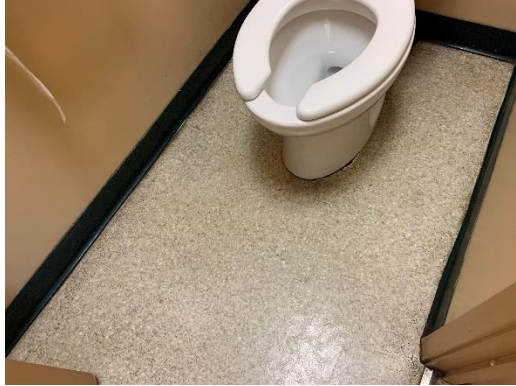
Material and Application	Asbestos Type/Friability	Photo
Vinyl sheet flooring, with a marbled pattern is present.	Presumed/Potentially Friable (sheet flooring) Presumed/Non-friable (mastic)

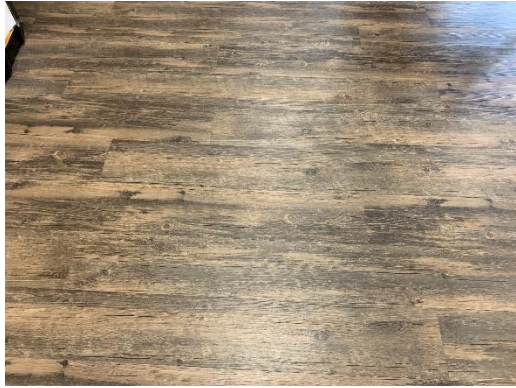
Vinyl floor tiles, 12"x12" wood look are present.	None (tile) Presumed/Non-friable (mastic)

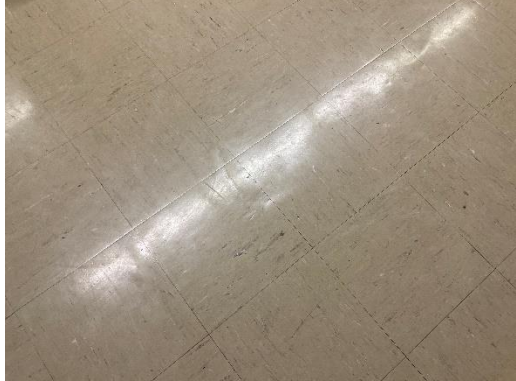
Vinyl floor tiles, 12"x12" white with brown fleck are present.	None (tile) Presumed/Non-friable (mastic)

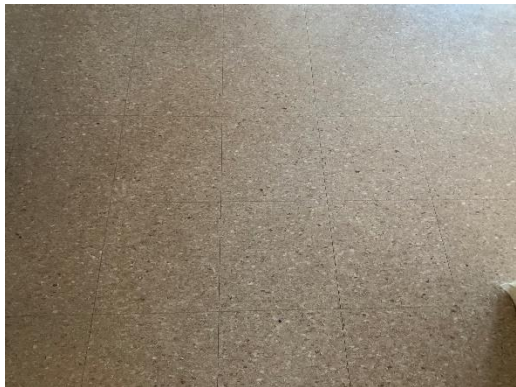
Material and Application	Asbestos Type/Friability	Photo
Vinyl floor tiles, 12"x12" pink with white and brown fleck are present.	None (tile) Presumed/Non-friable (mastic)

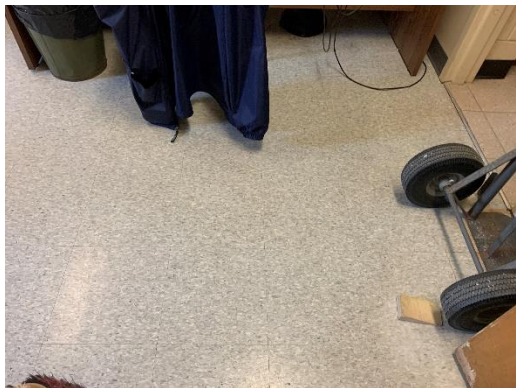
Vinyl floor tiles, 12"x12" grey multi-fleck are present.	None (tile) Presumed/Non-friable (mastic)

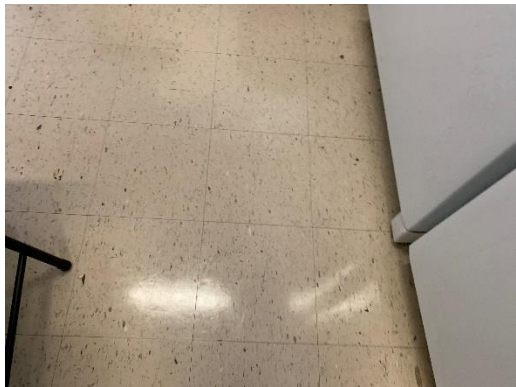
Vinyl floor tiles, 12"x12" beige with dark streaks are present.	Presumed/Non-friable (tile) Presumed/Non-friable (mastic)

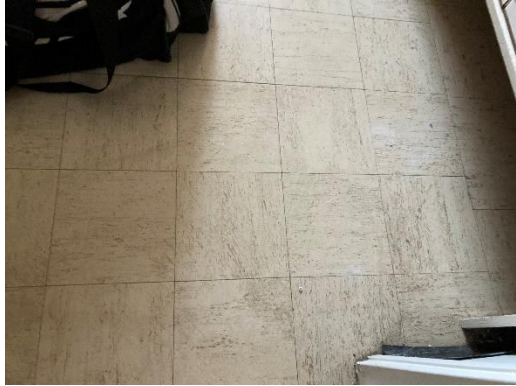
Material and Application	Asbestos Type/Friability	Photo
Vinyl floor tiles, 9"x9" cream with brown streaks are present.	Presumed/Non-friable (tile) Presumed/Non-friable (mastic)

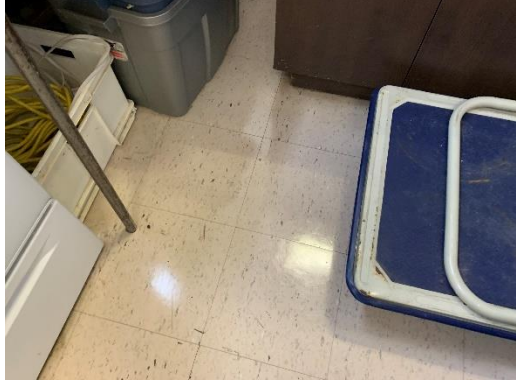
Vinyl floor tiles, 12"x12" beige with white and grey streaks are present.	Presumed/Non-friable (tile) Presumed/Non-friable (mastic)

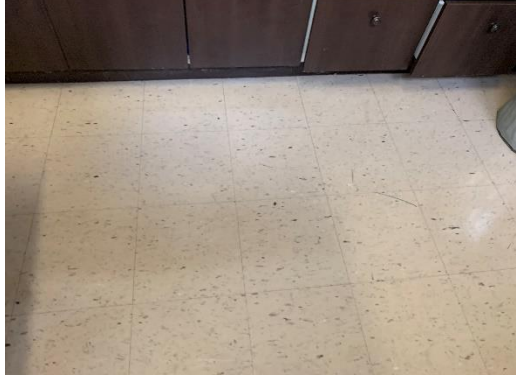
Vinyl floor tiles, 12"x12" white with black speck are present.	Presumed/Non-friable (tile) Presumed/Non-friable (mastic)

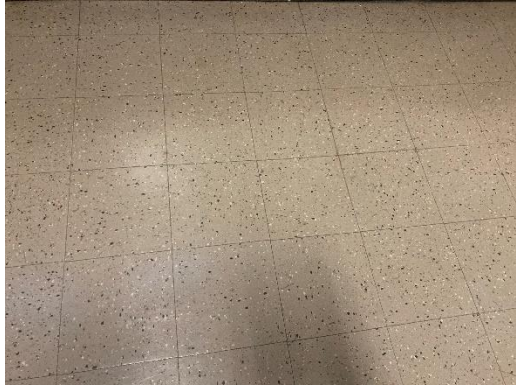
Material and Application	Asbestos Type/Friability	Photo
Vinyl floor tiles, 9"x9" brown with green/red/blue spots are present.	Presumed/Non-friable (tile) Presumed/Non-friable (mastic)

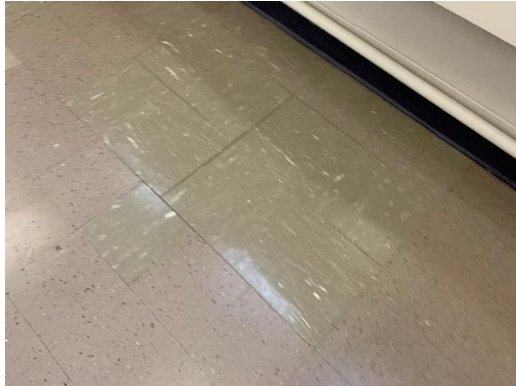
Vinyl floor tiles, 12"x12" green with streaks are present.	Presumed/Non-friable (tile) Presumed/Non-friable (mastic)

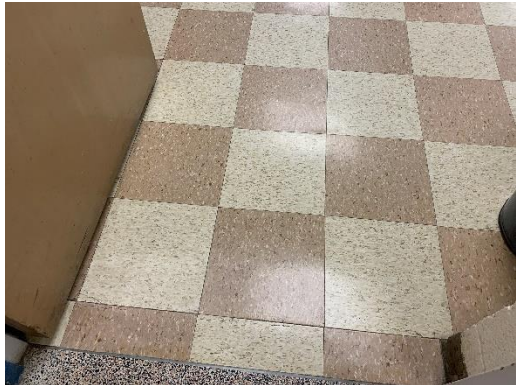
Vinyl floor tiles, 12"x12" pink marbled are present.	None (tile) Presumed/Non-friable (mastic)

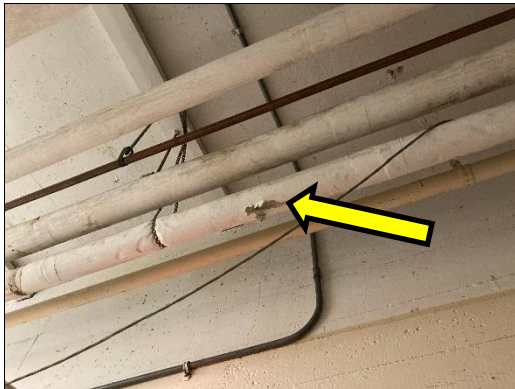
Material, Quantity, Condition and Photo #	Location Name (Location #)	Recommended Procedure
Aircell pipe insulation, 1 linear foot, fair condition, Photo 1	Corridor (Location 7)	Repair with canvas and lagging following Type 2 asbestos procedures
Parging cement pipe insulation, 1 fitting, poor condition, Photo 2	North end of Corridor (Location 1012)	Take asbestos precautions for work above ceiling where poor condition pipe insulation is present
