Asbestos Reassessment

St. Joachim
75 Concerto Court, Ancaster,
Ontario

August 12, 2022

Pinchin File: 303992.004

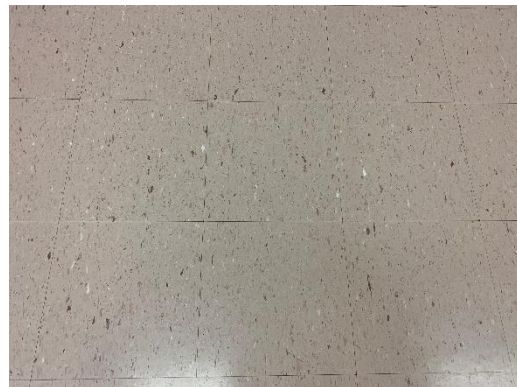
Material and Application	Asbestos Type/Friability	Photo
Pipes are either uninsulated or insulated with non-asbestos fibreglass or elastomeric insulation (Armaflex).	None	
Ducts are either uninsulated or insulated with non-asbestos fibreglass.	None	
Mechanical equipment is either uninsulated or insulated with non-asbestos fibreglass.	None	
All ceiling tiles are presumed to be non-asbestos based on the age of the building (1990)	None	
Asbestos in drywall joint compound was banned in Canada in 1980. Drywall joint compound in the building was installed after 1986 (1980 plus a reasonable non-compliance period based on our experience) and is assumed to contain no asbestos.	None	
Vinyl floor tiles, 12"x12", pink with pink and white fleck, are present.	None (tile) None (mastic)

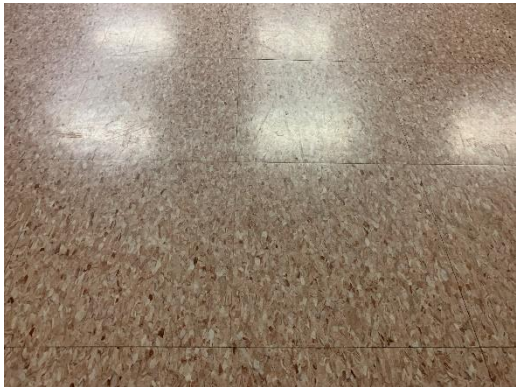
Material and Application	Asbestos Type/Friability	Photo
Vinyl floor tiles, 12"x12", pink oatmeal, are present.	None (tile) None (mastic)

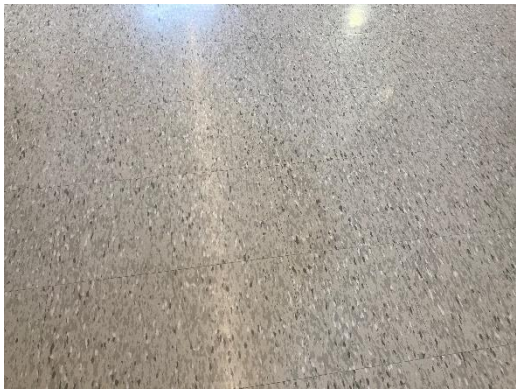
Vinyl floor tiles, 12"x12", grey oatmeal, are present.	None (tile) None (mastic)

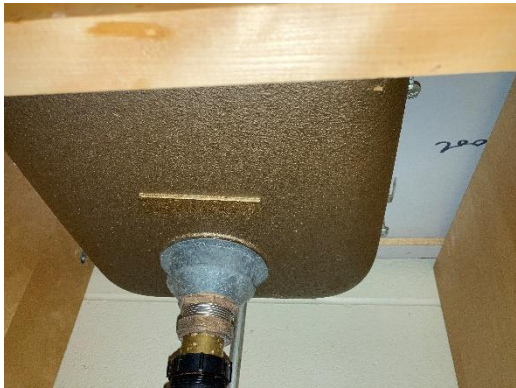
Remaining vinyl floor tiles and mastic are presumed to contain asbestos until sampling proves otherwise.	Presumed/Non-friable (tile) Presumed/Non-friable (mastic)	
Gold mastic is present as a sink undercoating.	Chrysotile/Non-Friable

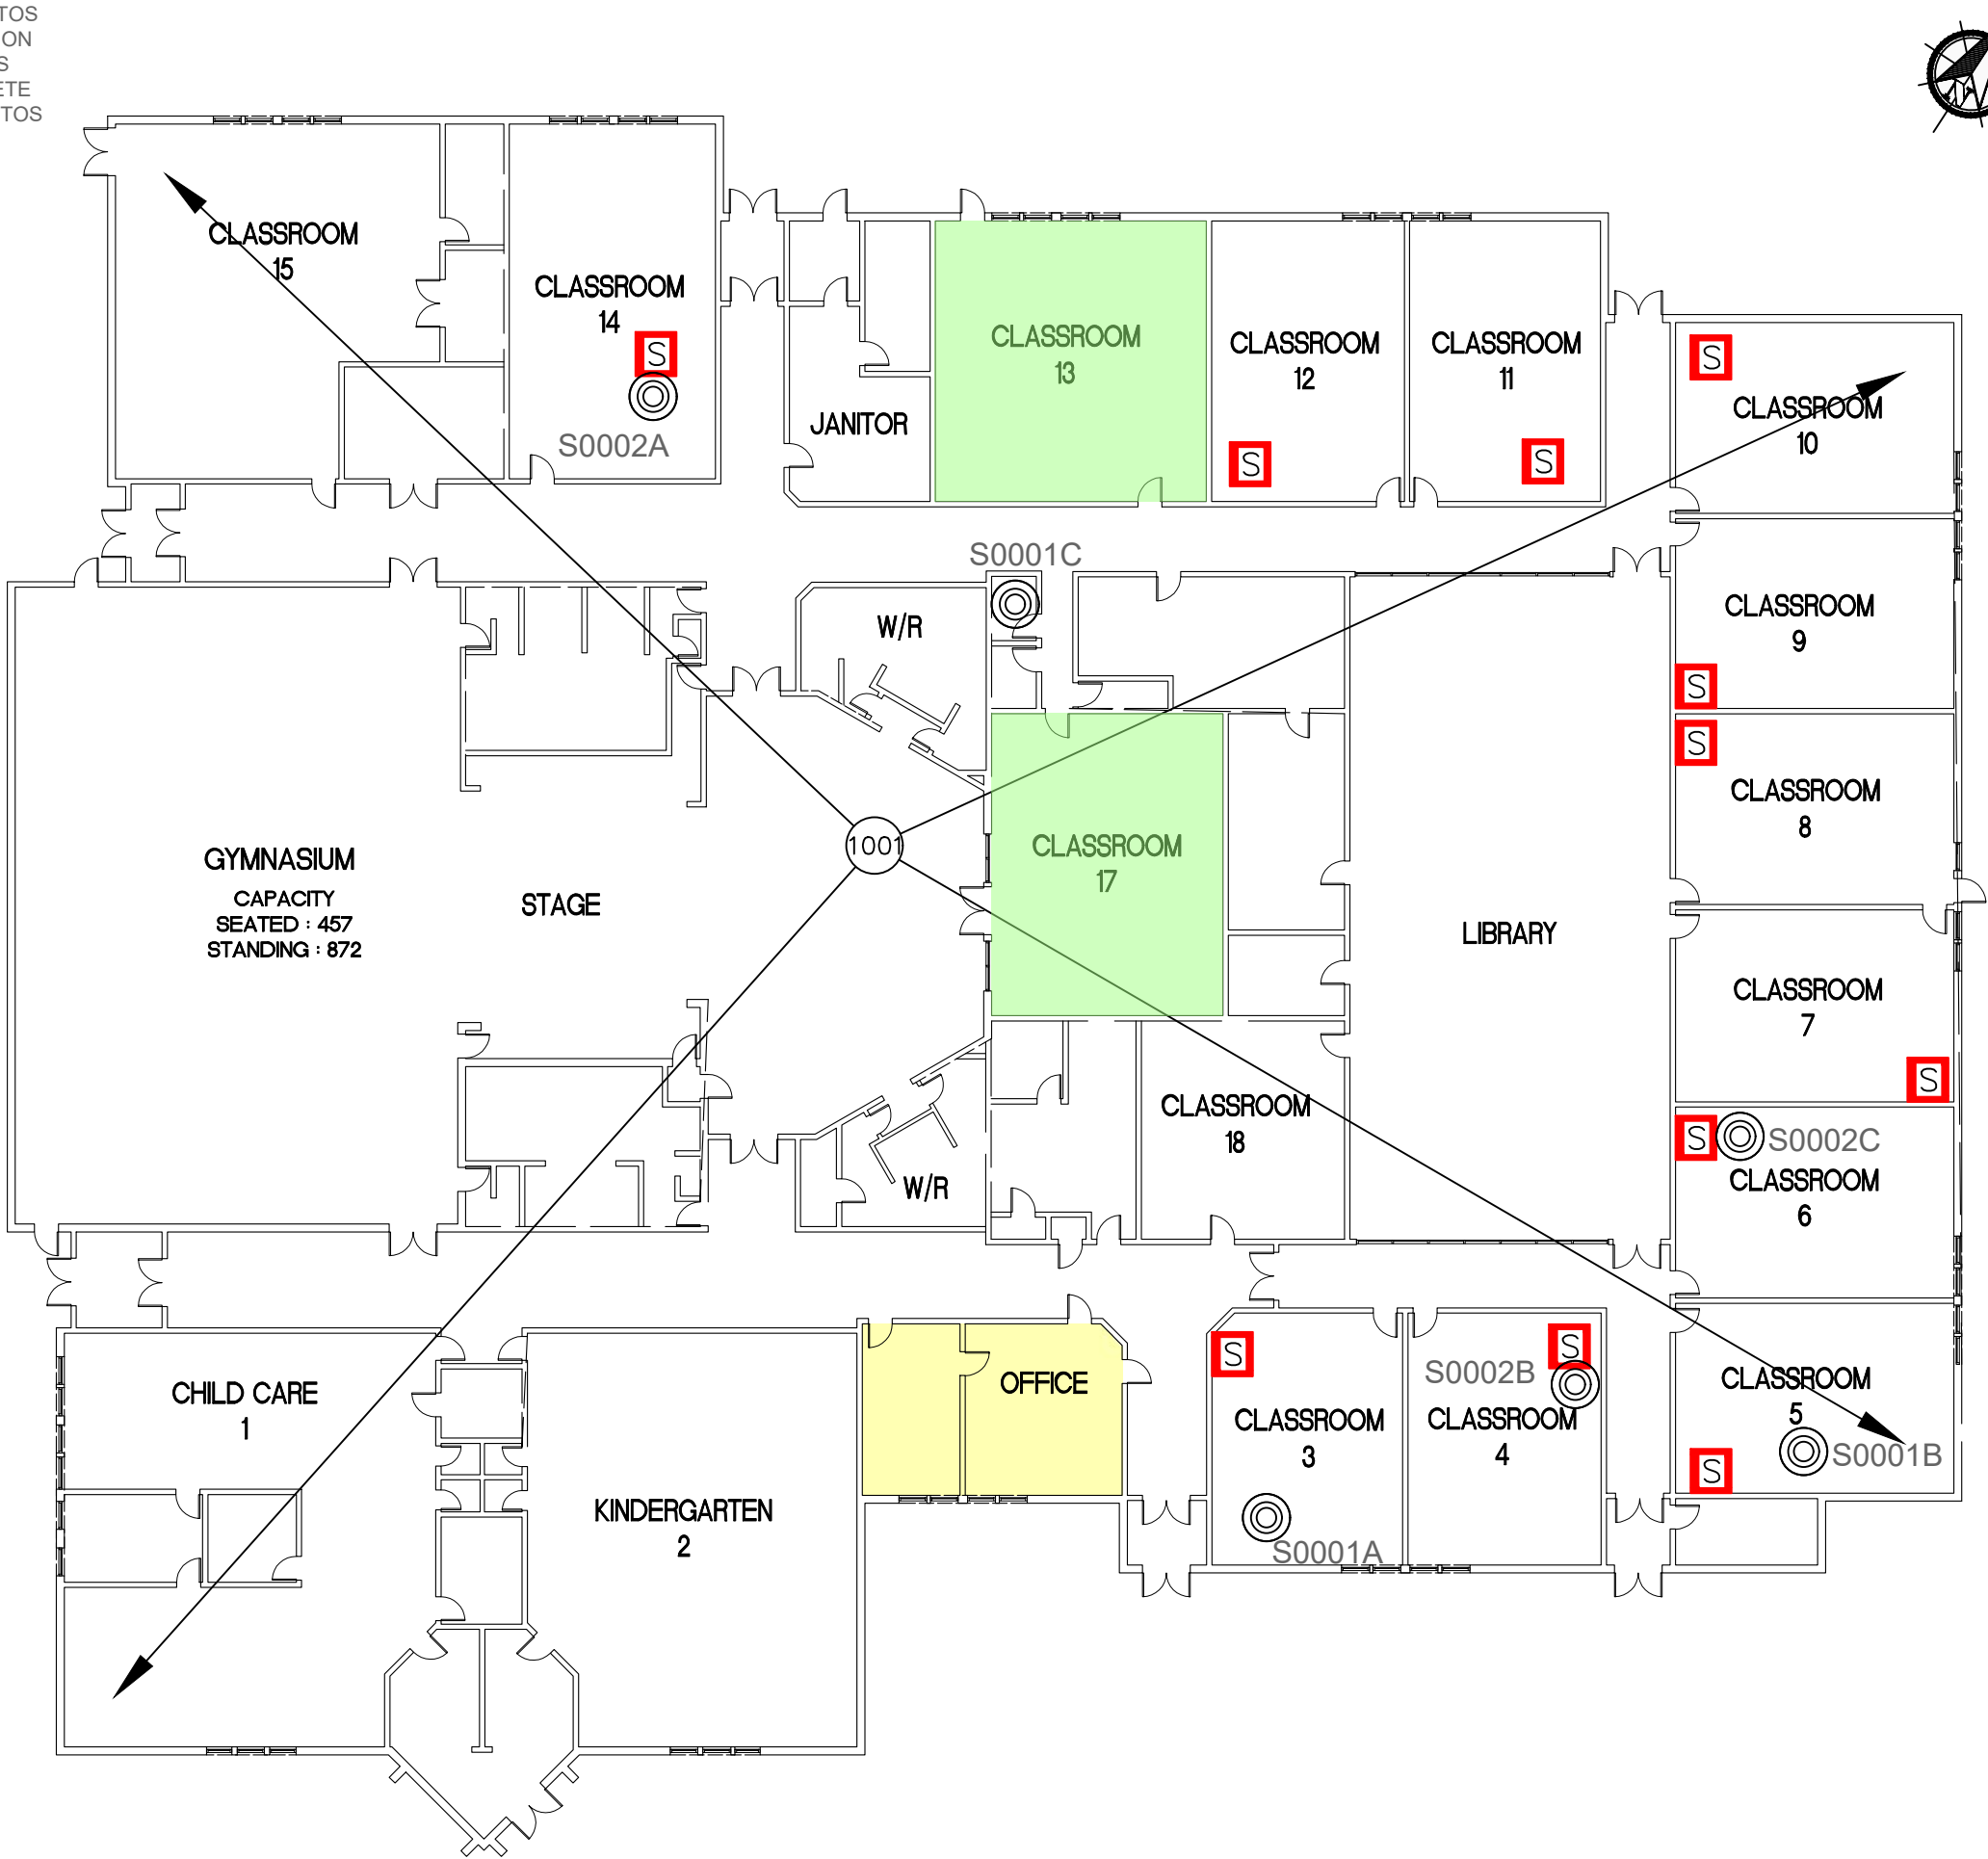
TITLE:
ASBESTOS REASSESSMENT
FLOOR LEVEL 1

- (S) SINK UNDERCOATING
- (Green) VINYL FLOOR TILES & MASTIC
- (Yellow) MASTIC
