Asbestos Reassessment

St. John the Baptist
115 London Street South,
Hamilton, Ontario

August 29, 2022

Pinchin File: 303992.004

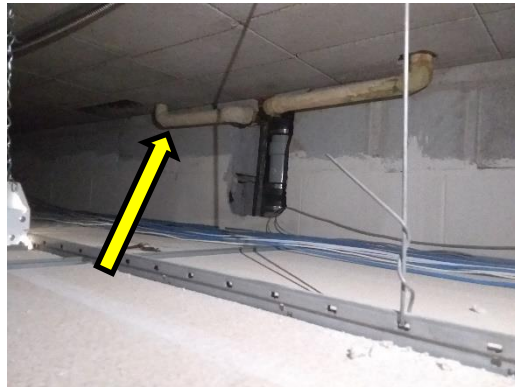
Material and Application	Asbestos Type/Friability	Photo
Parging cement asbestos, is present on pipe fittings (elbows, valves, tees, hangers etc.)	Chrysotile/Friable

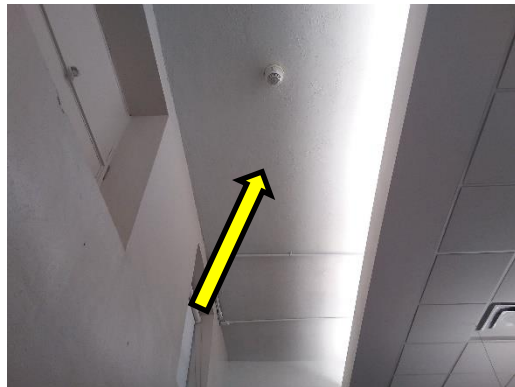
Remaining pipes are either uninsulated or insulated with non-asbestos fibreglass or elastomeric insulation (Armaflex).	None	
Ducts are either uninsulated or insulated with non-asbestos fibreglass.	None	
Mechanical equipment is either uninsulated or insulated with non-asbestos fibreglass.	None	
All ceiling tiles are presumed to be non-asbestos based on the date of manufacture determined from the date stamp applied to the top of the tiles, the age of the materials determined from the age of the building or the renovation, or by sample analysis.	None	
Textured plaster is present as a ceiling finish.	Chrysotile/Friable

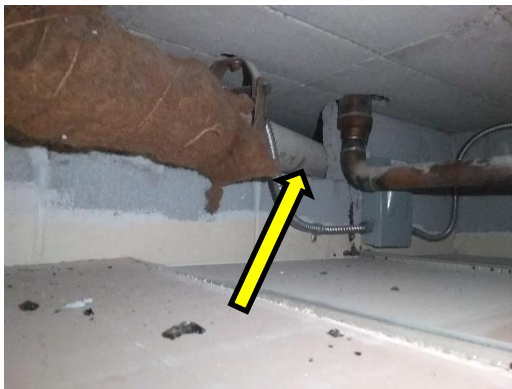
Material and Application	Asbestos Type/Friability	Photo
Smooth, textured, and rough plaster present on walls and ceilings does not contain asbestos.	None	
Non-asbestos drywall joint compound is present on wall and ceiling finishes.	None	
Asbestos in drywall joint compound was banned in Canada in 1980. Drywall joint compound in the 2000 addition was installed after 1986 (1980 plus a reasonable non-compliance period based on our experience) and is assumed to contain no asbestos.	None	
Transite pipe is present.	Presumed/ Non-friable

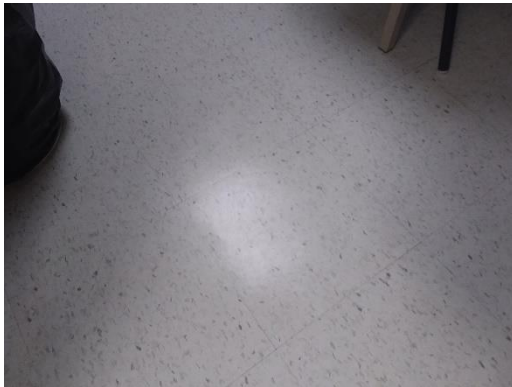
Vinyl floor tiles, 12"x12", white with black speck, are present.	Presumed/Non-friable (tile) Presumed/Non-friable (mastic)

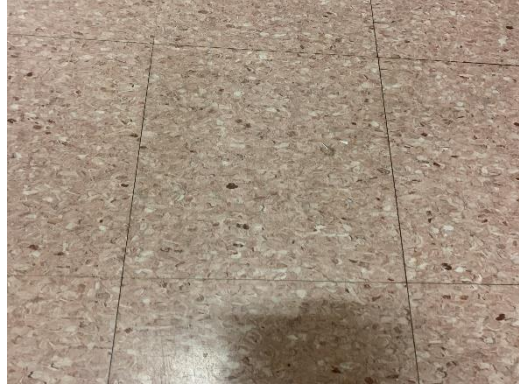
Material and Application	Asbestos Type/Friability	Photo
Vinyl floor tiles, 12"x12", beige, are present.	Presumed/Non-friable (tile) Presumed/Non-friable (mastic)

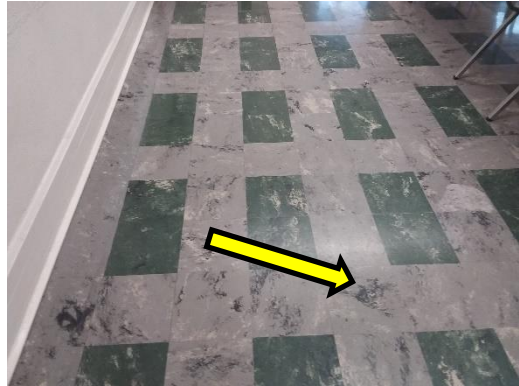
Vinyl floor tiles, 9"x9", grey with black and white, are present.	Presumed/Non-friable (tile) Presumed/Non-friable (mastic)

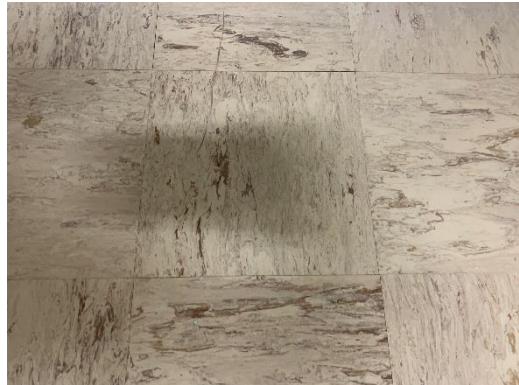
Vinyl floor tiles, 9"x9", white with grey streaks, are present.	Presumed/Non-friable (tile) Presumed/Non-friable (mastic)

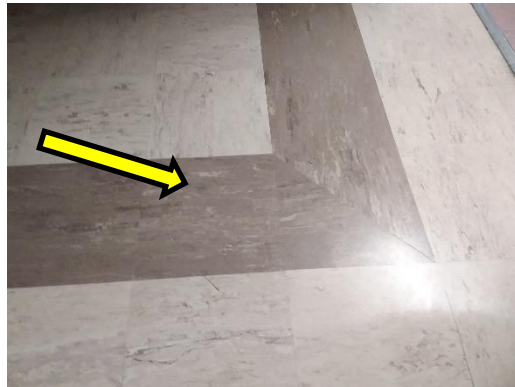
Material and Application	Asbestos Type/Friability	Photo
Vinyl floor tiles, 9"x9", brown with cream, are present.	Presumed/Non-friable (tile) Presumed/Non-friable (mastic)

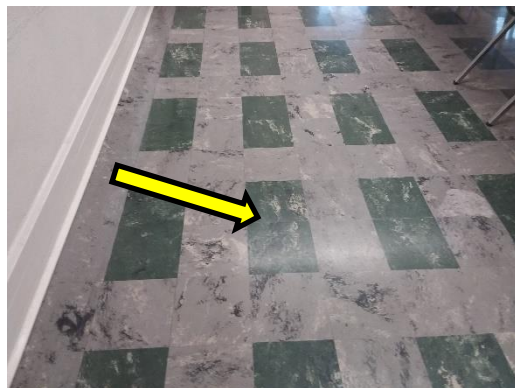
Vinyl floor tiles, 9"x9", green with golden, are present.	Presumed/Non-friable (tile) Presumed/Non-friable (mastic)

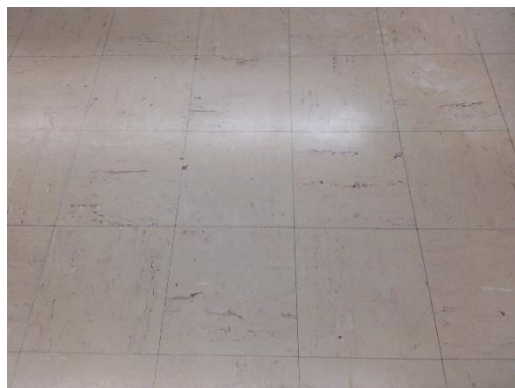
Vinyl floor tiles, 9"x9", golden with red, are present.	Chrysotile/Non-friable (tile) None (mastic)
