Asbestos Reassessment

St. Joseph
270 Locke Street South,
Hamilton, Ontario

August 30, 2022

Pinchin File: 303992.004

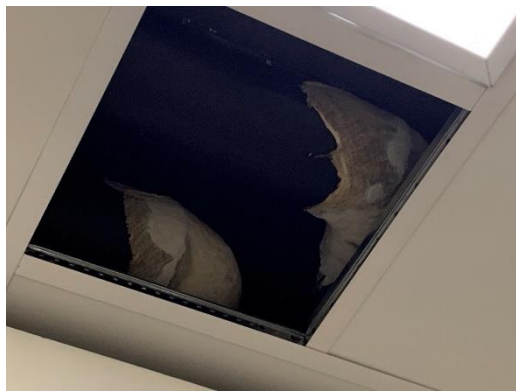
Material and Application	Asbestos Type/Friability	Photo
Parging cement is present on pipe fittings (elbows, valves, tees, hangers etc.).	Chrysotile/Friable

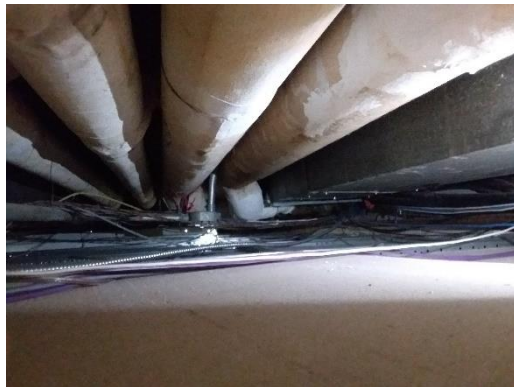
Material and Application	Asbestos Type/Friability	Photo
A white corrugated paper insulation (trade name Aircell), containing chrysotile asbestos, is present on straight sections of pipes.	Chrysotile/Friable

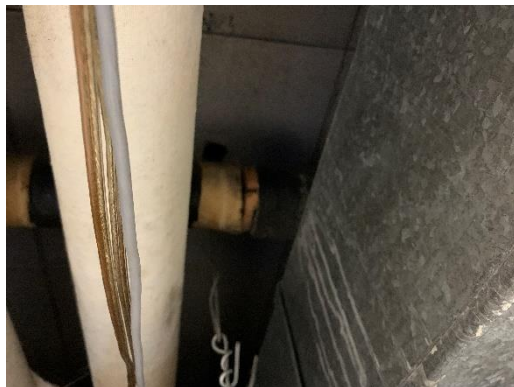
Sweatwrap insulation (brown layered paper) is present on straight sections of pipes.	None

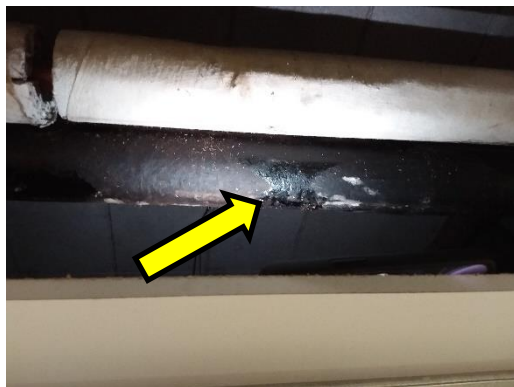
Tar is present on insulated pipe fittings and straight sections of pipes.	Presumed/Non-friable

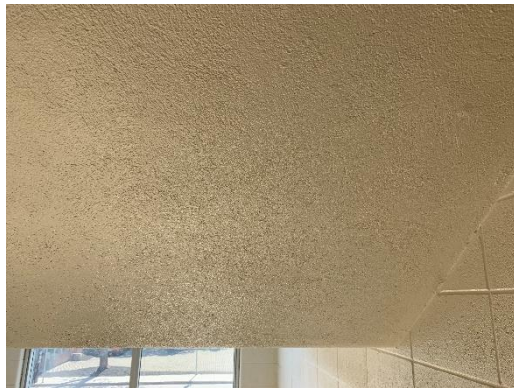
Material and Application	Asbestos Type/Friability	Photo
Ducts are either uninsulated or insulated with non-asbestos fibreglass (foil-faced or canvas).	None	
Mechanical equipment is either uninsulated or insulated with non-asbestos fibreglass.	None	
Vermiculite is present as insulation in perimeter masonry block walls.	Libby Amphibole/ Friable	
24"x48" lay-in ceiling tiles, with a honeycomb pinhole pattern are present.	Amosite/Non-friable	 
Remaining ceiling tiles were determined to be non-asbestos by analysis or are presumed to be non-asbestos based on the date of manufacture determined from the date stamp applied to the top of the tiles or the age of the materials determined from the age of the building renovation.	None	
Textured plaster, containing asbestos in the finish layer, is present on walls and ceilings.	Chrysotile/Potentially Friable

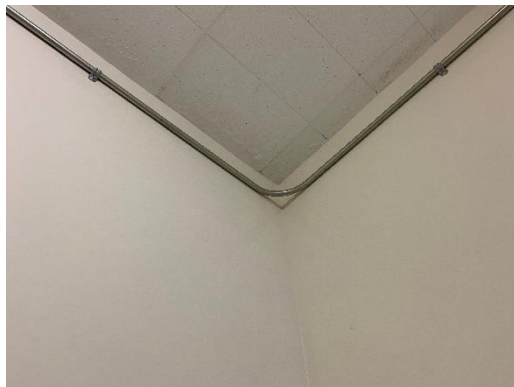
Material and Application	Asbestos Type/Friability	Photo
Smooth plaster present on walls and ceilings does not contain asbestos.	None	 
Drywall joint compound is present on wall and ceiling finishes.	Chrysotile/Non-friable

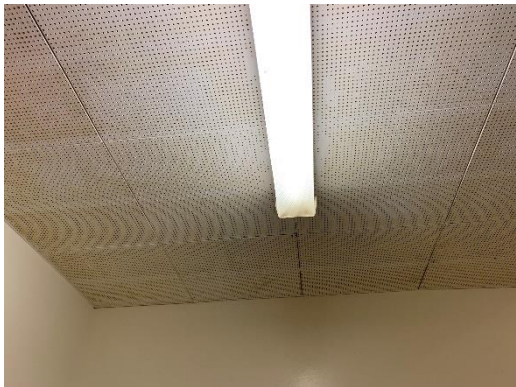
Material and Application	Asbestos Type/Friability	Photo
Transite board is present as acoustic ceiling tiles.	Presumed/Non-friable

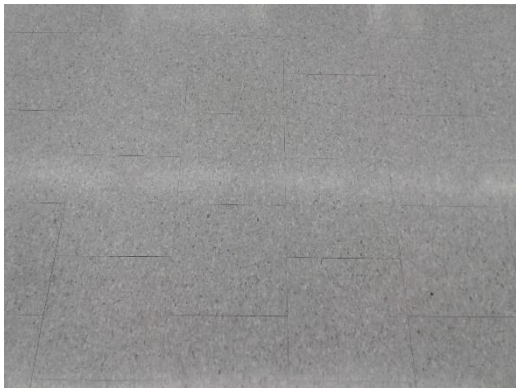
Vinyl floor tiles, 12"x12", beige with brown flecks, are present in the Gymnasium (Location 1015) underneath polyethylene sheeting	Presumed/Non-friable (tile) Presumed/Non-friable (mastic)	
Vinyl floor tiles, 12"x12", white with grey specks, are present.	Presumed/Non-friable (tile) Presumed/Non-friable (mastic)

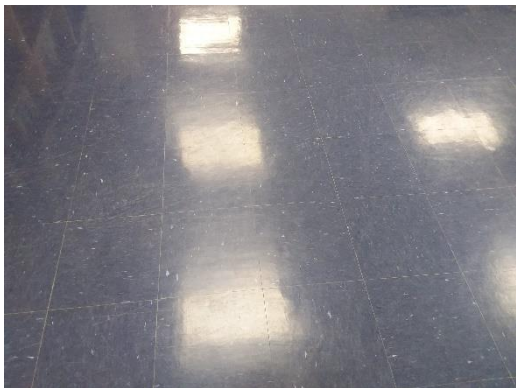
Vinyl floor tiles, 12"x12", blue with white flecks, are present.	Presumed/Non-friable (tile) Presumed/Non-friable (mastic)

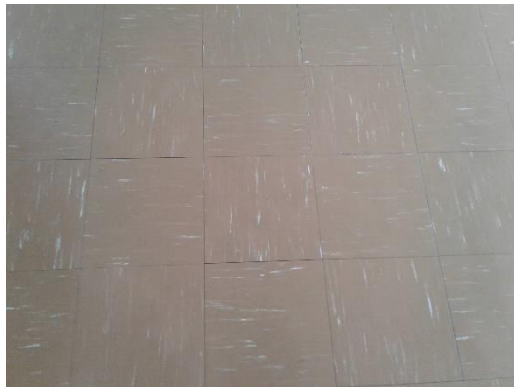
Material and Application	Asbestos Type/Friability	Photo
Vinyl floor tiles, 12"x12", brown with white streaks, are present.	Presumed/Non-friable (tile) Presumed/Non-friable (mastic)

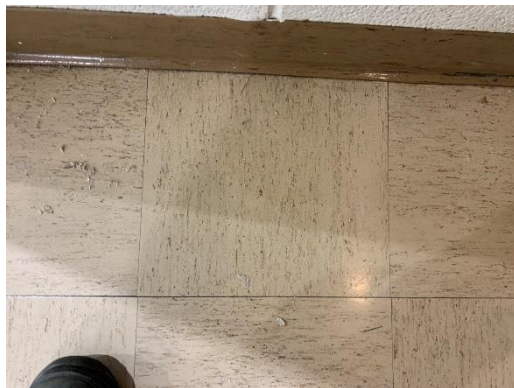
Vinyl floor tiles, 12"x12", white with black streaks, are present.	Presumed/Non-friable (tile) Presumed/Non-friable (mastic)

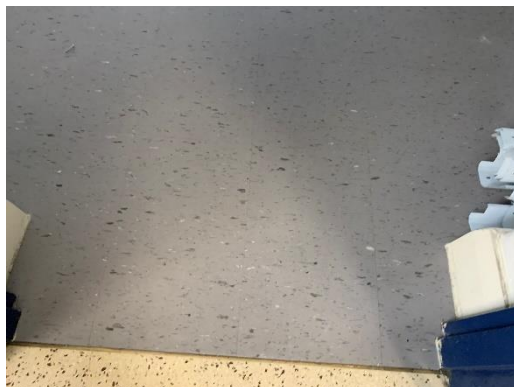
Vinyl floor tiles, 12"x12", green, are present.	Presumed/Non-friable (tile) Presumed/Non-friable (mastic)

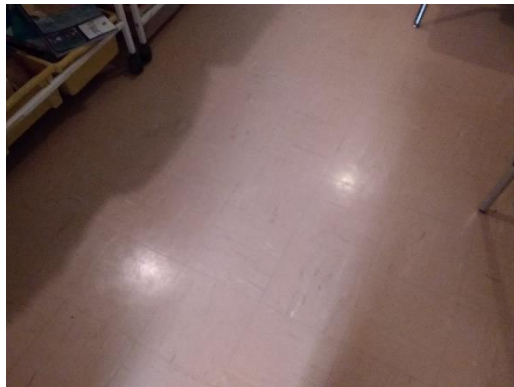
Material and Application	Asbestos Type/Friability	Photo
Vinyl floor tiles, 9"x9", pink with black and white streaks, are present.	Presumed/Non-friable (tile) Presumed/Non-friable (mastic)

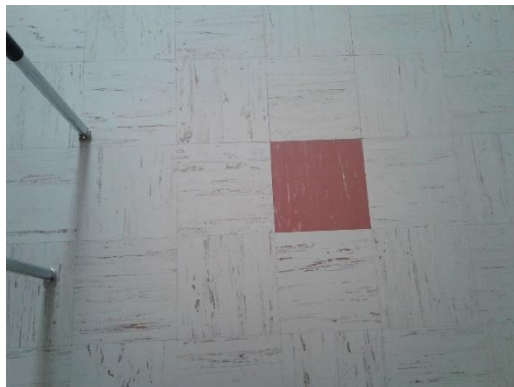
Vinyl floor tiles, 9"x9", red with white streaks, are present. Vinyl floor tiles, 9"x9", white with red streaks, are present.	Presumed/Non-friable (tile) Presumed/Non-friable (mastic)

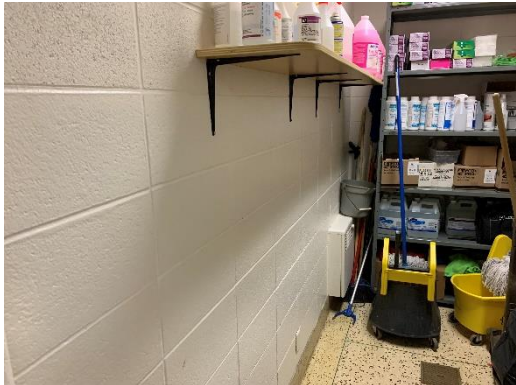
Material and Application	Asbestos Type/Friability	Photo
<p>Textured paints is present in the Custodian Closet, (Location 1010).</p> <p>The original paint has been painted over.</p>	<p>Chrysotile/Non-friable</p>

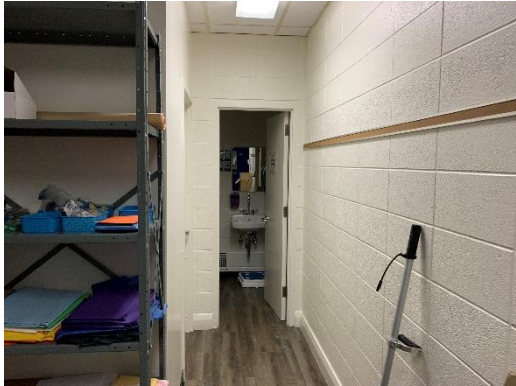
<p>Textured paint is present in the washroom of the Nurse (Custodial Supplies) room (Location 1008) and is also present in Corridors and Stairwells.</p> <p>The original paint has been painted over.</p>	<p>Chrysotile/Non-friable</p>

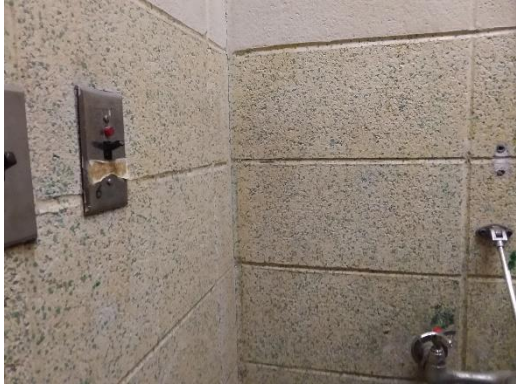
<p>Textured paint is present in the Sink Room (Location 3011).</p>	<p>Chrysotile/Non-friable</p>

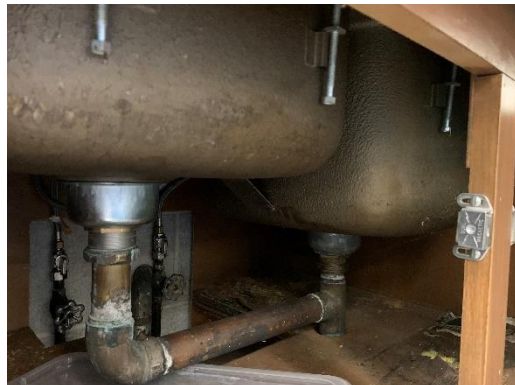
Material and Application	Asbestos Type/Friability	Photo
Gold mastic is present as a sink undercoating.	Presumed/Non-friable

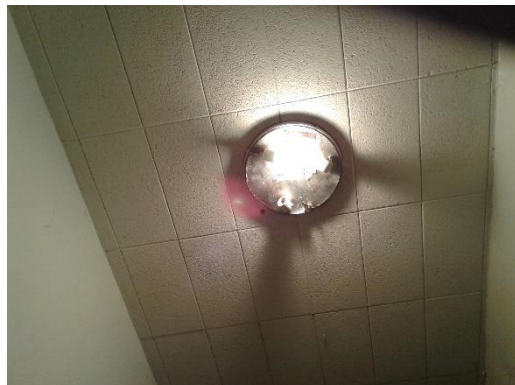
Paper heat shields are present in light fixtures.	Presumed/Non-friable
