# Asbestos Reassessment

St. Lawrence  
88 Macaulay Street East,  
Hamilton, Ontario

**Hamilton-Wentworth Catholic  
District School Board**

August 30, 2022

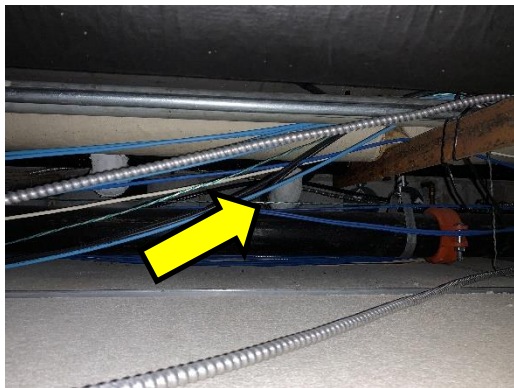
Material and Application	Asbestos Type/Friability	Photo
Non-asbestos fireproofing is present on structural steel including beams, trusses, joists, corrugated steel deck in Custodian Storage (Location 1009) and Electrical Room (Location 1010).	None	
Non-asbestos fireproofing is present on structural steel in Classroom 2 (Location 1001).	None	
Parging cement is present on pipe fittings (elbows, valves, tees, hangers etc.)	Chrysotile/Friable

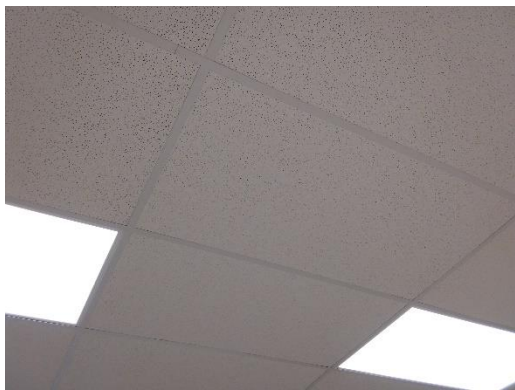
Material and Application	Asbestos Type/Friability	Photo
Remaining pipes are either uninsulated or insulated with non-asbestos fibreglass or elastomeric insulation (Armaflex).	None	
Ducts are either uninsulated or insulated with non-asbestos fibreglass (foil-faced or canvas).	None	
Mechanical equipment is either uninsulated or insulated with non-asbestos fibreglass.	None	
24"x48" lay-in ceiling tiles, with a textured pinhole pattern are present.	Amosite/Non-friable

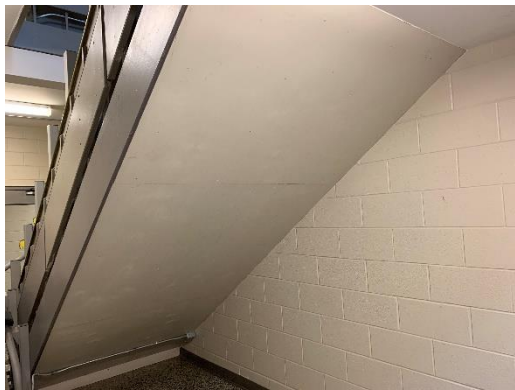
Material and Application	Asbestos Type/Friability	Photo
Asbestos in drywall joint compound was banned in Canada in 1980. Drywall joint compound in the 2010 addition was installed after 1986 (1980 plus a reasonable non-compliance period based on our experience) and is assumed to contain no asbestos.	None	
Transite board is present as a ceiling finish underneath stairs.	Presumed/Non-friable

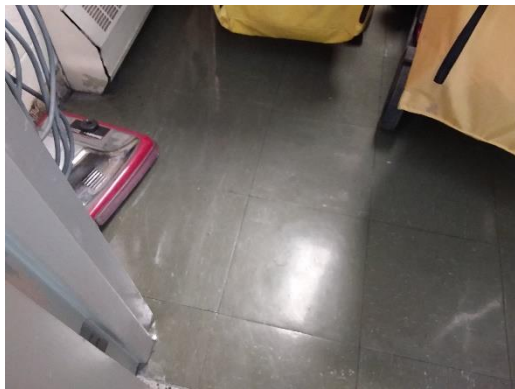
Vinyl floor tiles, 12"x12", dark green with white, are present.	Chrysotile/Non-friable (tile) Presumed/Non-friable (mastic)

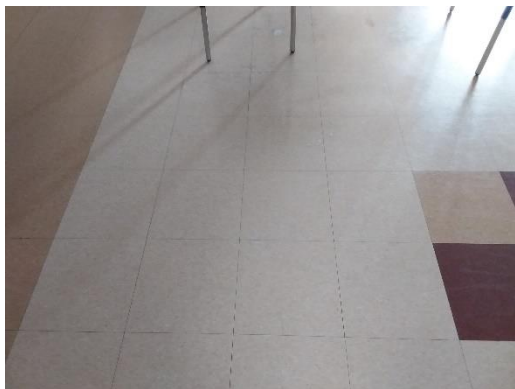
<p>Remaining vinyl floor tiles were presumed to be non-asbestos based on historical knowledge of the date of installation (2010).</p> <p>Mastic underneath new flooring is presumed to contain asbestos until sampling proves otherwise, with the exception of mastic in the addition which is non-asbestos based on the date of construction.</p>	None (tile) Presumed/Non-friable (mastic)
